Limited Geotechnical Engineering Report
Proposed Residences
530 38th Street
Bellingham, WA 98225

March 1, 2023
Project No. 23-0024

**Regarding: Limited Geotechnical Engineering Report
Proposed Residences**
530 38th Street
Bellingham, WA 98225
(Parcel No. 370306487445)

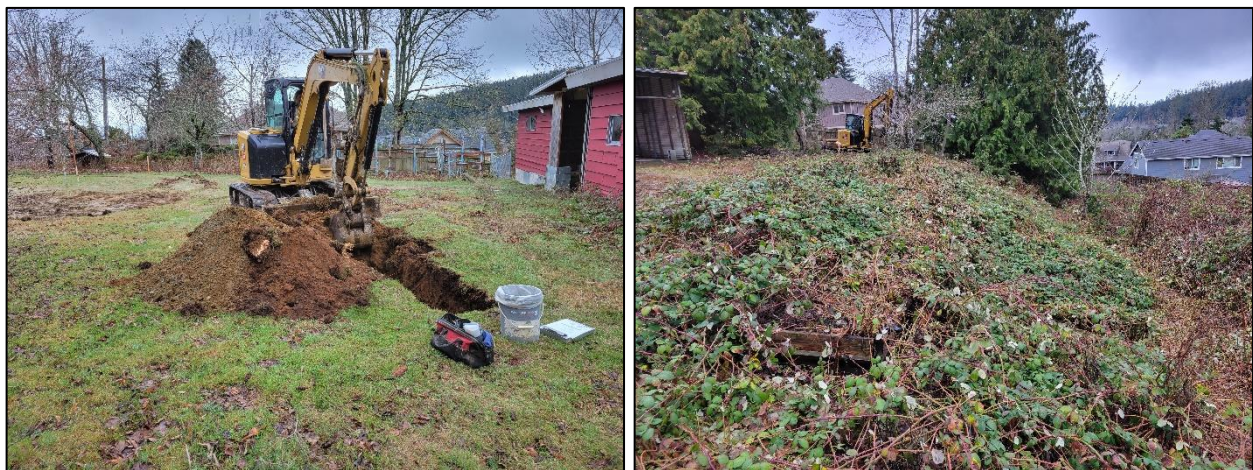
Image 1 (left) and Image 2 (right) – General surface conditions of the subject property. Image 1 is TP-2 in-progress facing southwest. Image 2 showing the slope area at the northern edge. Perspective is from the northeast corner facing southwest. Photos taken January 27th, 2023.

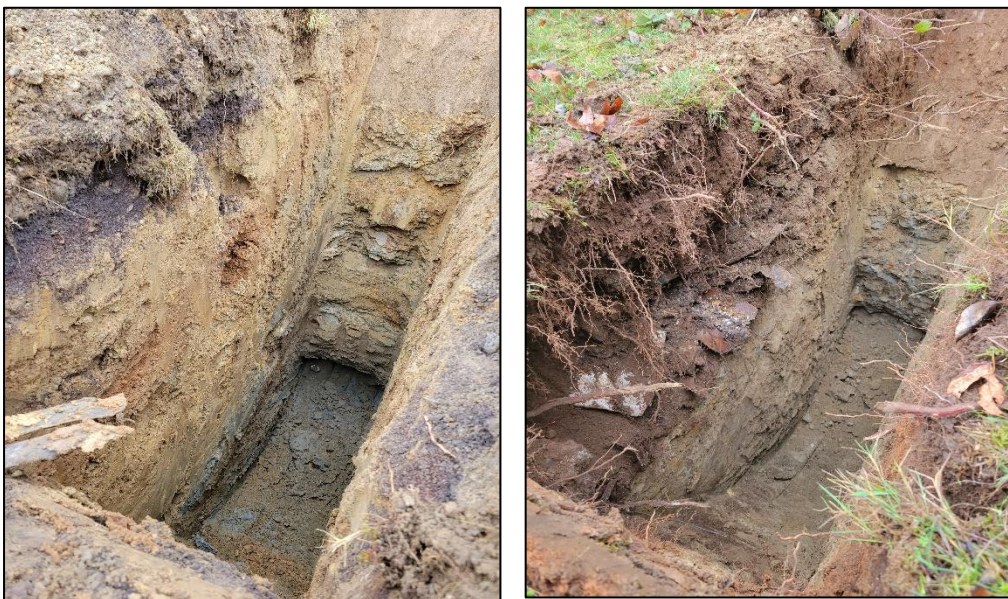
Image 3 (left) and Image 4 (right) – General subsurface conditions observed at the subject property. Image 3 shows subsurface conditions in TP-4. Note previously placed fill soils and debris atop native soils at depth in TP-5. Photos taken January 27th, 2023.

Our subsurface explorations displayed somewhat variable subsurface conditions across the site. Within TP-3, TP-4, and TP-5, GeoTest observed uncontrolled fill materials which extended from the surface to depths of between 1.0 and 3.5 feet BGS. These materials were variable but were generally described as loose to medium dense, brown to tan, damp, silty sand that contained various amounts of organic and anthropogenic debris. Within TP-1 and TP-2, between 0.5 and 0.75 feet of loose, dark brown, damp, silty sand that contained organics, and was interpreted as topsoil, was observed to extend to depth from the surface.

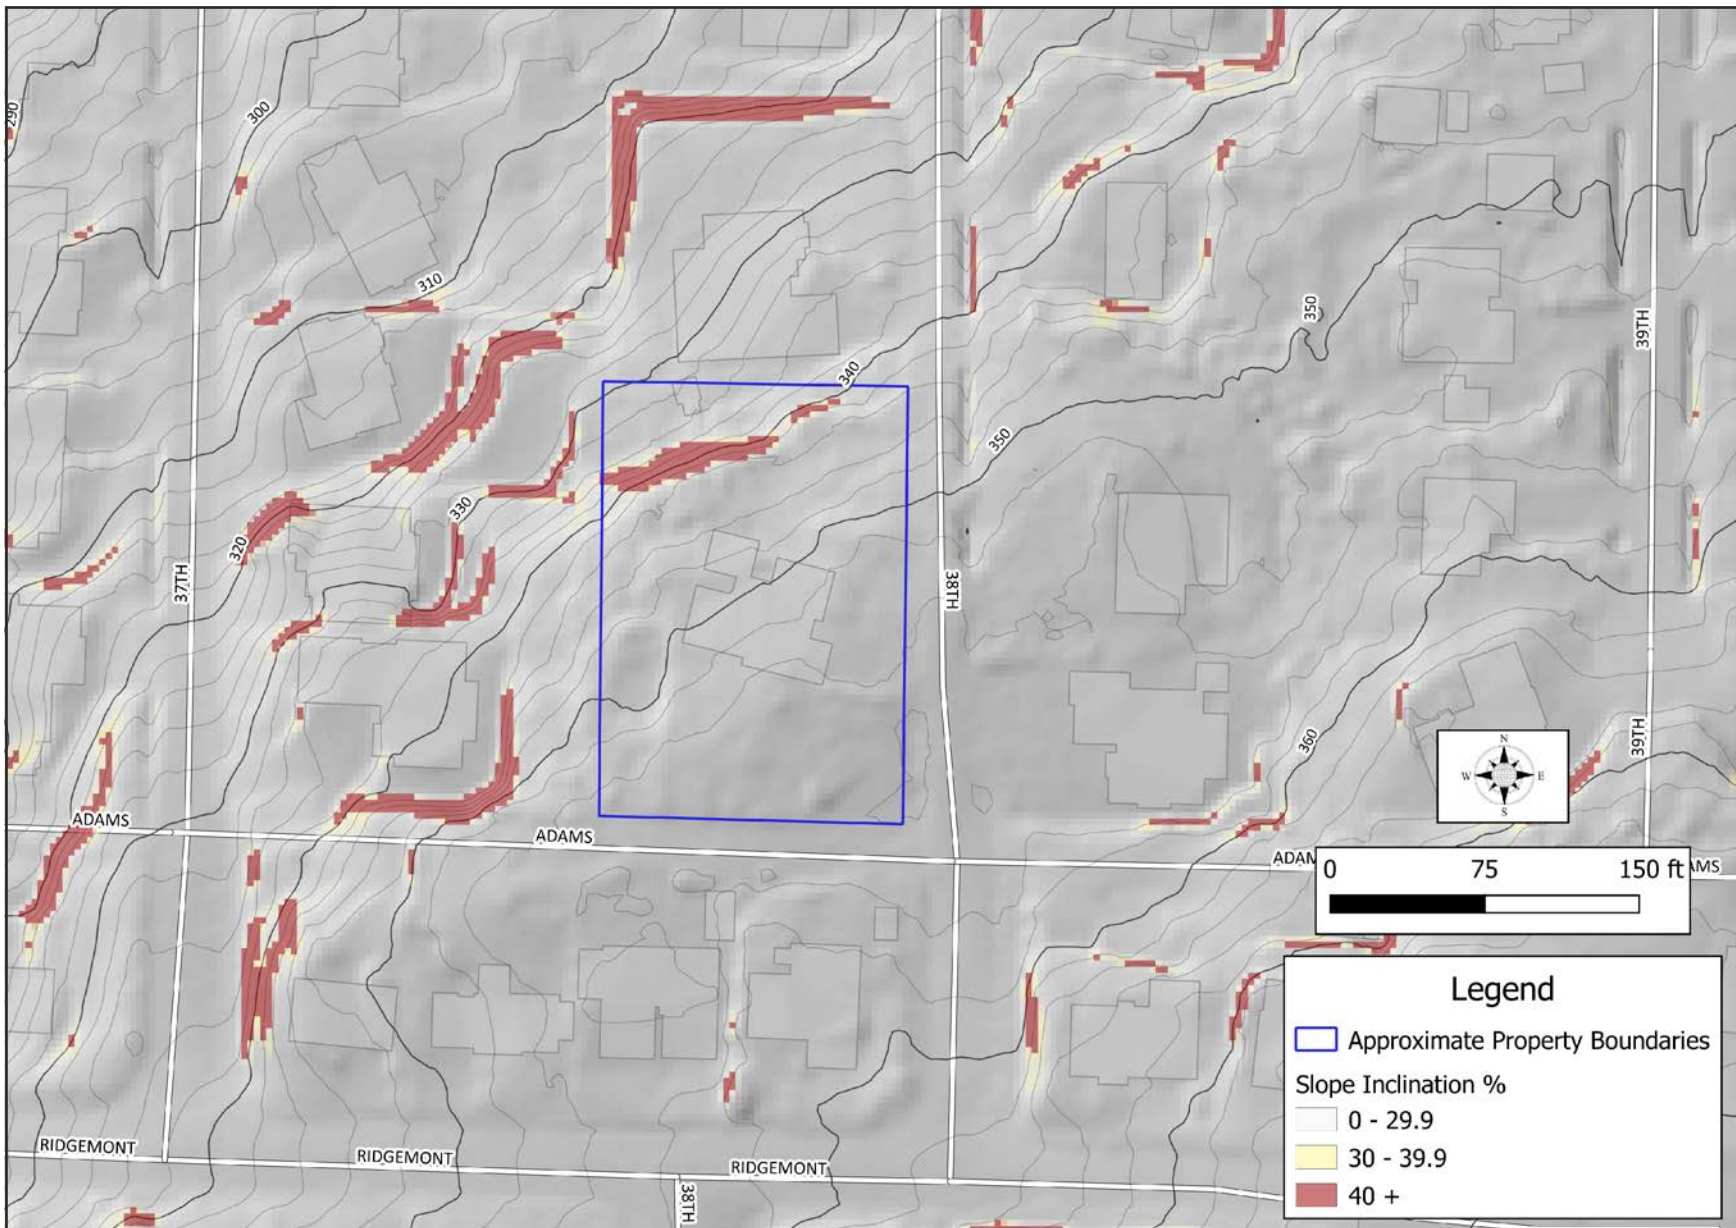
The soils underlying the project site are composed of greater than 50 percent sand and silt. Additionally, limited areas of the site exceed 30 percent grades within the northwestern most portion of the project site (See Figure 3 – *Bare Earth Imagery*). **Therefore, this portion of project site is considered to contain Erosion Hazard Areas per Bellingham Municipal Code.** Residential construction is required to meet the standards outlined in 16.55.440A. Thus, the development will require an erosion and sediment control, drainage, and mitigation plan prepared in compliance with BMC 15.42. In our opinion, the erosion potential at the project site can be managed with appropriate construction practices.

Based on our review of digital elevation models, topographic drawings, and our on-site observations, **the project site does not contain Landslide Hazard Areas as defined by Bellingham Municipal Code** (See Figure 3 – *Bare Earth Imagery*).

Long term slope erosion must be mitigated through proper drainage and civil design. Stormwater volumes generated from proposed impermeable surfaces should be collected and directed to a municipally acceptable location. The following recommendations are intended to prevent excessive erosion from occurring at the site during and following construction:

- We recommend that appropriate silt fencing be incorporated into the construction plan for erosion control.
- We recommend that on-site BMP's be implemented during construction. Areas of native vegetation should be left in place or may be enhanced by adding additional native plant species and/or other vegetation enhancements.

- Removal of vegetation and trees without proper mitigation may increase the risk of failure for the surficial soils during periods of wet weather. Planting additional native vegetation within the sloped portion of the subject site and in areas disturbed by excavation activities will help maintain near surface slope stability by providing a stable root base within the near surface soils.

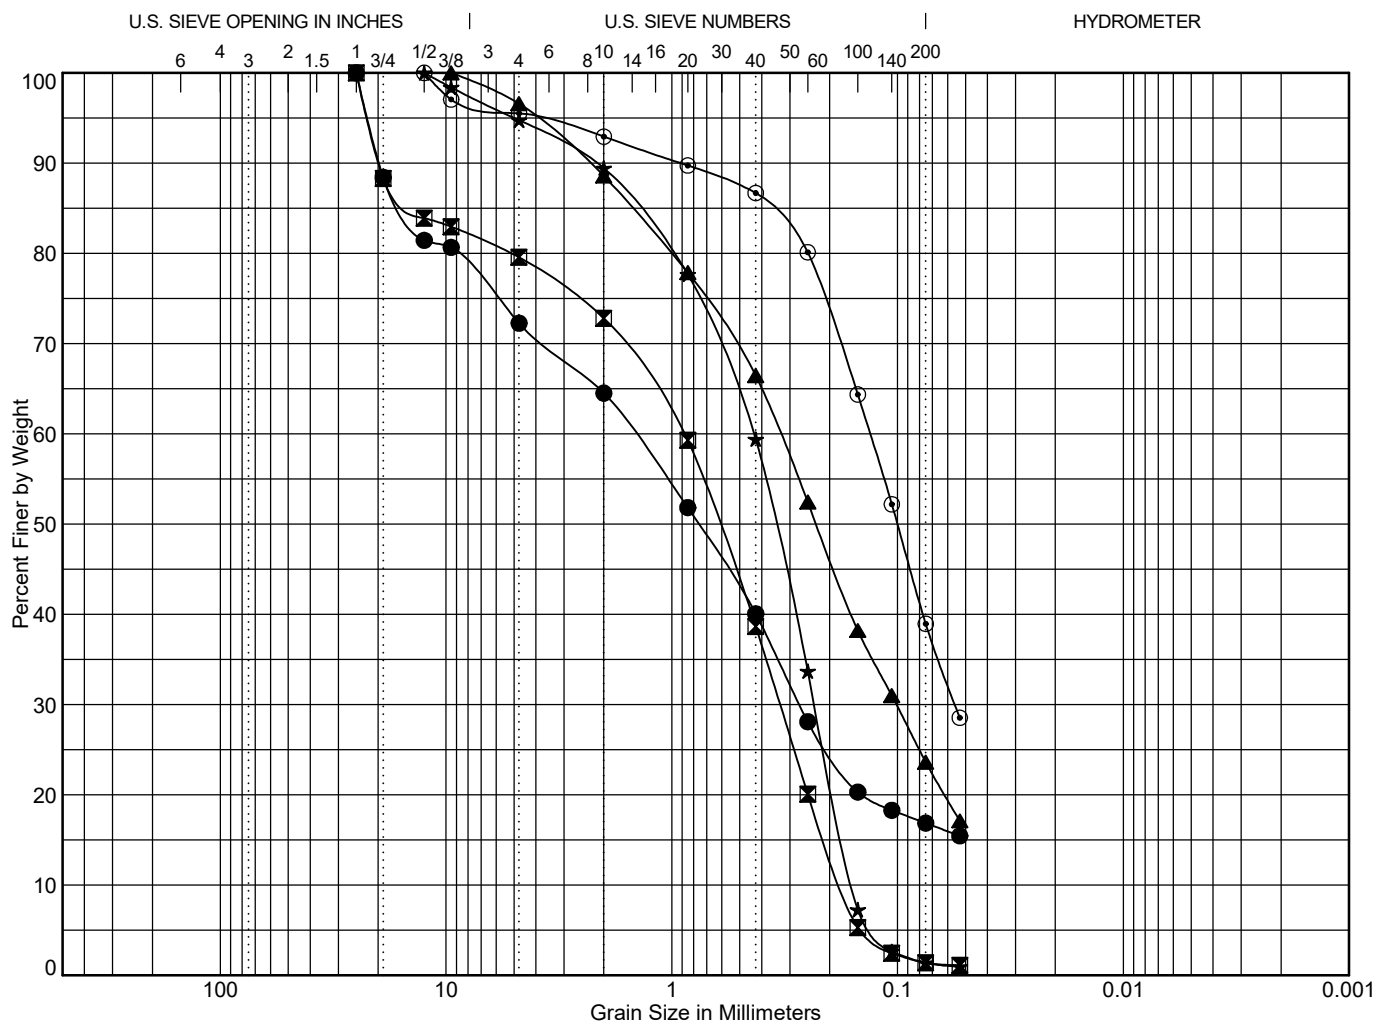
Figure
B-1

Point	Depth	Classification	LL	PL	PI	C _c	C _u
●	TP-1 1.2	Gravelly, silty SAND (SM)					
⊠	TP-1 2.3	Gravelly SAND (SP)				0.70	5.04
▲	TP-1 4.6	Silty SAND with trace gravel (SM)					
★	TP-2 2.6	Slightly gravelly SAND (SP)				0.79	2.75
⊙	TP-2 4.5	Very silty, slightly gravelly SAND (SM)

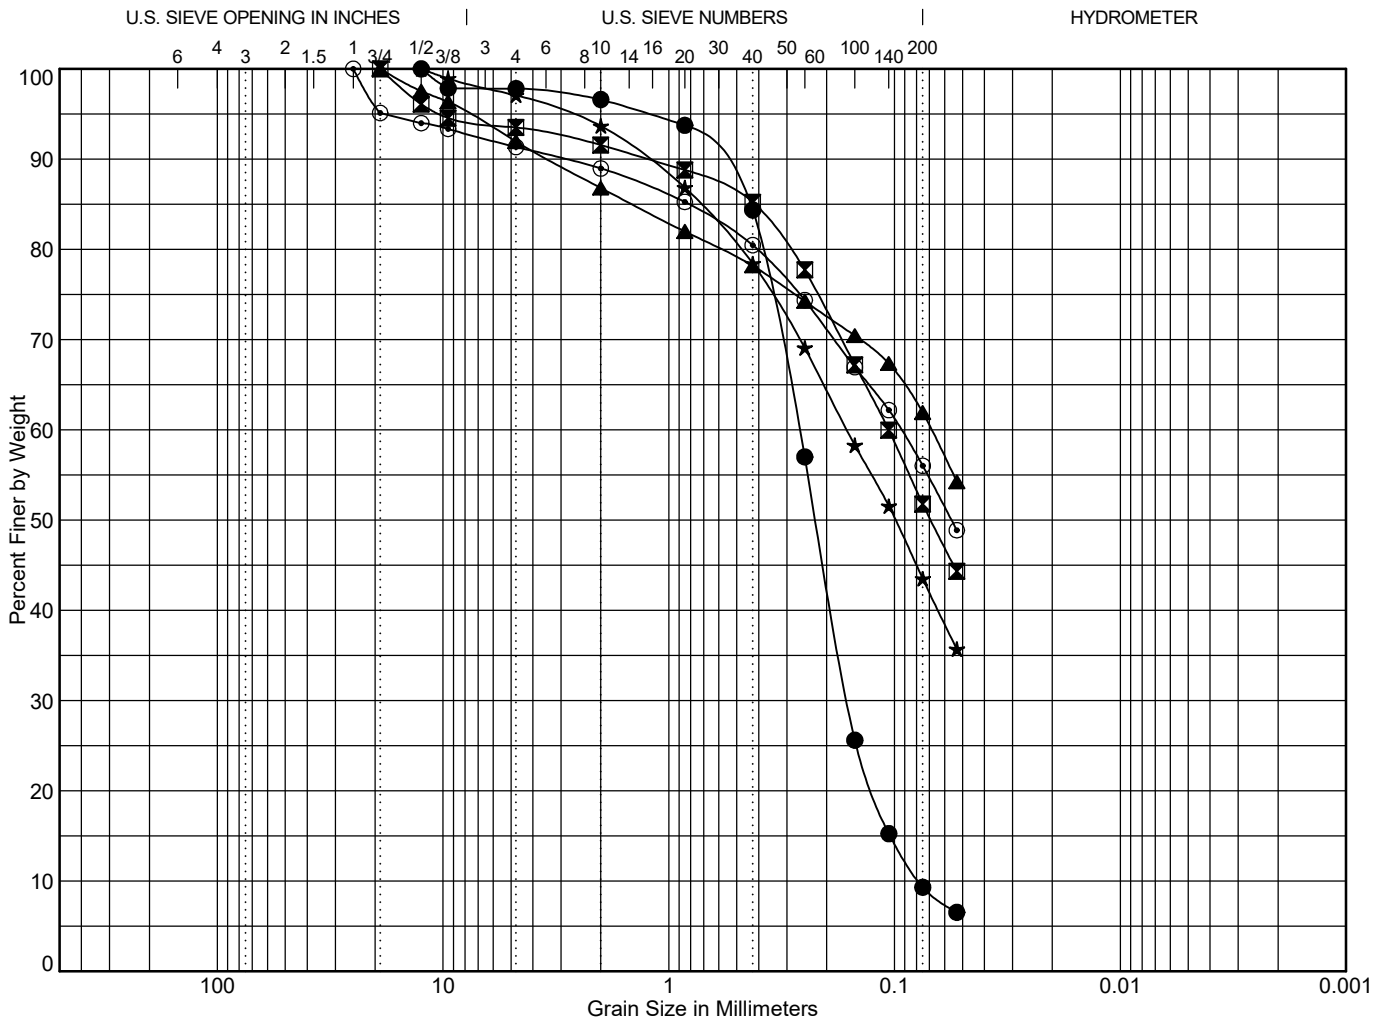
Figure
B-2

Point	Depth	Classification	LL	PL	PI	C _c	C _u
●	TP-2 5.8	Slightly silty SAND with trace gravel (SP-SM)				1.25	3.39
☒	TP-3 2.7	Very sandy, slightly gravelly SILT (ML)					
▲	TP-3 6.0	Very sandy, slightly gravelly SILT (ML)					
★	TP-4 3.5	Very silty SAND with trace gravel (SM)					
⊙	TP-4 6.8	Very sandy, slightly gravelly SILT (ML)
