March 27, 2024
Report No.: 24-013

RE: Coal Mine Hazard Report for 2530 Jaeger Street, Bellingham, Washington
Parcel No.: 380224230126

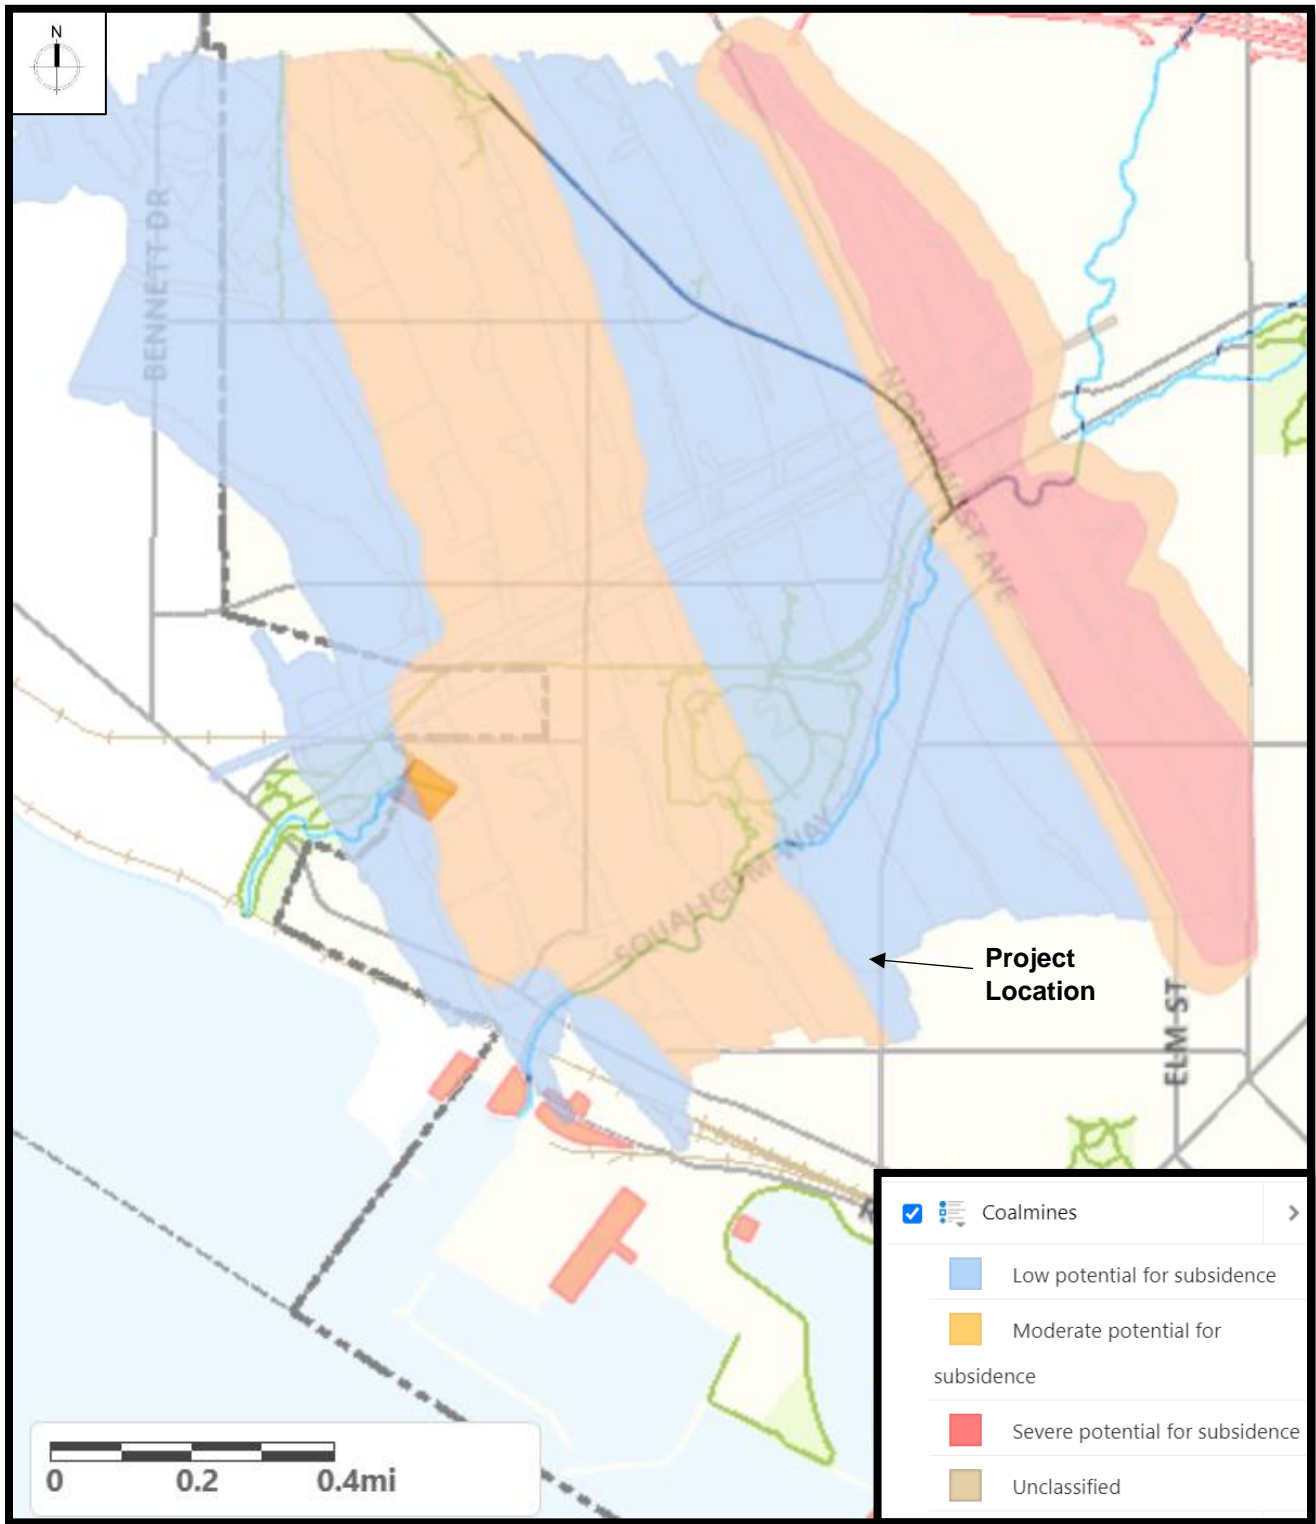
Figure 3: A portion of the Bellingham *City IQ* map showing the general project location and coal mine stability classifications. Image acquired from City of Bellingham *City IQ*, 2024.

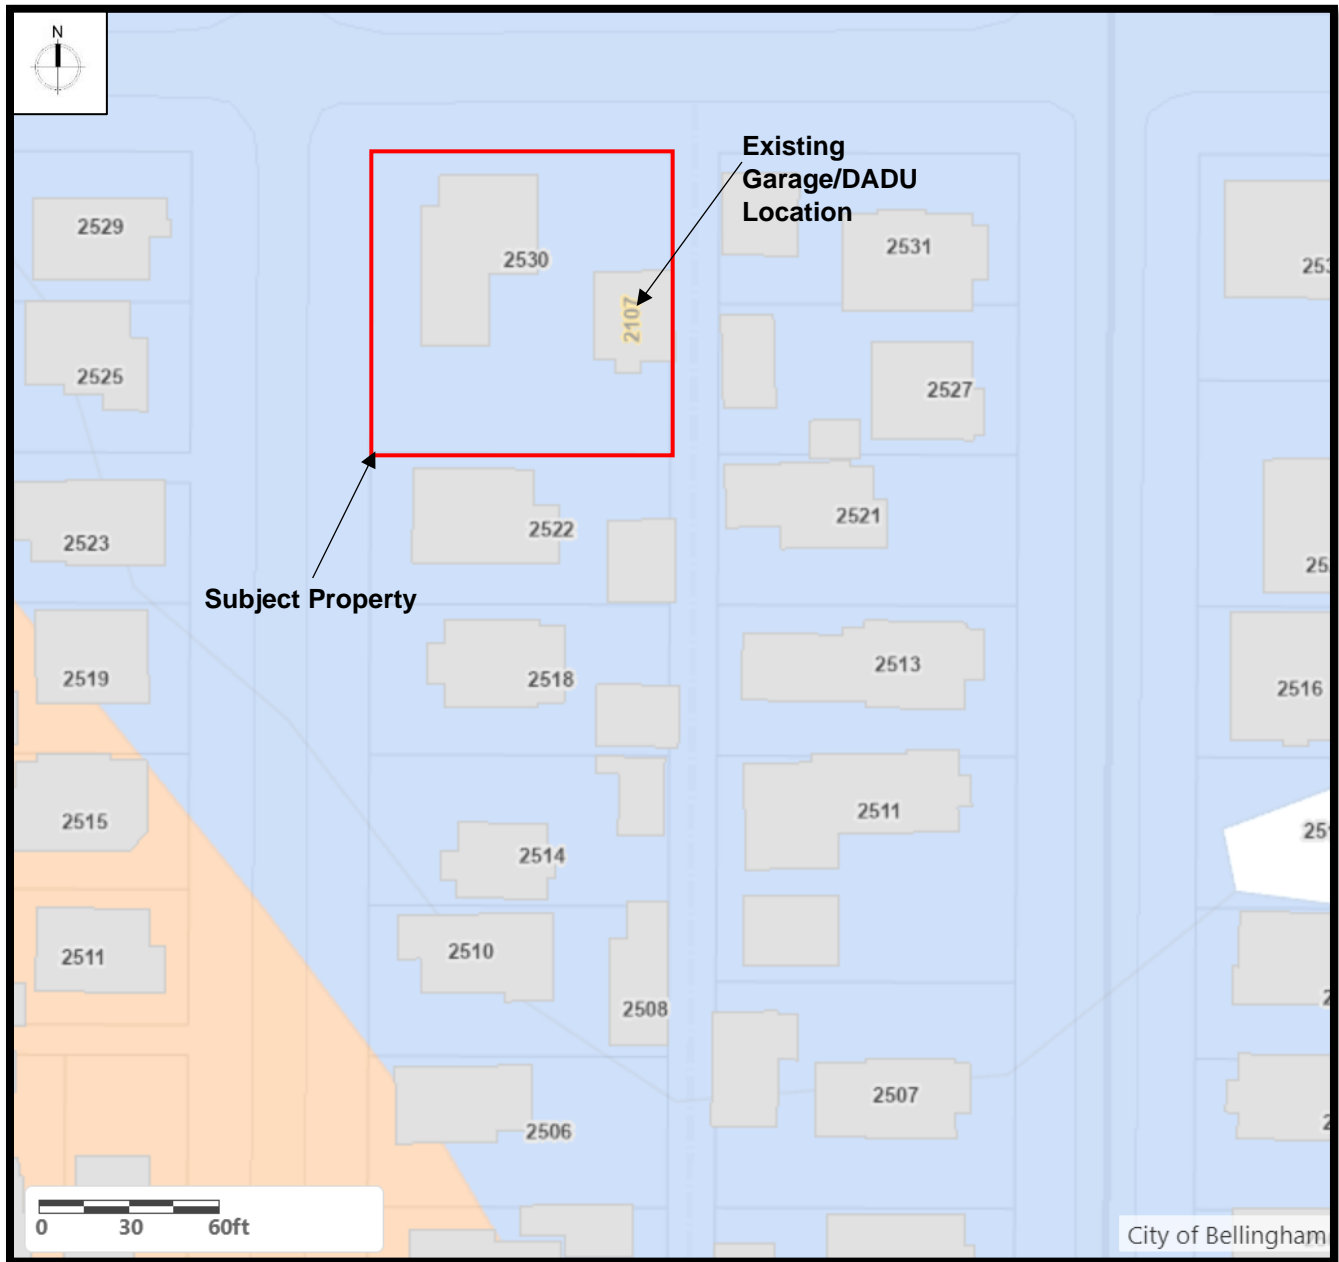
According to the Tetra Tech hazard classification maps, the subject property is in an area considered to have a “low potential for subsidence”, due to the location within an area of pillar stability. While the true degree of stability of the pillars in this area is uncertain, the mathematical analysis by Tetra Tech indicated that even the smallest, weakest pillars of the mine are theoretically able to remain stable down to about 790 feet below ground surface. At the subject property, the Bellingham Coal Mine workings are located approximately 630 to 640 feet below ground surface. Below the estimated depth of stability, any unstable pillars are assumed to have already failed in the time since the mine was decommissioned. Furthermore, Tetra Tech suggests that pillar failure would likely only cause subsidence at surface level if two or more pillars in an area were to yield.

Figure 4: The Bellingham *City IQ* map showing the property at 2530 Jaeger Street within a low potential for subsidence classification. Image acquired from City of Bellingham, 2024.

In conclusion, it is our opinion that the proposed construction is feasible and that the risk of ground subsidence due to coal mine related hazards is low. With the potential for subsidence classified as low, we are not recommending any additional mitigations for design and construction of the DADU. The guidelines for new building engineering found within the International Building Code and International Residential Code contain safeguards for structural design. We recommend the design engineer follow the parameters found within the current IBC/IRC when designing the new accessory dwelling unit.

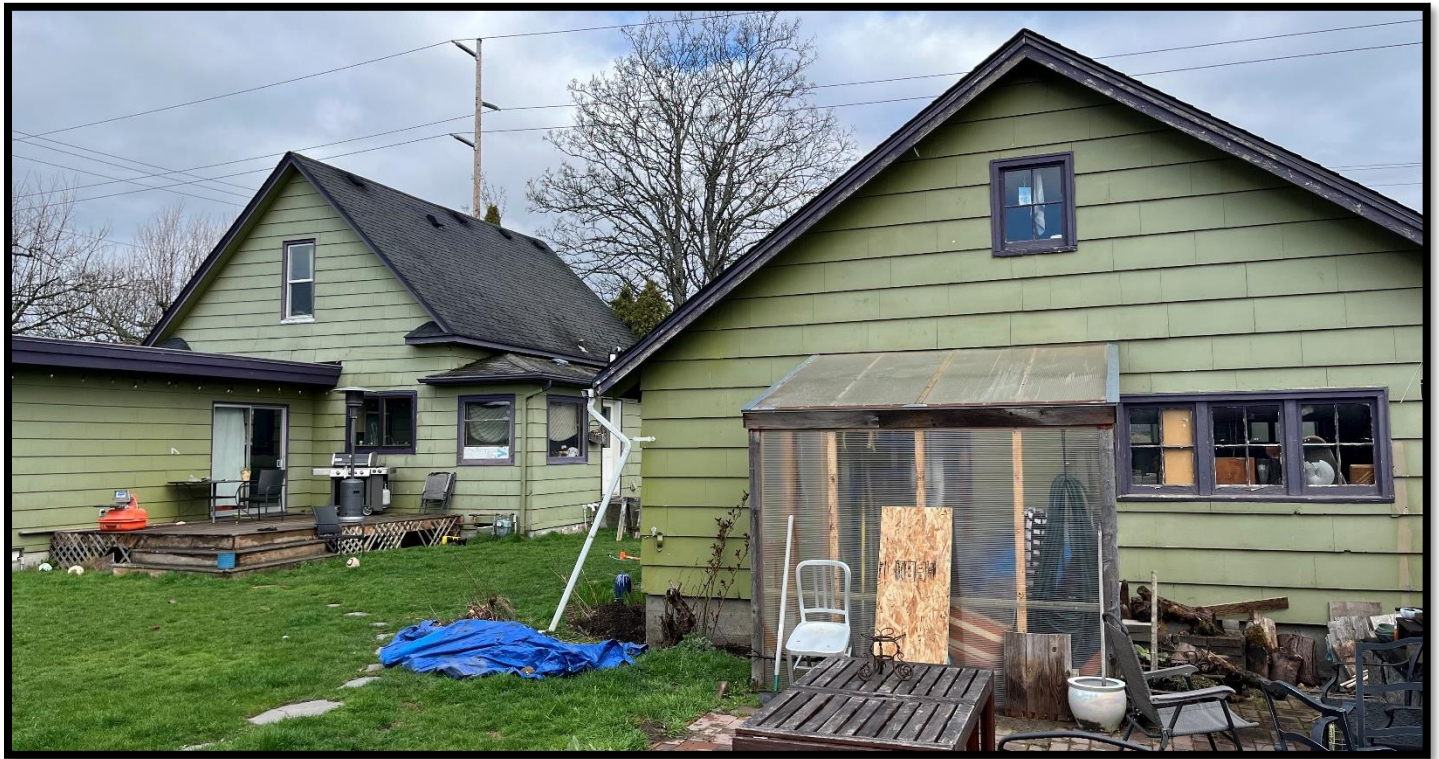
Additionally, no evidence of significant foundation cracking, settlement or other signs of building or soil displacement were observed at the project site or vicinity. The property owner reported no concerns over the last 30 years with settlement at the property or within the immediate vicinity due to coal mine related hazards.

Image 1: Existing conditions at 2530 Jaeger Street with the residence (left) and garage (right). Facing north on March 26, 2024.

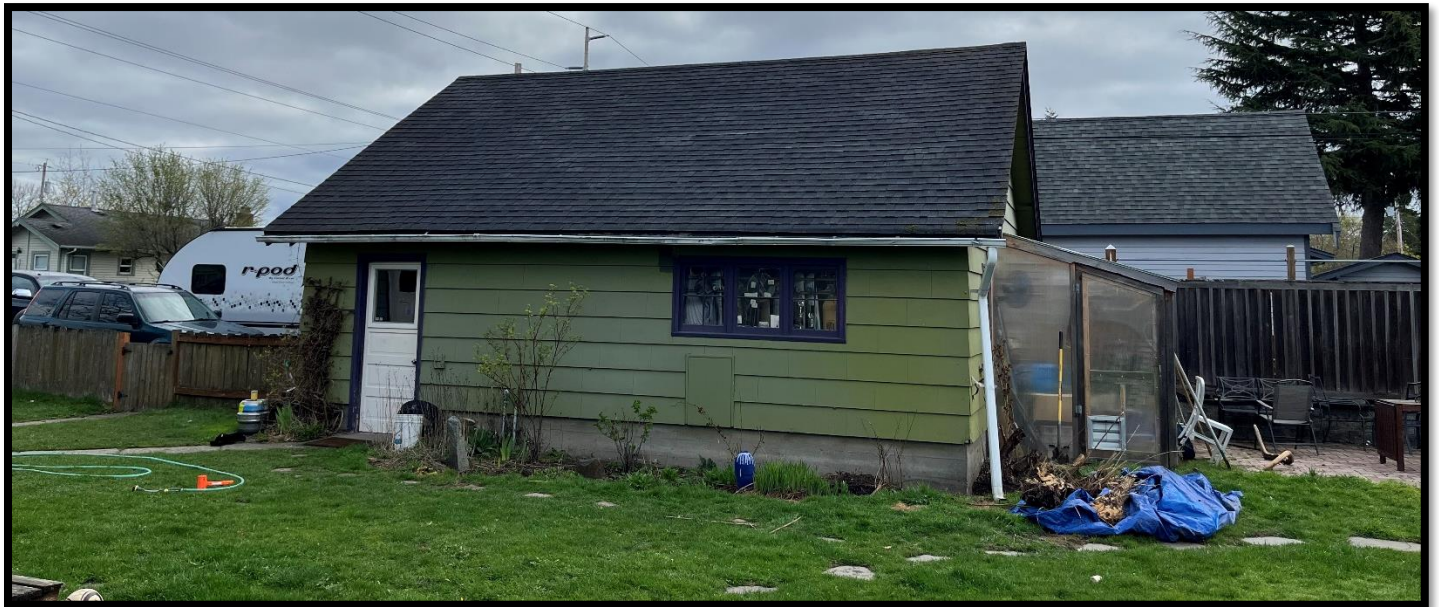
Image 2: Project site conditions at 2530 Jaeger Street with the existing garage in center. Facing east on March 26, 2024.
