May 1, 2024

**SUBJECT:** Coal Mine Hazard Evaluation for a Short Plat  
2933 Lindbergh Avenue (Parcel 380223 519114)  
Bellingham, Washington

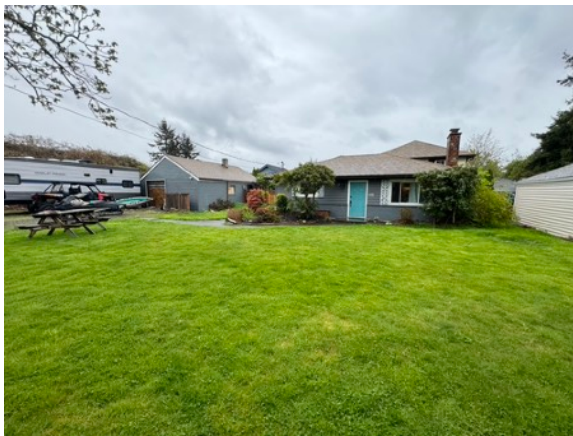
The photo above faces to the south and shows the front of the existing residence and detached garage.

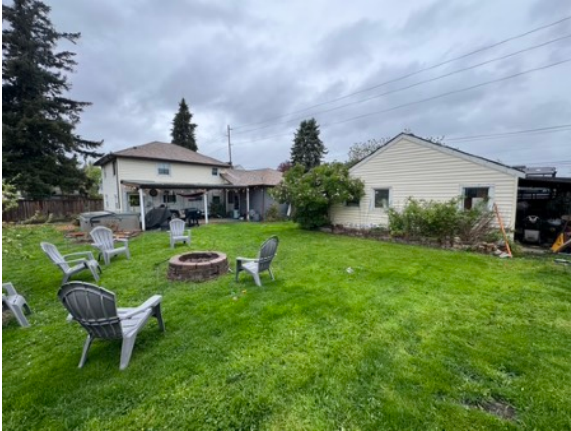
The photo above faces to the north and shows the rear of the existing detached garage and residence.

We did not observe any obvious evidence of subsidence within the vicinity of the project site based on our fieldwork or review of aerial photos and Light Detection and Ranging (LiDAR) imagery. Geomorphic features that could indicate the presence of subsidence may include but are

not necessarily limited to: sinkholes; subsidence troughs and basins; portal collapse; cracks and fissures; linear sinks; and hummocky or uneven terrain (Johnson, 2013). In addition, we did not observe large settlement cracks in the existing building foundations or nearby paved surfaces. The client indicated that they are not aware of existing settlement issues or any mine-related features, such as entries, portals, adits, shafts or spoil piles on the property.

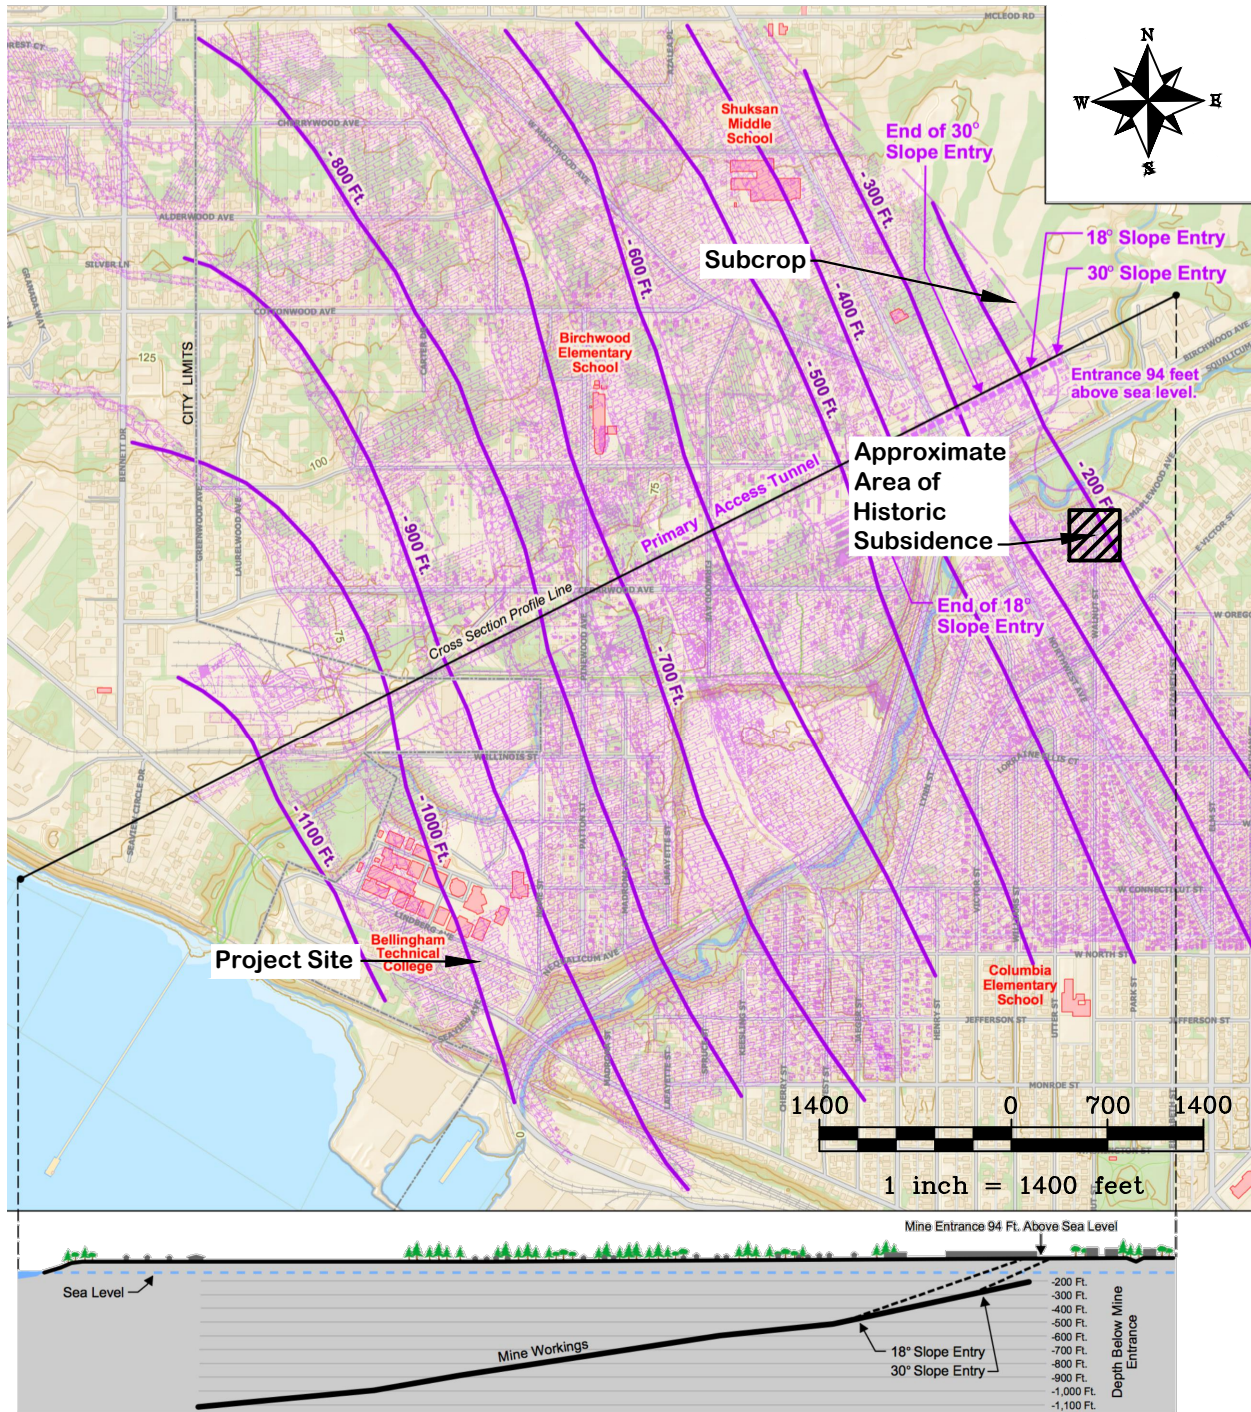
<p><b>SOUND GEOLOGY</b> 360.306.6171 www.soundgeology.com</p>	Date 4-26-2024	<p><b>Mine Hazard Map</b> Proposed Short Plat 2933 Lindbergh Avenue (Parcel 380223 519114) Bellingham, Washington</p>	<p><b>FIGURE</b>  <b>3 of 3</b></p>
	File No. 24032		
	Drawn By DEJ		
	Scale 1" = 1400'

The mine workings are at a depth of approximately 990 feet below the elevation of the project site, and the area of historic subsidence is approximately 1.0 mile to the northeast of the site. Please refer to the Mine Hazard Map (Figure 3) to review the approximate location of the subsidence near the Maplewood Avenue and Walnut Street intersection.

Please refer to the Mine Hazard Map (Figure 3) for the approximate locations and elevations of the mine workings for the Bellingham No. 1 Mine, entrances, subcrop line, and the approximate area of historic subsidence at the Maplewood Avenue and Walnut Street intersection. The 2007 City of Bellingham's Coal Mine Plan Layout and Depth Profile Map was used for the base map.

Based on our review of Tetra Tech's Subsidence Classification Maps, it appears that the project area is mapped within a 'Mine Area of Stability Due to Arching'. This area is where pillars, barrier pillars, and sections where coal has not been mined are stable enough to support a major arch that can bridge an area of mine openings and weak pillars.

The site also appears to be located within a 'Surface Area Which Can Be Affected By Pillar Instability'. 'Mine Areas of Possible Pillar Instability' are areas where Tetra Tech's analysis showed that the pillars are not capable of supporting the overburden; however, it would require the failure of more than one pillar for surface disturbance to occur.
