**Critical Areas Ordinance Permit
Findings and Decision
Type I**

1909 36th St.
CAP2024-0029

Subject: **Geologic Hazard Review & Stormwater Feasibility Assessment**

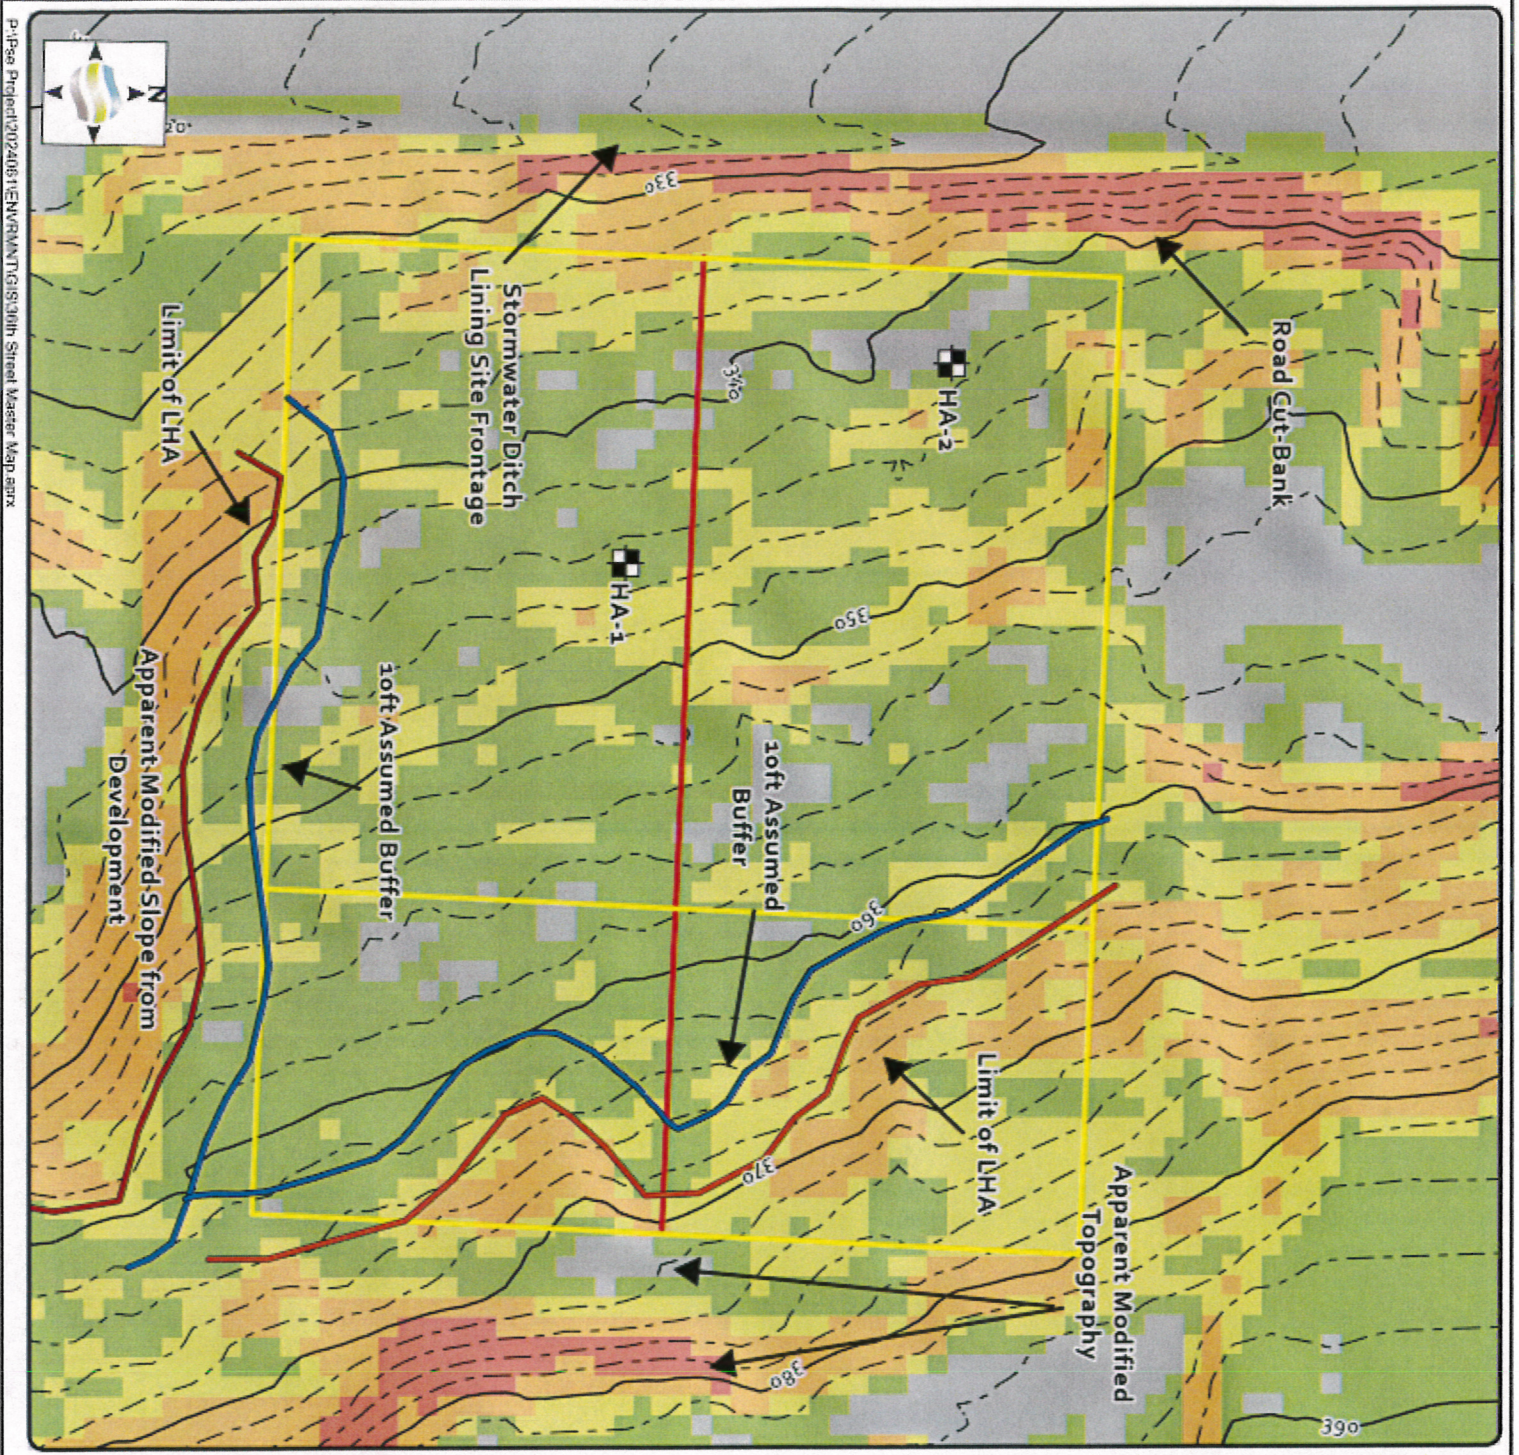
The ***easternmost uphill margin of the site generally has steeper graded terrain, and is deemed an LHA based on steep grade consistently over 40% for typically over 10 feet vertical.*** The LHA limit generally trends northwest-southeast, consistent with the native terrain surrounding the site, extending through the topmost east end of the proposed parcels. Our site reconnaissance confirmed that there are no active geologic hazards nor suspected activity present along the slope. LiDAR imager does not portray any features of concern.

In conclusion, the moderate to steeply graded areas of terrain within the eastern margin of the site and adjacent to the southern boundary of the site are code-delineated as ***potential landslide hazard areas*** with grades greater than 40% and heights greater than 10 feet. However, we found no evidence of active or recent historical instability within the project area or its direct vicinity based on conditions seen during the field visit. The remainder of the subject parcels are free of LHA features.

Adjusting the parcel boundary will allow both sites to be accessed directly from 36th Street, instead of requiring development of Lindsay Avenue to access the current uphill parcel. As noted above and shown on Figure 3, the undeveloped ROW of Lindsay Avenue contains a modified slope defined as an LHA and its buffer. The elevation gain east from 36th Street is also significant along the ROW corridor, which would present additional challenges for extension of Lindsay Avenue uphill of 36th Street. From a geohazard avoidance perspective, and to maximize buildable area on both parcels outside of delineated LHAs, we recommend that the boundary adjustment be completed and that the parcels be developed with access on the west end from 36th Street.

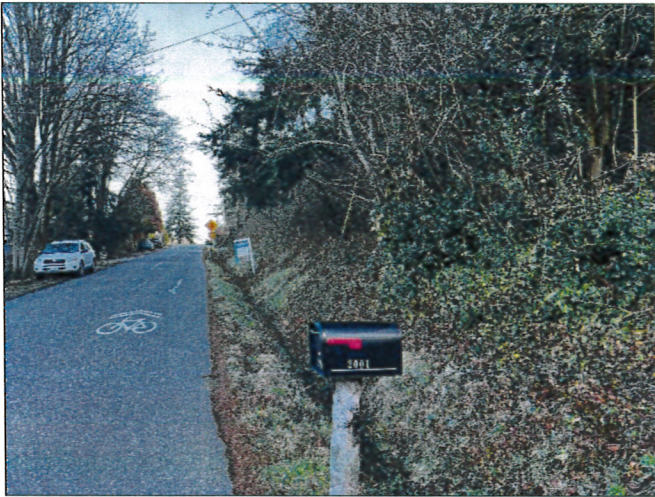
Photo 1: Western frontage of study area – note stormwater ditch

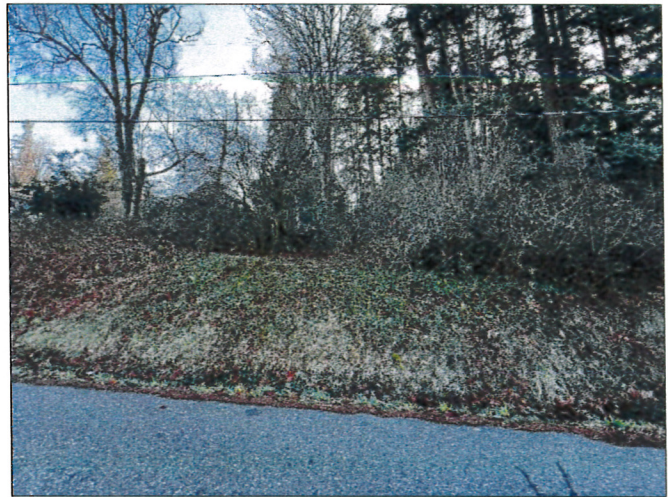
The existing roadside cut bank along the western boundary of the site is a localized feature that extends along the 36th Street eastern frontage. The cut bank descends into an existing stormwater drainage ditch with a general slope height below 8 feet as observed in the field. The cutbank is generally clear of large vegetation and consists of grass covering. Though the base of the cutbank is presumably subject to low levels of surface water flow, no exposed soils or evidence of erosion or failure was present along the existing cut bank.

Lastly, the localized, ***steeply graded roadside cut bank along the western boundary of the site is determined to NOT be defined as landslide hazard area,*** based upon the limited height below 10 feet, despite grades generally exceeding 40%. The existing road cut is defined as an erosion hazard area (EHA) due to the steep sustained grades over 30% and potential for erosion over time along the base of the slope related to stormwater runoff and steeply sloping terrain. Our field reconnaissance did not observe any indication of past or active erosion. The slope is generally vegetated with grass covering. The overall level of activity along the existing cut bank is considered low due to the little outside influence on the erosion other than weathering and limited stormwater conveyance within the ditch at its base. Future development is expected to utilize the western frontage of the site at 36th Street as the main access point; therefore, various cut and fill development features may further change the steep geometry of the slope. The presence of an EHA does not preclude reasonable and well planned and constructed development.

Photo 2: Road Cutbank along western frontage. Note grass covering and no exposed soils.

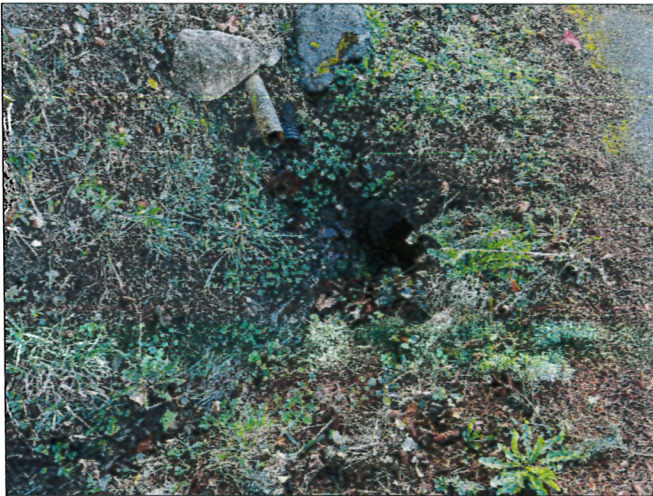
Photo 3: Stormwater drainage ditch culvert along SW corner of site.

We interpret that the site is not feasible for infiltration design according to typical residential stormwater guidelines and their local municipal application. We recommend stormwater to be collected on site and conveyed via gravity tightline downhill to below the existing road cut bank to be released at the stormwater ditch lining the western frontage of the site.

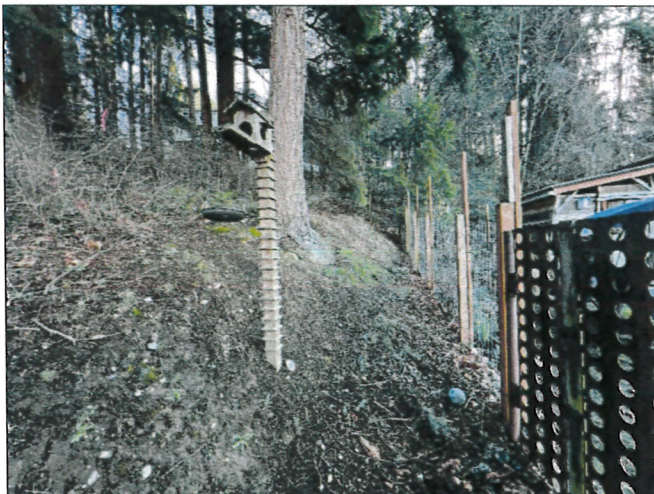
Photo 5: Southern modified slope feature. Note minimal vegetation cover.

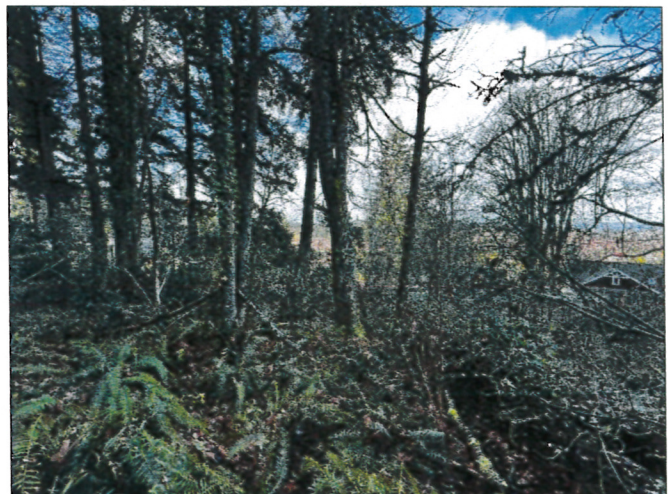
Photo 6: Conditions within the subject parcels.

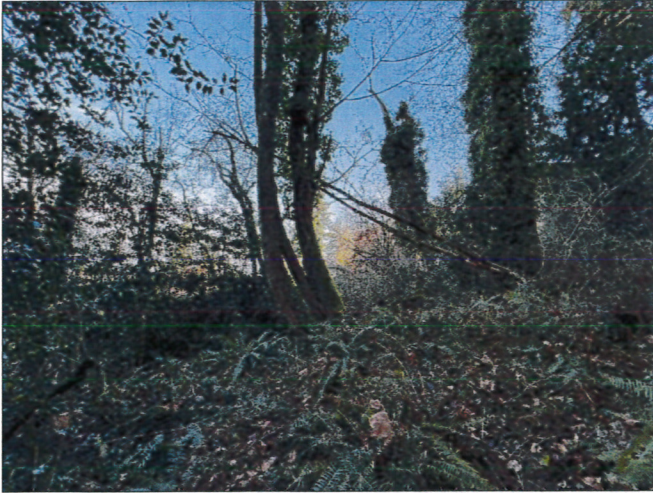
No exposed soils or loss of vegetation was observed within the study area. The small trees along the eastern and southeast margin of the site and site vicinity displayed slight curves along the base of the stumps to accommodate for the sloping terrain and as result of minor soil creep on the moderate grades during growth. However, the mature trees along the eastern margin were primarily straight and lacked any indication of significant slope movement over the long term.

Photo 7: Some areas of curved tree trunks along the northeast margin of the site.

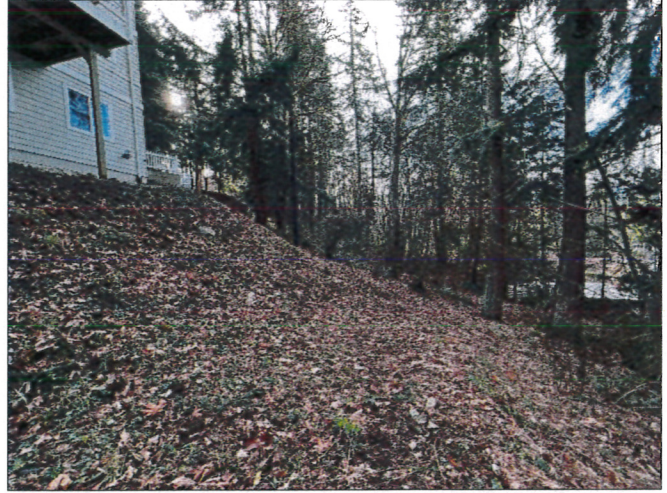
The easternmost margin of the sloping terrain, directly east of the subject parcels, is suspected to have been previously altered by historical clearing and grading activities from SFR development, exhibiting locally higher grades. The apparent modified slope was primarily clear of vegetation and consisted of light grass covering with leaves covering the ground. Grades were generally steep and descend into a local 'bench' feature. The slope did not show any indication of eroding soils, downhill accumulations, or visible failure features.

Photo 8: Assumed modified topography directly east of the site.

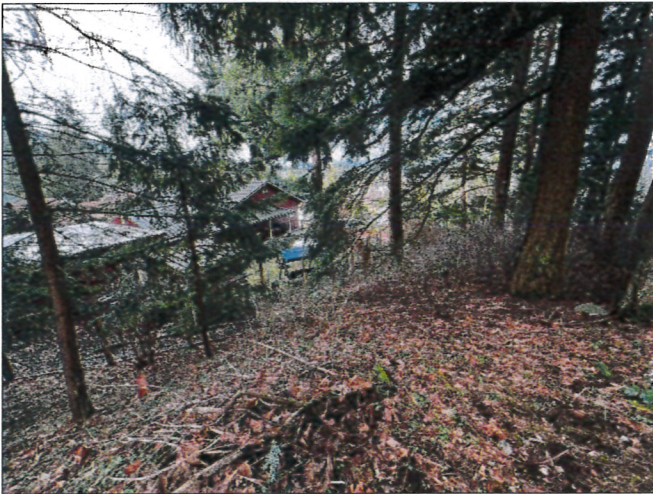
Photo 9: Southeast sloping conditions of the site. Looking south.
