April 10, 2024

Attachment E

SUBJECT: Coal Mine Hazard Evaluation for a Subdivision & Residential Improvements
2912 Birchwood Avenue (Parcel 380223 562531)
Bellingham, Washington

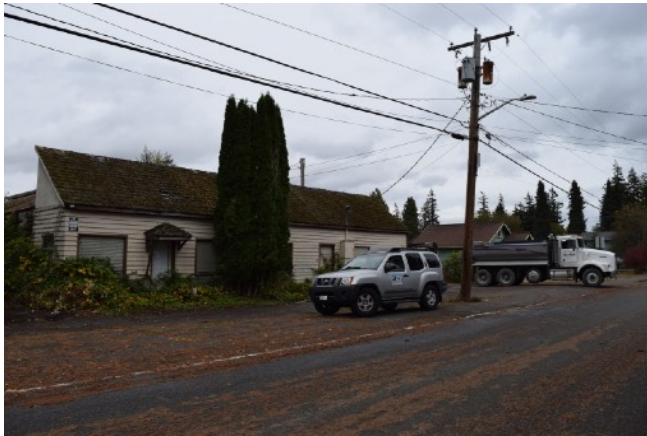
The photo above was taken from Birchwood Avenue and faces to the northeast toward the southern end of the site.

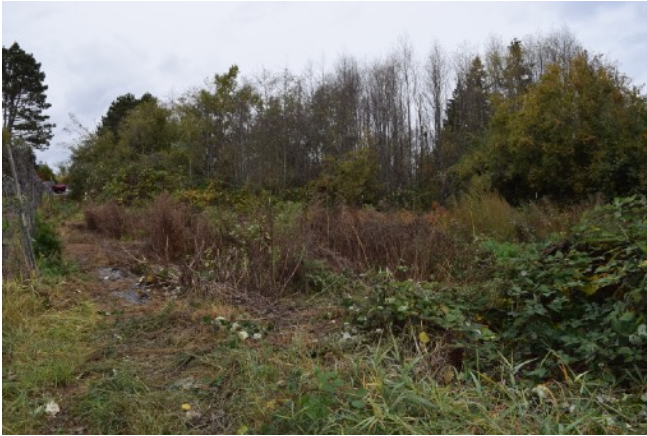
The photo was taken from the central portion of the property and faces to the north-northeast.

We did not observe any obvious evidence of subsidence within the vicinity of the project site based on our fieldwork or review of aerial photos and Light Detection and Ranging (LiDAR) imagery. Geomorphic features that could indicate the presence of subsidence may include but are not necessarily limited to: sinkholes; subsidence troughs and basins; portal collapse; cracks and fissures; linear sinks; and hummocky or uneven terrain (Johnson, 2013). In addition, we did not observe any large settlement cracks in the existing building foundations or road surface.

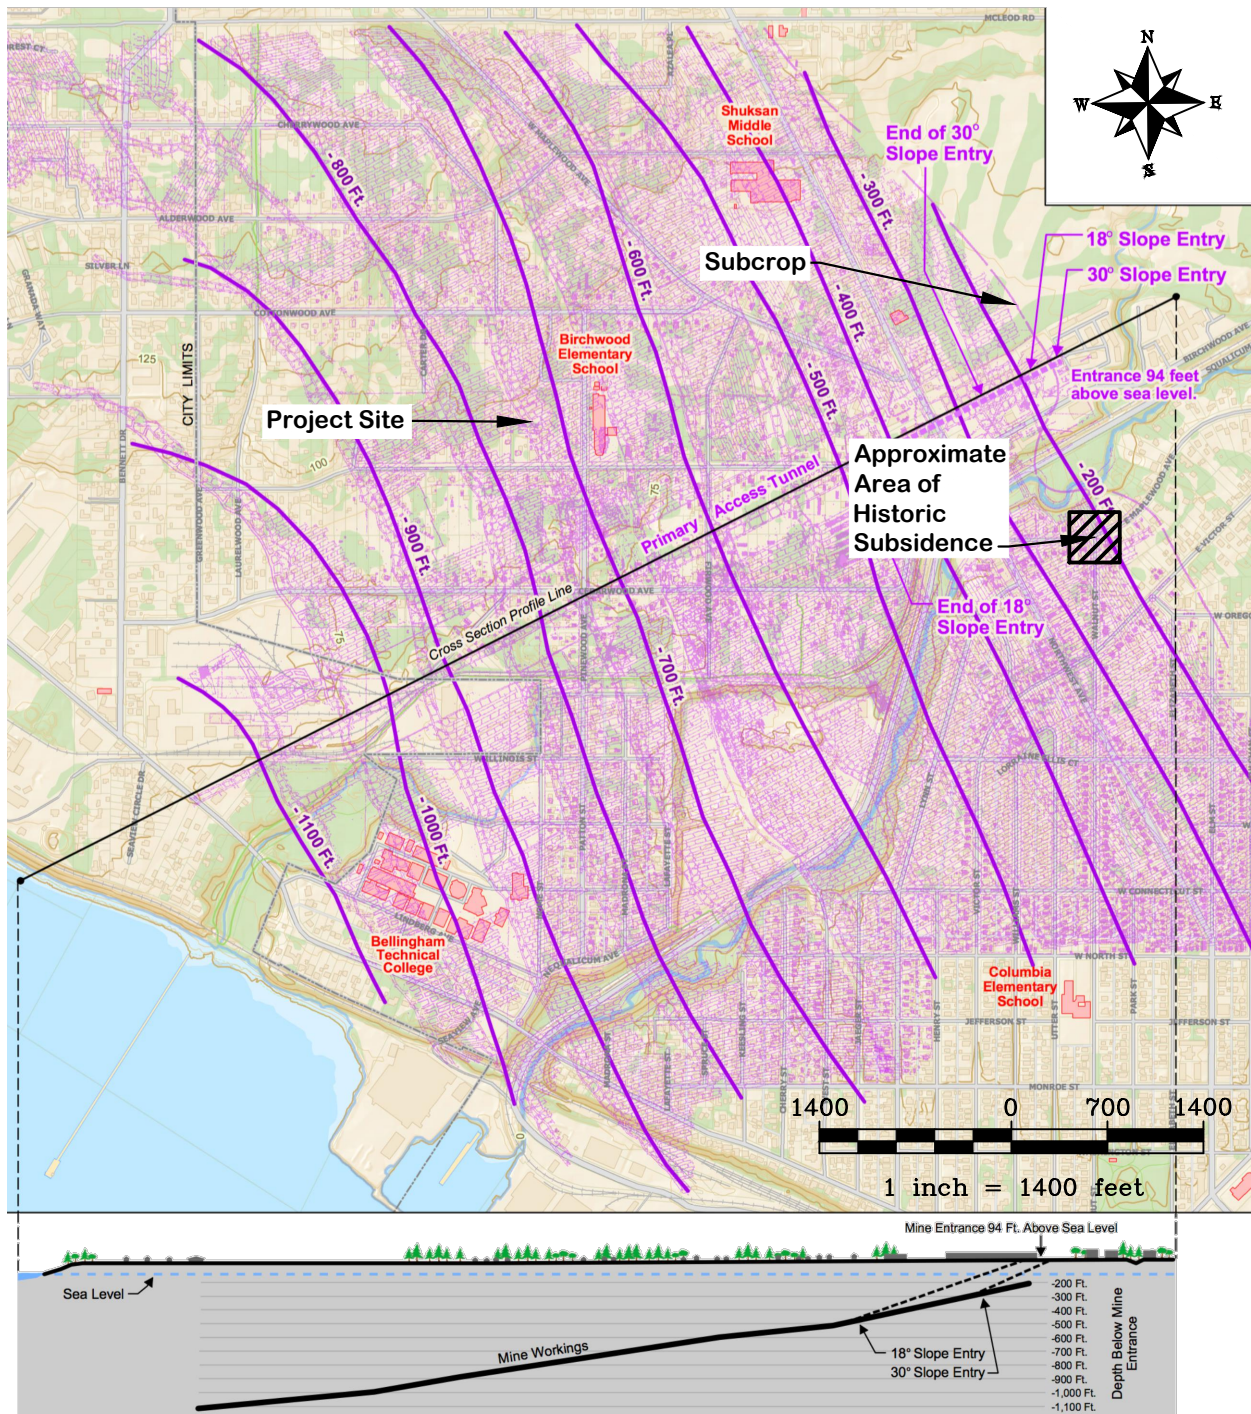
The mine workings are at depths ranging from approximately 700 to 760 feet below the elevation of the project site, and the area of historic subsidence is approximately 3/4 mile to the east-southeast of the site. Please refer to the Mine Hazard Map (Figure 3) to review the approximate location of the subsidence near the Maplewood Avenue and Walnut Street intersection.

Based on our review of Tetra Tech's Subsidence Classification Maps, it appears that the project site is mapped within a 'Mine Area of Possible Pillar Instability'. This is an area where Tetra Tech's analysis showed that the pillars are not capable of supporting the overburden; however, it would require the failure of more than one pillar for surface disturbance to occur.

4. Although the project site is mapped within a 'Mine Area of Possible Pillar Instability', Tetra Tech defined these areas using an analysis that showed the pillars not capable of supporting the overburden (depths greater than 790 feet). The mine workings at the site are shallower than 790 feet, with depths ranging from approximately 700 to 760 feet. In addition, it would require the failure of more than one pillar for surface disturbance to occur.

Notes: Based upon the 2007 City of Bellingham's Coal Mine Plan Layout and Depth Profile Map. The approximate area of historic subsidence is based upon descriptions from Tetra Tech's 1984 Final Report Bellingham Abandoned Mine Land Survey. The project site is mapped within a 'Mine Area of Possible Pillar Instability' as shown on Figures 7B-1 and 7B-2 of the Bellingham No. 1 Mine - Subsidence Classification Map (Tetra Tech, 1984). No visual indications of subsidence were observed within the vicinity of the project site. Please refer to the report for more details.

Due to the relatively low potential for subsidence to occur from the Bellingham No. 1 Coal Mine, it is our opinion that mitigation is not needed for structural damage from potential coal mine hazards for the project.
