March 26, 2024

Project: **Proposed Residential Redevelopment (#2024058)**
2302 Alabama Street, Bellingham, WA 98229 (WC Parcel #: 380320 540078)

Subject: **Geotechnical Evaluation & Stormwater Feasibility Assessment**

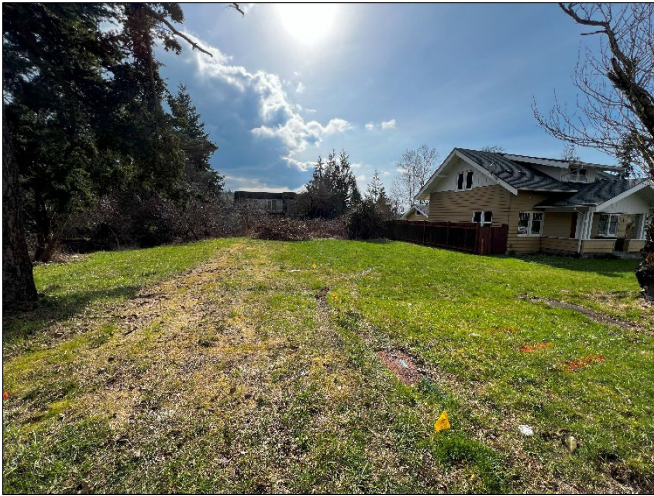
Photo 1: Upland site conditions during recon visit – Looking south.

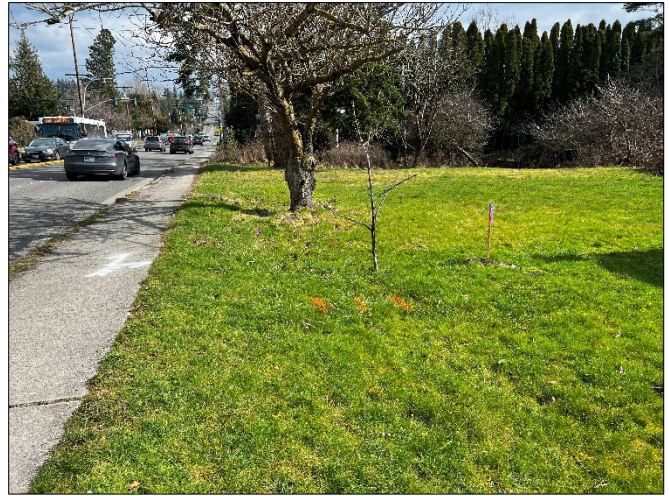
Photo 2: Site frontage – looking east.

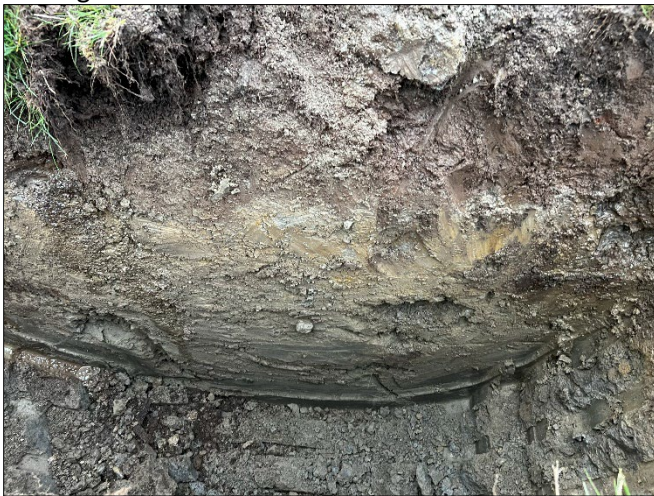
Photo 3: TP-1 conditions. Note mottled GMD layer overlying very stiff/hard glacial drift.

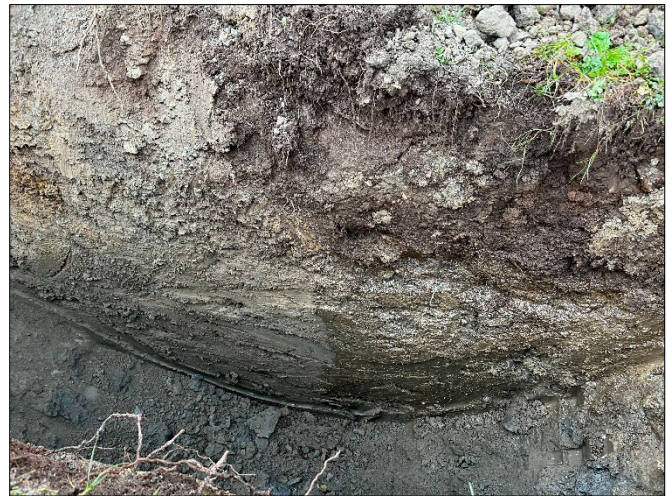
No surface ponding was observed at the subject parcel at the time of field work. Shallow water seepage was observed within the topsoil overlying the shallow fine-grained clay-rich deposits, and along the lower soil boundary of the cover soils over the clay unit. The seepage was observed in all test pits between 1.1 to 1.6 feet BPG. Moderate to strong mottling was common in the upper fine-grained clay-rich glaciomarine drift soils, along with high moisture soil conditions ranging from moist to wet locally. Dry and cemented glacial drift soils were observed with depth throughout the study area which had little to no signs of water transmission and were generally damp to dry. No regional water table was contacted by end depth.

Photo 4: TP-2 conditions. Note seepage along topsoil-GMD boundary.

- Foundation Drainage - The site exhibits shallow restrictive glacial soils, and may be susceptible to shallow water migration and perched water conditions in winter months. Embedded foundations will impede transient water flow and may exacerbate perched water build-up. We highly recommend use of perimeter foundation drains to promote long-term dry foundation conditions and avoid build-up of water against the structure.

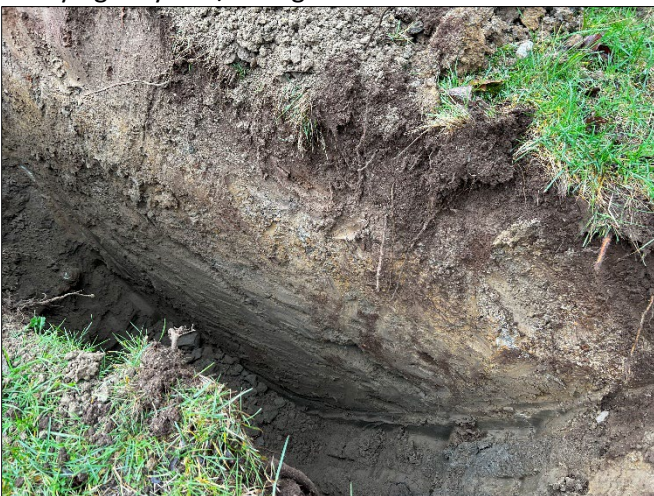
Photo 5: TP-3 conditions

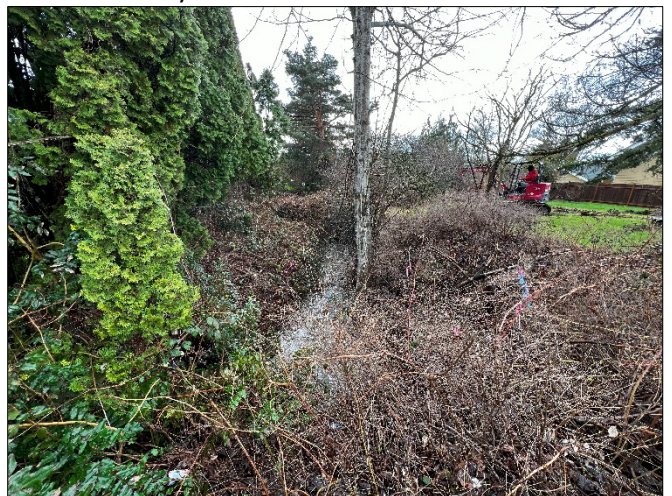
Photo 6: Fever Creek along NE corner of site – Looking south.

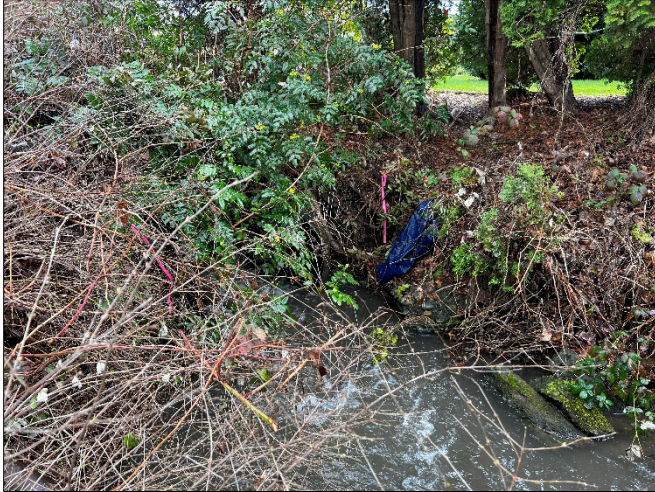
Photo 7: Creek exiting culvert along NE corner of site.

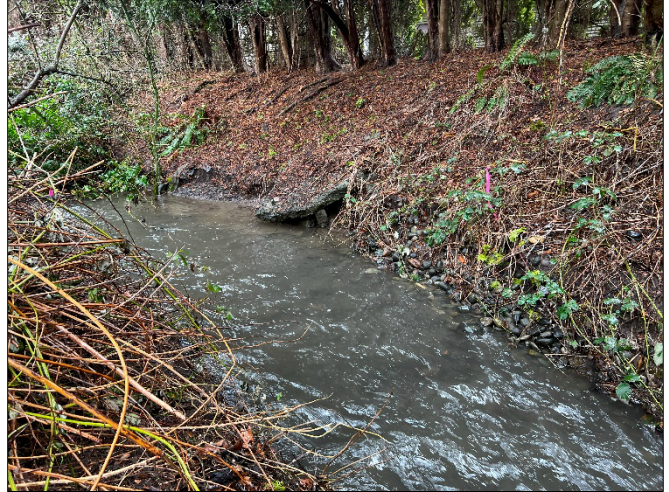
We found little to no exposed areas where active erosion of soils was occurring within the parcel boundaries. Where soil was exposed, the bank area did not display active soil wasting nor soil debris along the base, indicating the exposed soil’s weathering/erosion is a slow process. Surface conditions appeared well stabilized within the parcel boundaries. The mature trees within the site display generally straight trunks aside from one tree along the southwest corner. The smaller trees along the northeastern slopes are commonly curved with some tilted and fallen trees along the base of the slope. The orientation of the younger trees appears to be related to growth patterns as opposed to ground instability.

Photo 8: East-southeast slope conditions along creek.

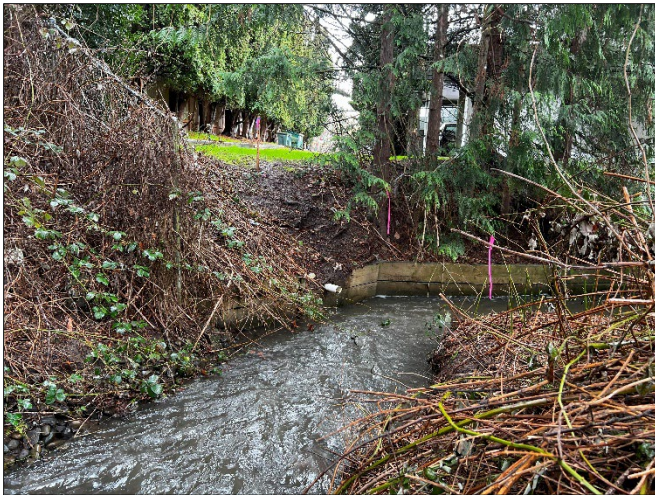
Photo 9: Southeast slope conditions to the south of subject parcel. Note pipes directing to creek.

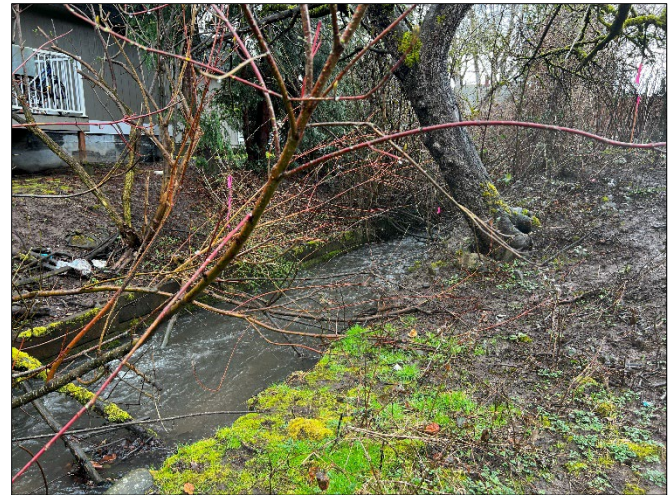
The south and southeastern bank slopes, located off-site on the opposite sides of the creek, appear to display some minor evidence of weathering and erosion. The base of the slope within this area has existing support lagging, presumably to minimize the risk of erosion to adjacent properties. Various stormwater pipes were also observed along the southern slopes, releasing directly into the stream channel, with no evidence of erosion from the presence or continued operation of the outlet pipes. These observations on the far side of the creek at the southeast corner area are consistent with a higher erosion potential for the outer bend, or “cut bank” side, of the creek as it takes a sharp turn from south to west.

Photo 10: Southern boundary of site. Grades are generally steeper out of site. Note lagging along southern slope.
