# Geohazard and Infiltration Feasibility Report

Ashley Street Residence  
119 Ashley Street  
Bellingham, WA 98225

August 29, 2024 (Revised September 6, 2024)  
Project No. 24-2327

**Regarding: Geohazard and Infiltration Feasibility Report – Revision 1**  
**Ashley Street Residence**  
119 Ashley Street  
Bellingham, WA 98225  
(Parcel No. 3803320250950000)

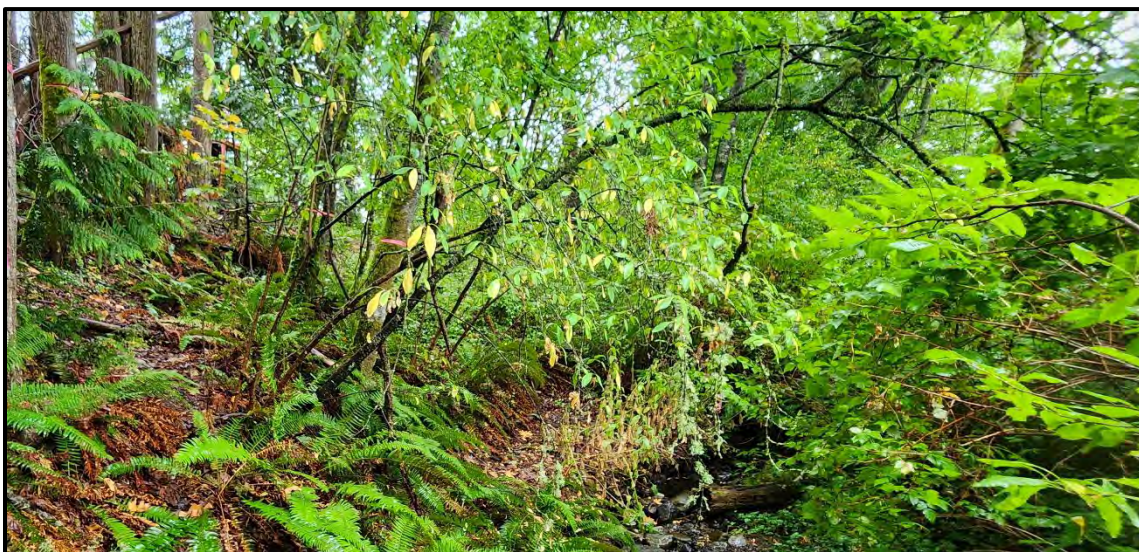
**Image 1:** Site conditions viewed from Lincoln Creek where it enters the property's eastern edge. View is facing approximately northwest. The proposed house site is to picture left. Photo taken July 29<sup>th</sup>, 2024

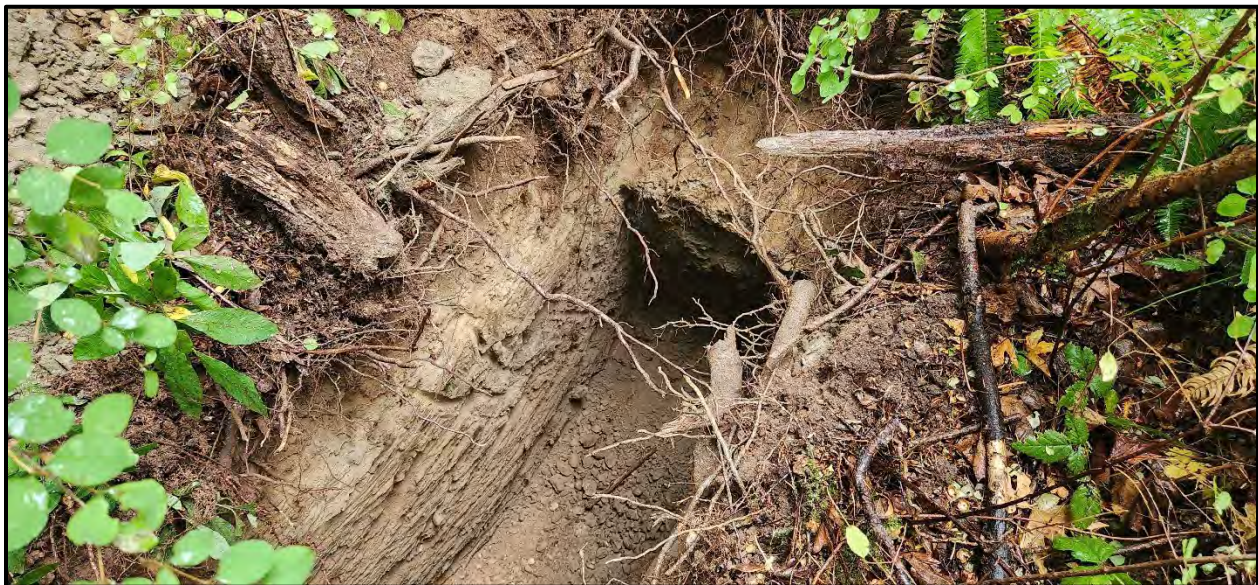
**Image 2:** Subsurface conditions as observed in TP-2. Note dense, undifferentiated glacial deposits materials extending to depth from near surface elevations. Photo taken July 29<sup>th</sup>, 2024

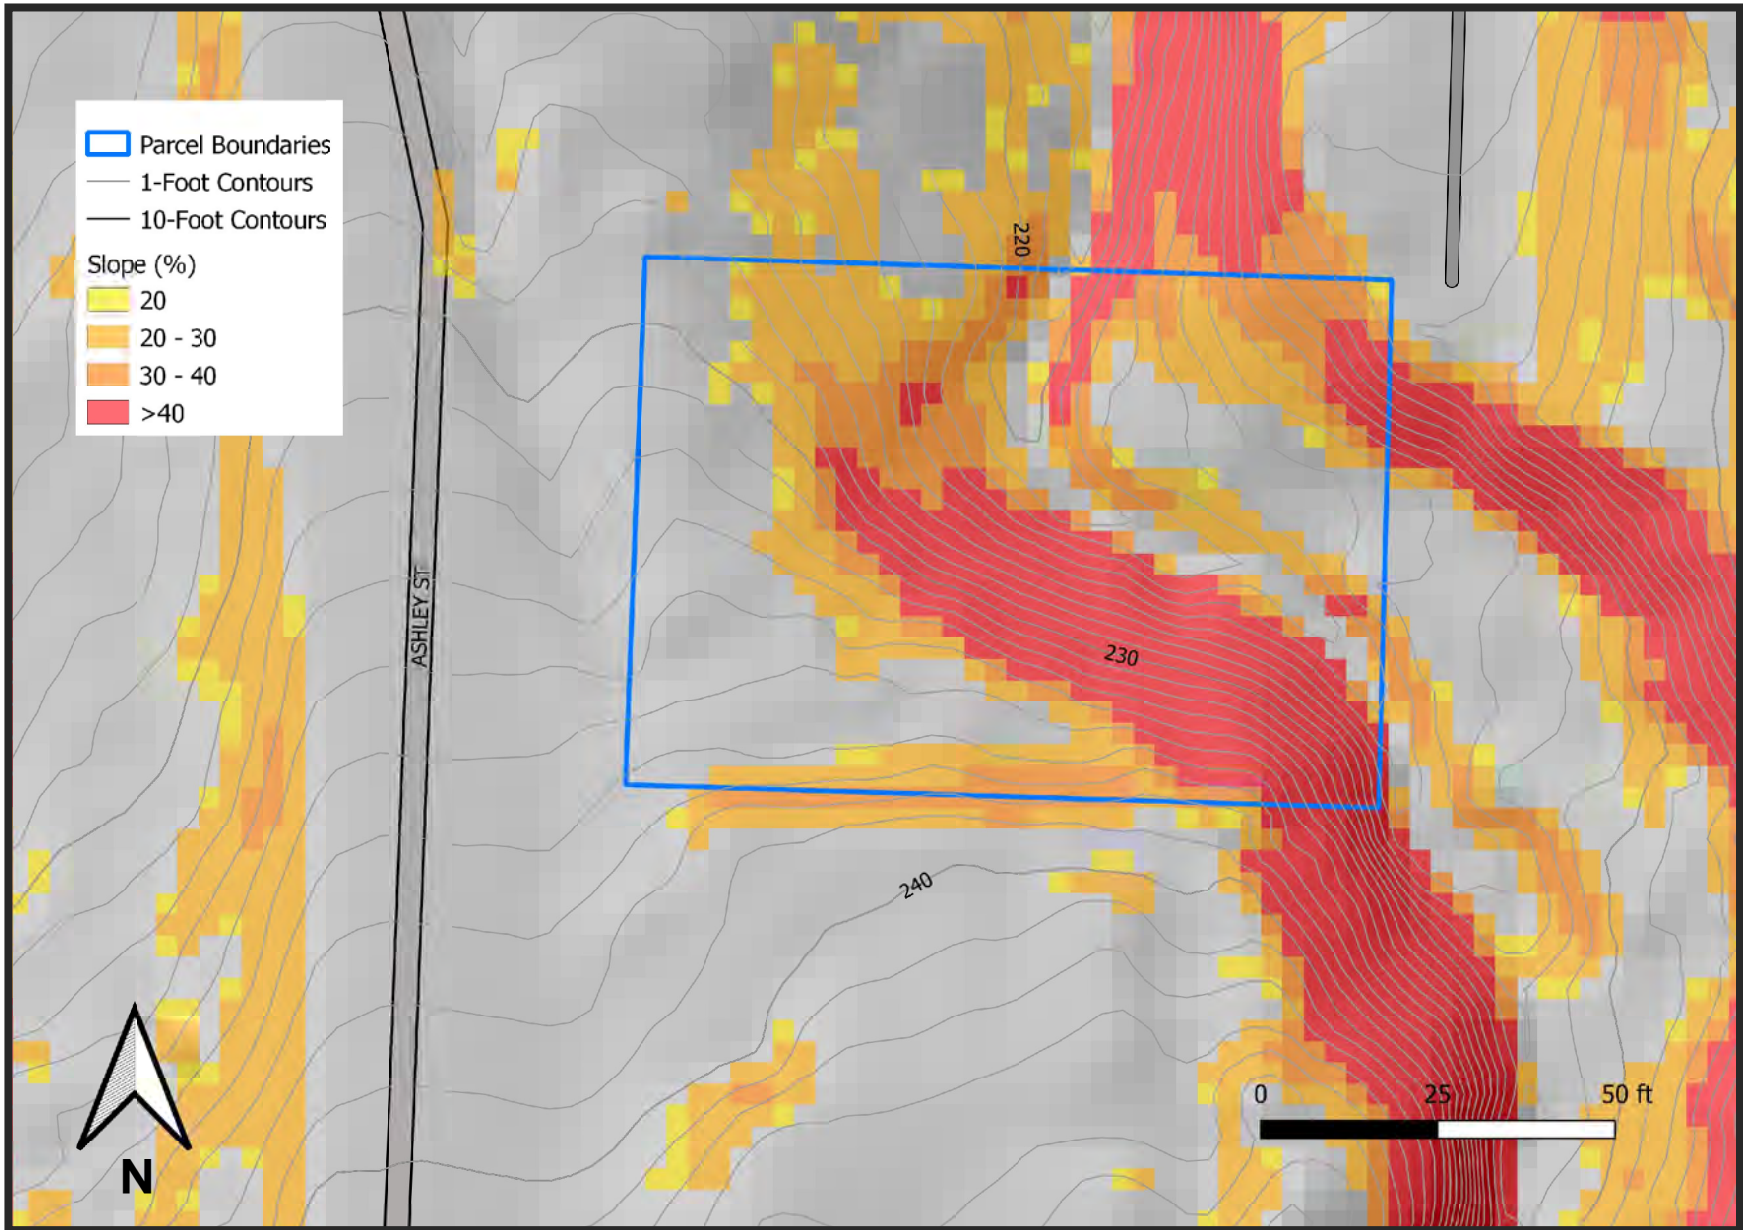
No evidence of instability, such as tension cracks, head scarps, or significant downslope accumulations of materials were noted on or adjacent to the project site. (*Bare Earth Site Plan*, Figure 3). Outside of the general topographic profile of the site slopes, no signs of large scale “global” instability on subject property were observed in our bare earth imagery review.

Figure 3 – *Bare Earth Imagery*). **Therefore, this portion of the project site is considered to contain Erosion Hazard Areas per Bellingham Municipal Code.** Residential construction is required to meet the standards outlined in 16.55.440A. Thus, the development will require an erosion and sediment control, drainage, and mitigation plan prepared in compliance with BMC 15.42. In our opinion, the erosion potential at the project site can be managed with appropriate construction practices.

Based on our review of digital elevation models, topographic drawings, and our on-site observations, **the project site does contain Landslide Hazard Areas as defined by Bellingham Municipal Code along the marginal slopes of Lincoln Creek** (See Figure 3 – Bare Earth Imagery).

Long term slope erosion must be mitigated through proper drainage and civil design. Stormwater volumes generated from proposed impermeable surfaces should be collected and directed to a municipally acceptable location. The following recommendations are intended to prevent excessive erosion from occurring at the site during and following construction:

- We recommend that appropriate silt fencing be incorporated into the construction plan for erosion control.
- We recommend that on-site BMP's be implemented during construction. Areas of native vegetation should be left in place or may be enhanced by adding additional native plant species and/or other vegetation enhancements.
