Scouting objectives:

Scouting form: [12/24 Seneca Hill Arboretum - WTA scouting form](#)

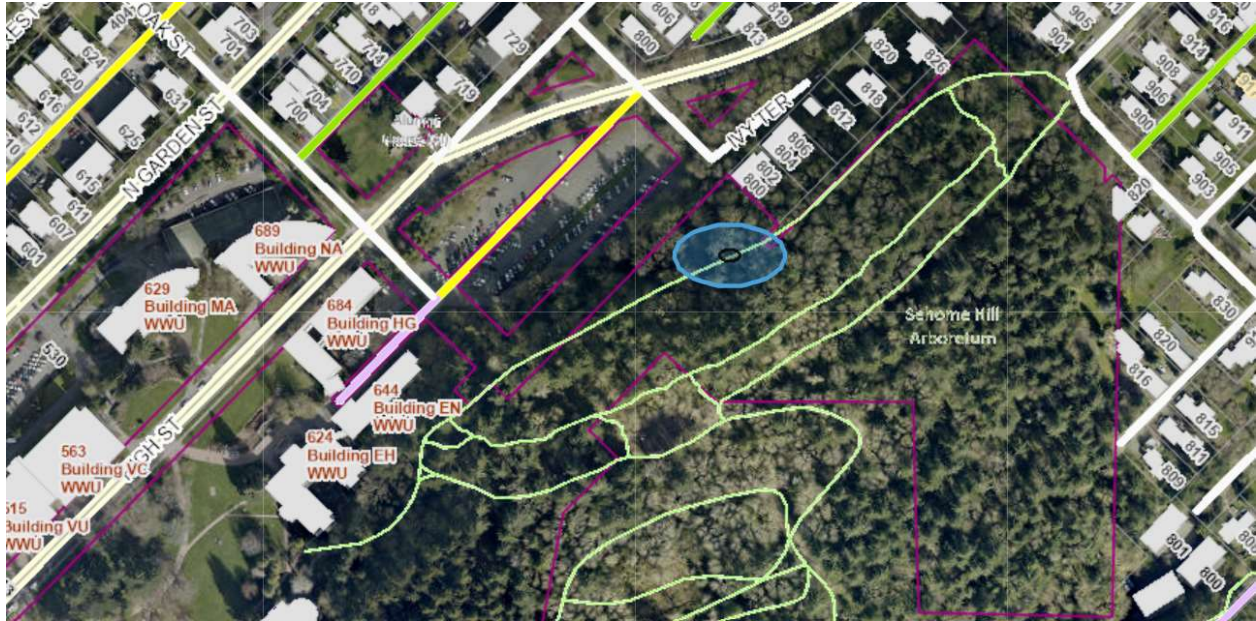
- Main Problem: Extending from the entrance from Jersey street to about where the mud pit is marked on the map in blue ($\frac{1}{8}$ of a mile in my estimate), the [whole tread](#) is covered in about [two inches](#) of decomposing leaf litter. The organic material is holding onto water and becoming mud. In one place the [trail is widening](#) as users attempt to walk around it, but mostly hikers seem to be cutting a path [straight through](#). In a steep downhill section leading into the Jersey street entrance, the mud is very slick and causes a lack of traction for hikers.

- Possible Solution: Underneath the mud, the tread is made up of [hardpacked gravel](#) and clay. It is possible to [scrape the leaf litter off](#) and have a perfectly serviceable tread again. I estimate that it would take a crew one or two work parties to scrape the trail clean again. I'm not sure how to prevent the problem in the future however, as the tread [does not seem to be insloped](#), and there is no significant berm keeping water in. It is possible that the whole tread could be crowned with gravel after it has been scraped clean. This would raise a portion of the tread out of any future mud and give users a dry but narrower path to walk.
