## **Stream Bellingham Townhomes Potential Retention Tree Analysis**

3509 Meridian St.  
Bellingham, WA 98225  
Parcels: 380331219481,

Prepared by Aubrey J. Stargell  
Forester, Certified Arborist PN 6860A  
TRAQ

August 3, 2022  
*Revised 1/23/23*

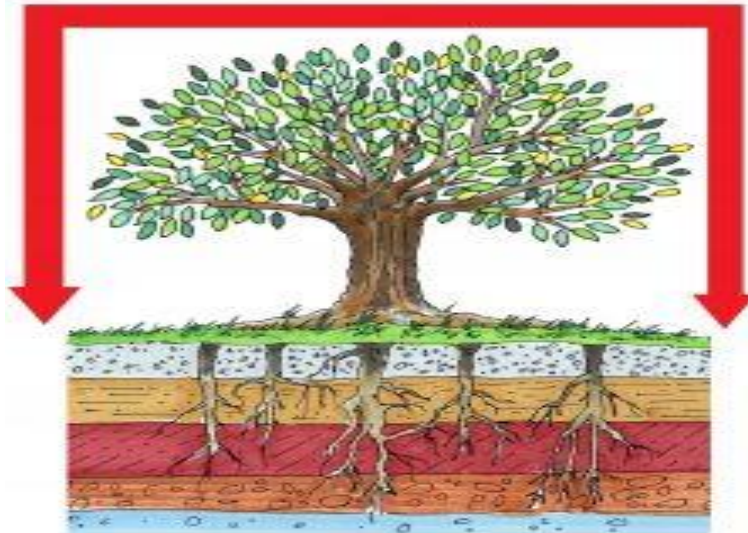
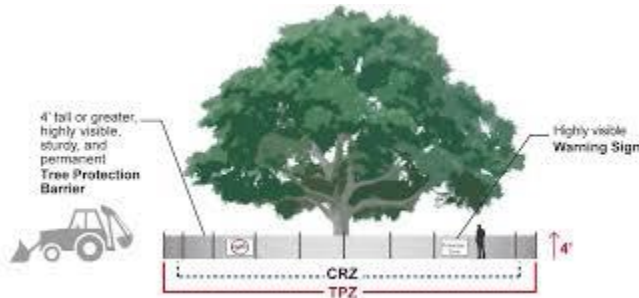
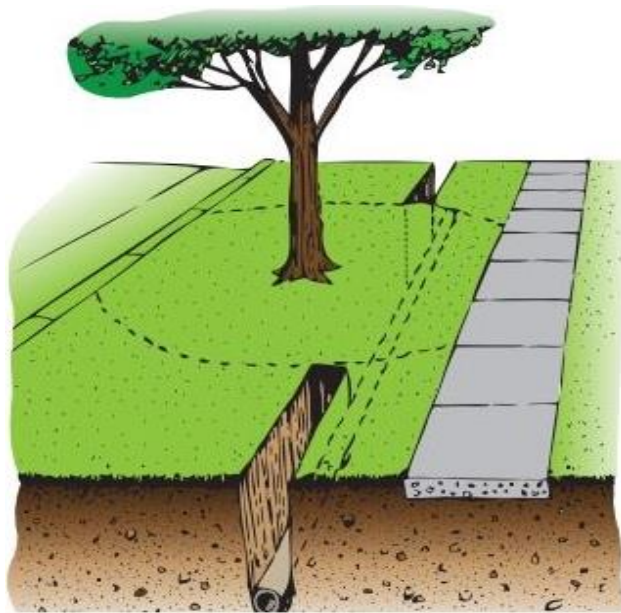
Exhibit A

ISA Best Management Practices define the Critical Root Zone (CRZ) as a footprint of ground 1’ in radius from the trunk for every inch of diameter at breast height (dbh) of the tree.

Thus, a 20" dbh tree would have a CRZ with a radius of 20'.

**Critical Root Zone**

Avoid any grade changes, placement of fill, vehicle parking, heavy equipment traffic, or underground utility work within the CRZ of each tree to minimize root disturbance and soil compaction. Efforts should be made to go over or under with utility lines when roots larger than 2" diameter are encountered in the utility trench. Hand excavation is recommended around larger roots. Where roots must be cut they should be severed cleanly using sharp tools at right angles to the root length to minimize surface area damage/tearing and exposure and to facilitate compartmentalization of the wound. Do not cut any roots larger than 3" in diameter.
