GEOTECHNICAL REPORT

Proposed Townhome Development

Meridian Street and Birchwood Avenue

PROJECT NO. 21-591

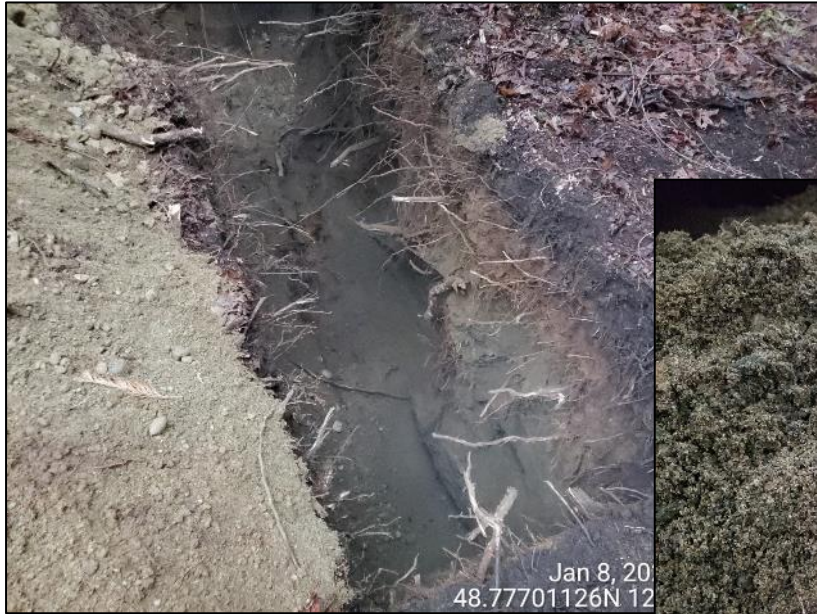
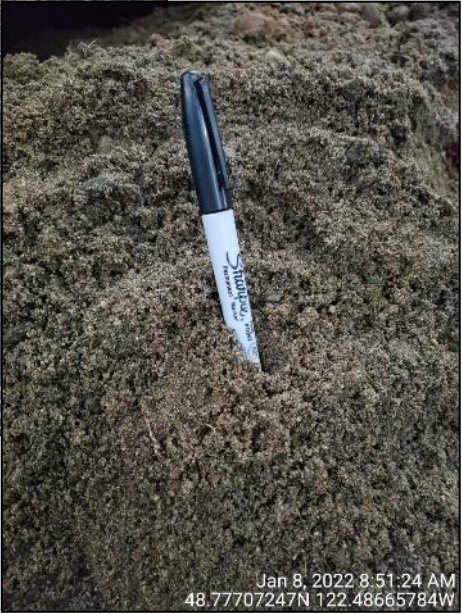
Test Pit No. TP-1
 Approximate ground surface elevation (NAVD88): 92 feet
 Coordinates (Washington State Plane - North): 652532, 1241785

<u>Depth (ft)</u>	<u>Material Description</u>
0 – 2	Duffy topsoil above loose, dark brown to orange-brown, silty fine SAND; trace gravel, roots and rootlets, some trash debris; disrupted texture, iron-oxide staining; non-plastic, moist [Fill]
2 – 8	Medium dense, gray-brown, well-graded SAND; some gravel; trace rootlets; non-plastic, moist
8 – 9	Medium dense, gray-brown; silty fine SAND; rootlets; iron-oxide staining; non-plastic, moist
9 – 10	Medium dense, gray-brown, well-graded SAND with GRAVEL; trace cobble; non-plastic, moist [Glacial Outwash, Sumas Stade - Qgos]

Photo TP-1 (left): Shows TP-1 at approximately 10 feet in depth
Photo TP-1 (right): Shows spoils from TP-1 at approximately 8 feet in depth
 TP-1 was terminated approximately 10 feet below grade.
 Some caving observed at approximately 3 to 6 feet below grade.
 No groundwater seepage was encountered during explorations.

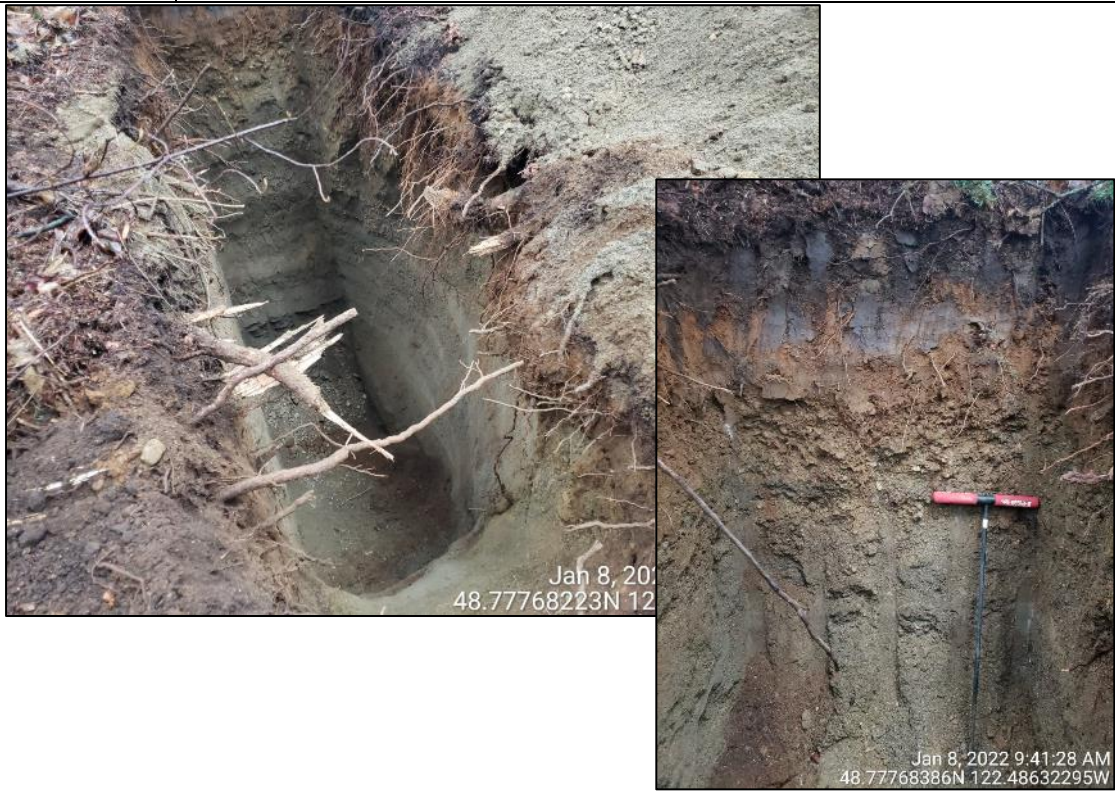
Test Pit No. TP-2
 Approximate ground surface elevation (NAVD88): 96 feet
 Coordinates (Washington State Plane - North): 652702, 1241834

Depth (ft)	Material Description
0 – 2½	Duffy topsoil above loose, dark brown to orange-brown, silty fine SAND; trace gravel, roots and rootlets; disrupted texture, iron-oxide staining; non-plastic, moist [Fill]
2½ – 7	Medium dense, gray-brown, well-graded SAND; some gravel near top; trace rootlets; laminated texture; non-plastic, moist
7 – 9	Stiff, gray-brown; SILT; laminated to massive; non-plastic, moist
9 – 10	Medium dense, gray-brown, well-graded SAND with GRAVEL; trace cobble; non-plastic, moist [Glacial Outwash, Sumas Stade - Qgos]

Photo TP-2 (left): Shows TP-2 at approximately 10 feet in depth

Photo TP-2 (right): Shows profile of TP-2 at approximately 0 to 6 feet in depth

Some caving observed at approximately 3 to 6 feet below grade.

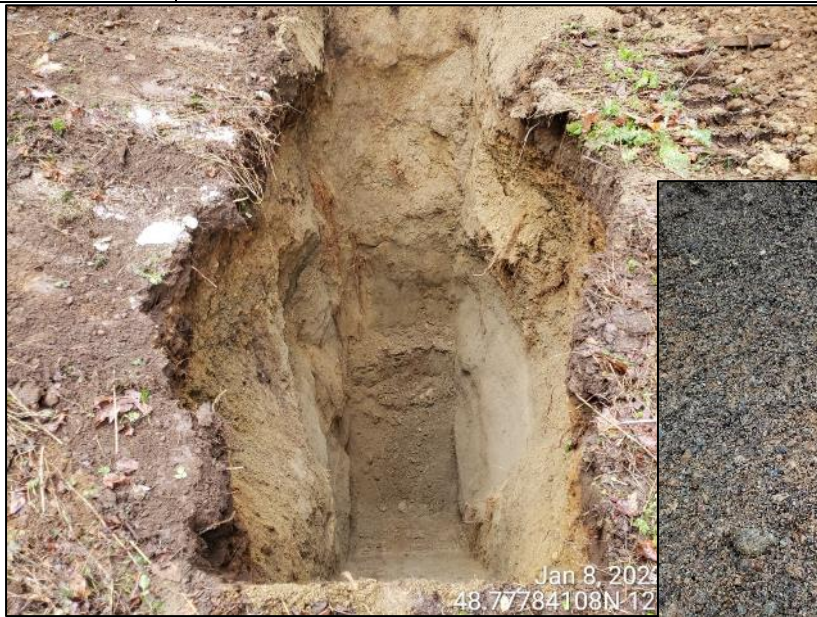
Test Pit No. TP-3
 Approximate ground surface elevation (NAVD88): 97 feet
 Coordinates (Washington State Plane - North): 652822, 1241760

Depth (ft)	Material Description
0 – 2	Duffy topsoil above loose, dark brown to orange-brown, well-graded SAND; trace gravel, trace silt, roots and rootlets; disrupted texture, iron-oxide staining; non-plastic, moist [Fill]
2 – 7	Medium dense, gray-brown, well-graded SAND; some gravel, trace rootlets; non-plastic, moist
7 – 10	Medium dense, gray-brown, well-graded SAND; trace gravel, trace iron-oxide staining; non-plastic, moist
10 – 12	Stiff, gray; clayey SILT; massive; trace iron-oxide staining; low-plasticity, moist [Glacial Outwash, Sumas Stade - Qgos]

Photo TP-3 (left): Shows TP-3 at approximately 12 feet in depth

Some caving observed at approximately 0 to 6 feet below grade.

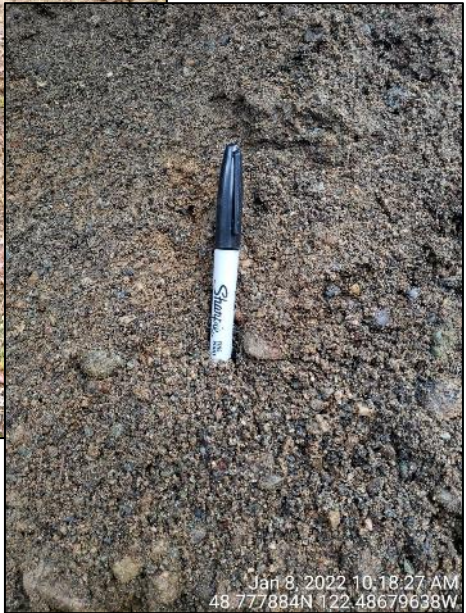
Photo TP-3 (right): Shows spoils from TP-3 at approximately 6 feet in depth

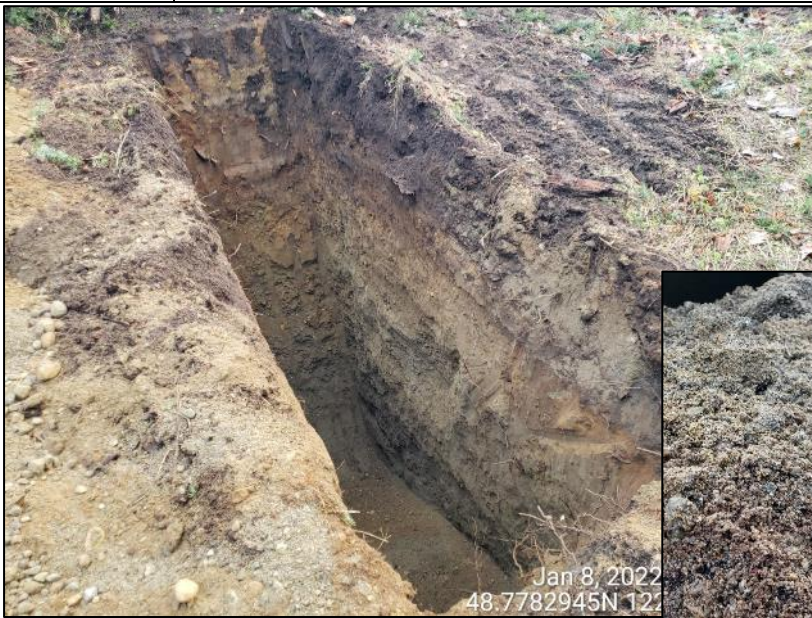
Test Pit No. TP-4
 Approximate ground surface elevation (NAVD88): 99 feet
 Coordinates (Washington State Plane - North): 652966, 1241833

Depth (ft)	Material Description
0 – 3½	Duffy topsoil above loose, dark brown to orange-brown, silty fine SAND; trace gravel, roots and rootlets; disrupted texture, iron-oxide staining; non-plastic, moist [Fill]
3½ – 8½	Medium dense, gray-brown, well-graded SAND with GRAVEL; trace rootlets; non-plastic, moist
8½ – 11	Medium dense, gray-brown, well-graded SAND; trace silt, some gravel; non-plastic, moist [Glacial Outwash, Sumas Stade - Qgos]

Photo TP-4 (left): Shows TP-4 at approximately 11 feet in depth

No caving observed during explorations.

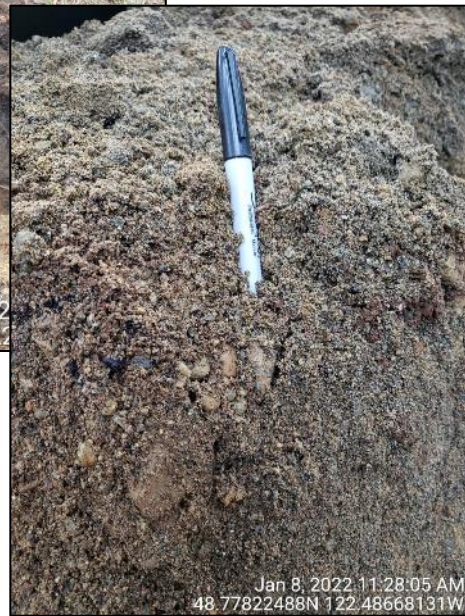
Photo TP-4 (right): Shows spoils from TP-4 at approximately 6 feet in depth

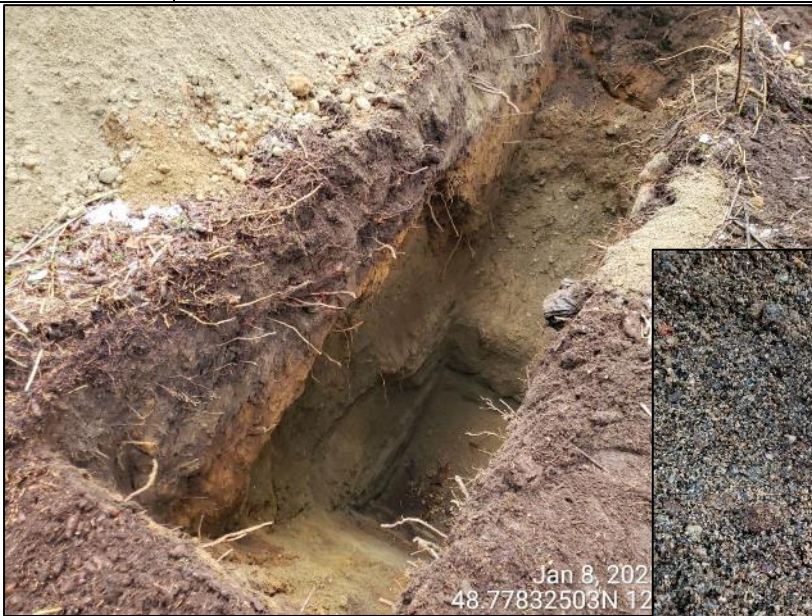
Test Pit No. TP-5
 Approximate ground surface elevation (NAVD88): 101 feet
 Coordinates (Washington State Plane - North): 653005, 1241670

Depth (ft)	Material Description
0 – 3½	Duffy topsoil above loose, dark brown to orange-brown, silty fine SAND; trace gravel, roots and rootlets, some trash debris; disrupted texture, iron-oxide staining; non-plastic, moist [Fill]
3½ – 8	Medium dense, gray-brown, well-graded SAND; some gravel, trace rootlets; non-plastic, moist
8 – 13	Medium dense, gray-brown, well-graded SAND; trace silt, some gravel; non-plastic, moist [Glacial Outwash, Sumas Stade - Qgos]

Photo TP-5 (left): Shows TP-5 at approximately 13 feet in depth

Some caving observed at approximately 3 to 6 feet below grade.

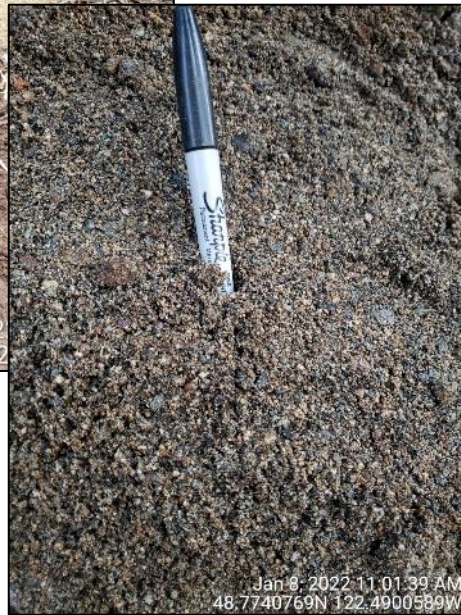
Photo TP-5 (right): Shows spoils from TP-5 at approximately 6 feet in depth

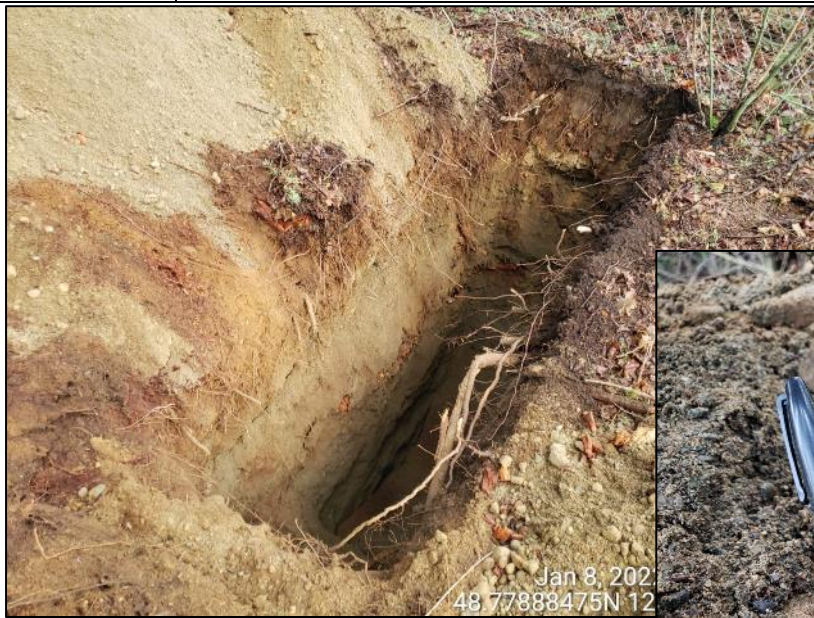
Test Pit No. TP-6
 Approximate ground surface elevation (NAVD88): 101 feet
 Coordinates (Washington State Plane - North): 653171, 1241843

Depth (ft)	Material Description
0 – 3	Duffy topsoil above loose, dark brown to orange-brown, silty fine SAND; trace gravel, roots and rootlets, some trash debris; disrupted texture, iron-oxide staining; non-plastic, moist [Fill]
3 – 6	Medium dense, gray-brown, well-graded SAND with GRAVEL; some cobble, trace rootlets; non-plastic, moist
6 – 10	Medium dense, gray-brown, well-graded SAND; trace gravel; non-plastic, moist [Glacial Outwash, Sumas Stade - Qgos]

Photo TP-6 (left): Shows TP-6 at approximately 10 feet in depth

No caving observed during explorations.

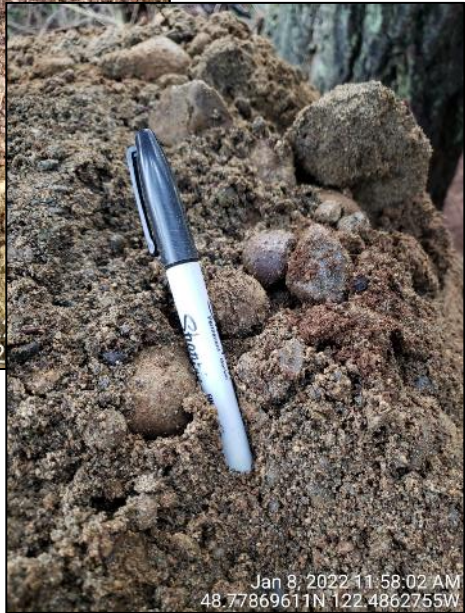
Photo TP-6 (right): Shows spoils from TP-6 at approximately 6 feet in depth

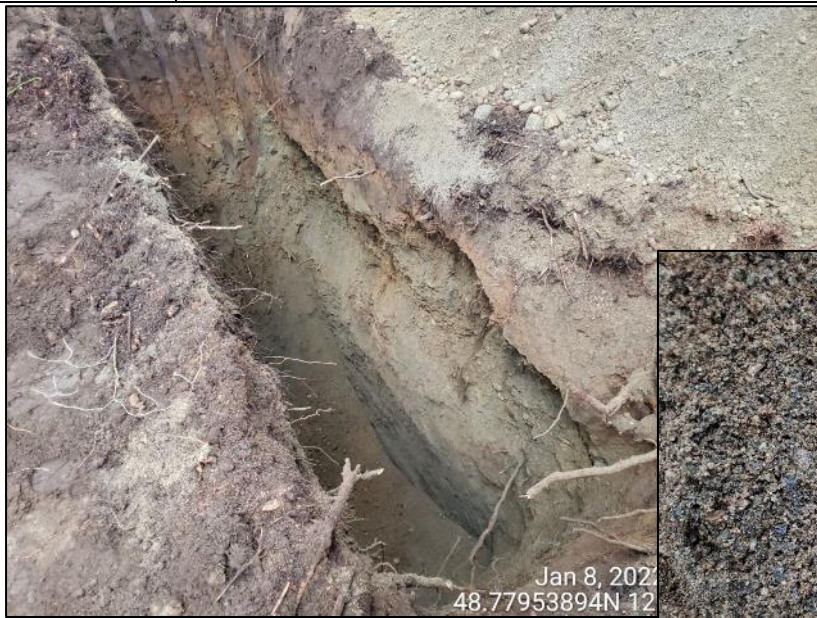
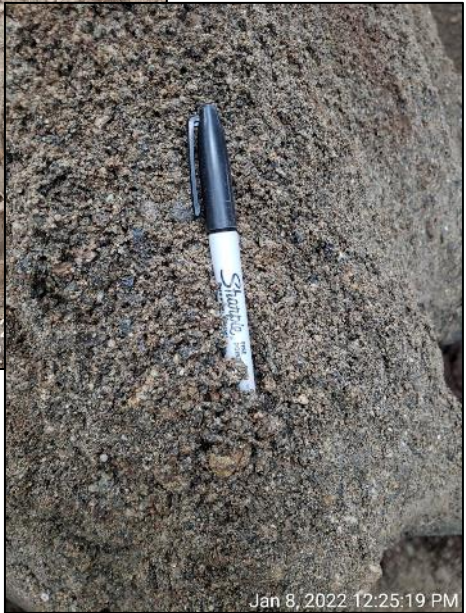
Test Pit No. TP-7
 Approximate ground surface elevation (NAVD88): 101 feet
 Coordinates (Washington State Plane - North): 653410, 1241749

Depth (ft)	Material Description
0 – 3½	Duffy topsoil above loose, dark brown to orange-brown, silty fine SAND; trace gravel, roots and rootlets; disrupted texture, iron-oxide staining; non-plastic, moist [Fill]
3½ – 8	Medium dense, gray-brown, well-graded SAND with GRAVEL; trace rootlets; trace iron-oxide staining, non-plastic, moist
8 – 10	Medium dense, gray-brown, well-graded SAND; trace gravel; non-plastic, moist [Glacial Outwash, Sumas Stade - Qgos]

Photo TP-7 (left): Shows TP-7 at approximately 10 feet in depth
Photo TP-7 (right): Shows spoils from TP-7 at approximately 6 feet in depth
 TP-7 was terminated approximately 10 feet below grade.
 Some caving observed at approximately 3 to 5 feet below grade.
 No groundwater seepage was encountered during explorations.

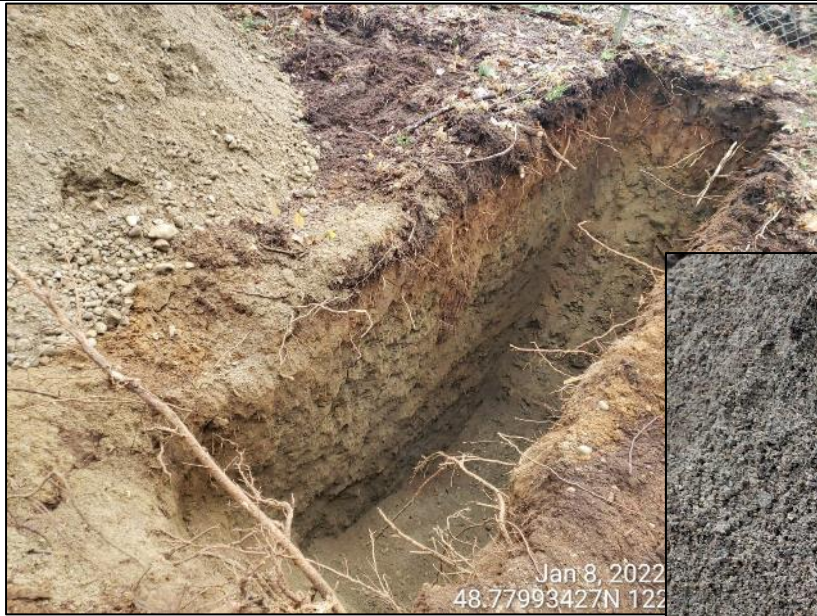
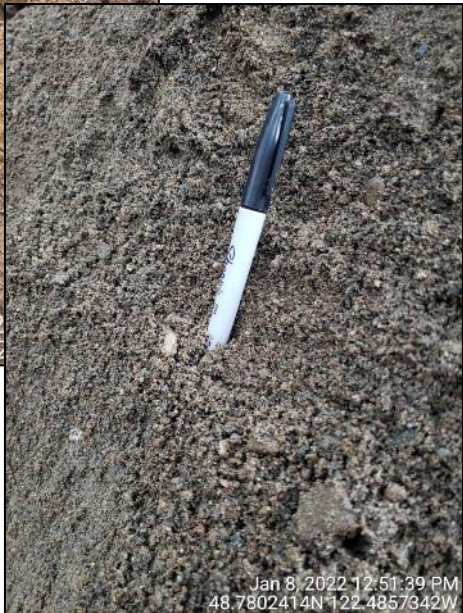
Test Pit No. TP-8
 Approximate ground surface elevation (NAVD88): 102 feet
 Coordinates (Washington State Plane - North): 653600, 1241845

Depth (ft)	Material Description
0 – 2	Duffy topsoil above loose, dark brown to orange-brown, silty fine SAND; trace gravel, roots and rootlets; some trash debris; disrupted texture, iron-oxide staining; non-plastic, moist [Fill]
2 – 10	Medium dense, gray-brown, well-graded SAND with GRAVEL; non-plastic, moist <ul style="list-style-type: none"> • <i>Decrease in gravel content at about 10 feet below surface</i> <p style="text-align: right;">[Glacial Outwash, Sumas Stade - Qgos]</p>

Photo TP-8 (left): Shows TP-8 at approximately 10 feet in depth
Photo TP-8 (right): Shows spoils from TP-8 at approximately 6 feet in depth
 TP-8 was terminated approximately 10 feet below grade.
 No caving observed during explorations.
 No groundwater seepage was encountered during explorations.
