Tree Inventory
For Single Residential Development
 119 Ashley St.
 Bellingham, WA 98225

Prepared by Aubrey J. Stargell
 Forester, Certified Arborist PN 6860A
 TRAQ

July 19, 2024

MITIGATION SITE PLAN
 119 ASHLEY ST.
 NEW 2,111 SF SINGLE FAMILY RESIDENCE
 W/4-BDRM, 4-BATH, 2-CAR GARAGE

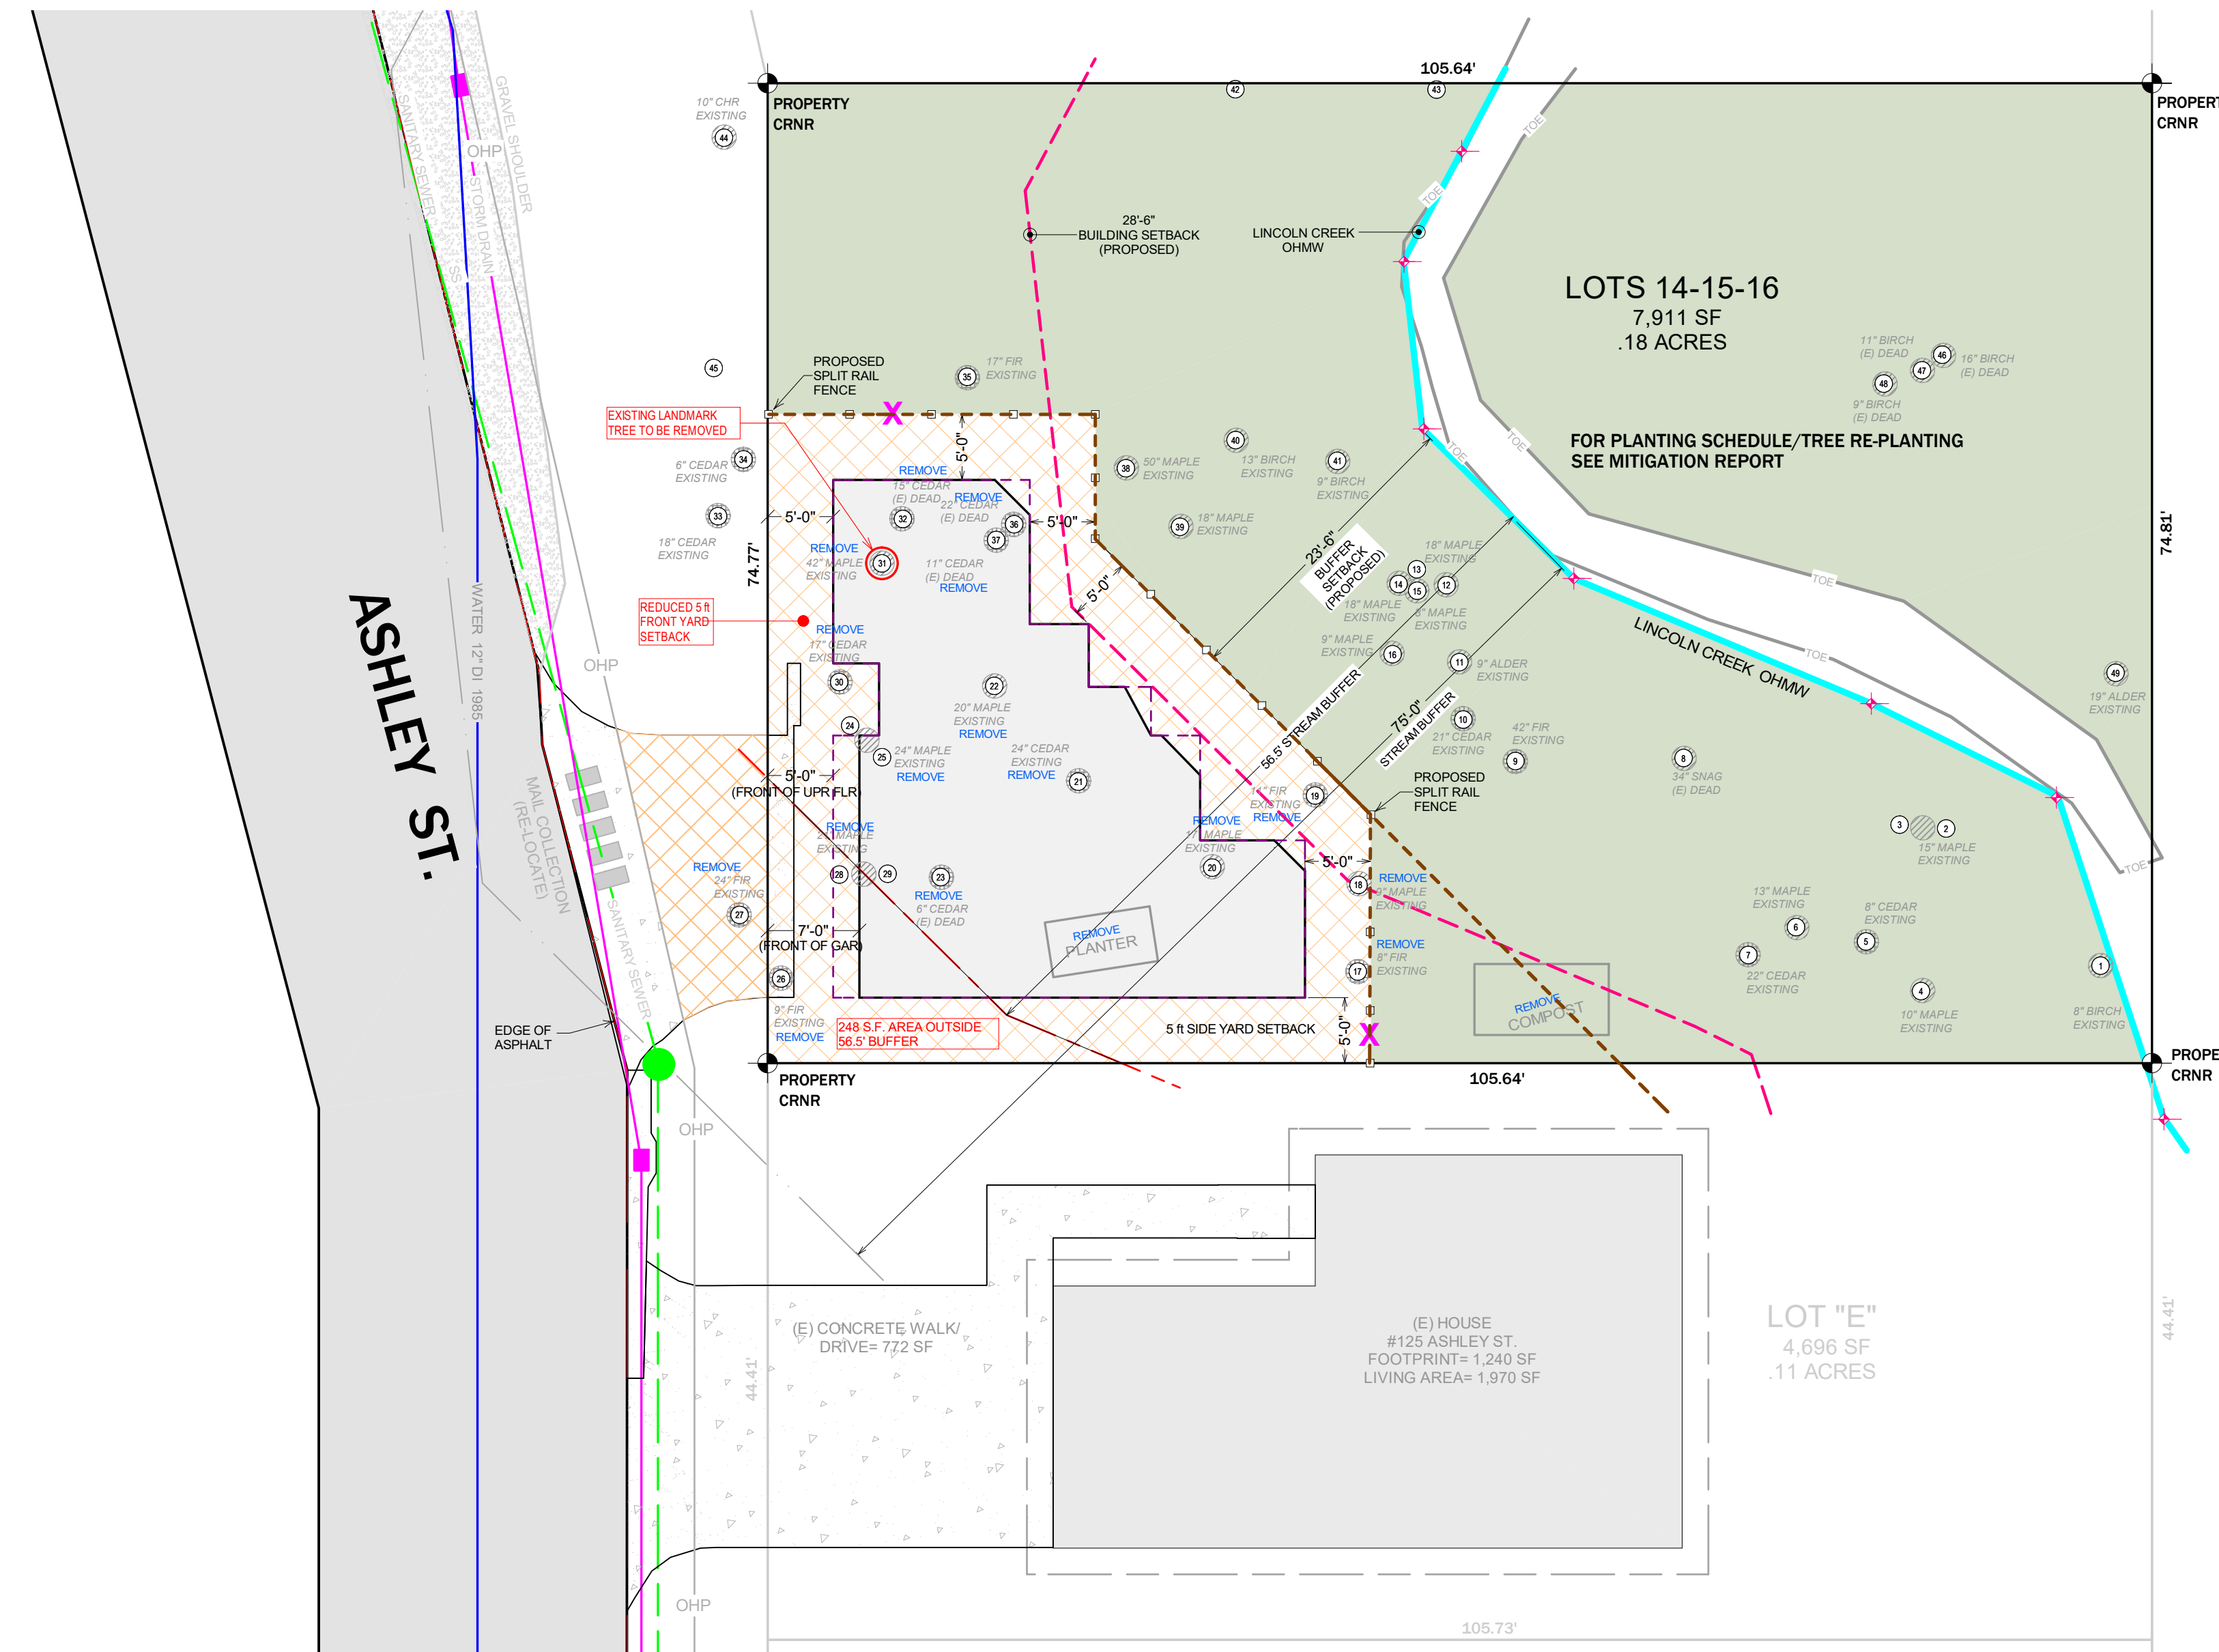
SHEET
A5

The entirety of the subject parcel is within a 75 ft. stream buffer. The development envelope would occupy **2,043 square feet of stream buffer area** including all structures, concrete surfacing, and the small areas of maintained landscaping around and in front of the home. Impacts to stream buffer functions and values are anticipated to be permanent. To mitigate unavoidable buffer impacts, the proposal includes **enhancement of 5,514 square feet** of area surrounding the residence through conifer underplanting with some shrubs and removal of ivy. Minor impacts to water quality functions are expected to be offset through stormwater controls and site enhancement plantings, including native trees, shrubs, and groundcover, which would filtration and year-round water quality improvement functions over the existing site condition. All mitigation plantings would be maintained and monitored for a period of five years. A split-rail fence with native growth protection signage would be installed along the boundary of the mitigation, and all retained critical areas (both enhancement area and retained native area) would be placed in a permanent conservation easement recorded with the Whatcom County auditor's office.
