Geotechnical Engineering Report

1204 Yew Street
Bellingham, WA 98229

April 7, 2022
Project No. 22-0336

Regarding: Geotechnical Engineering Report
1204 Yew Street Development
1204 Yew Street
Bellingham, WA 98229
(Parcel No. 3803330384410000)

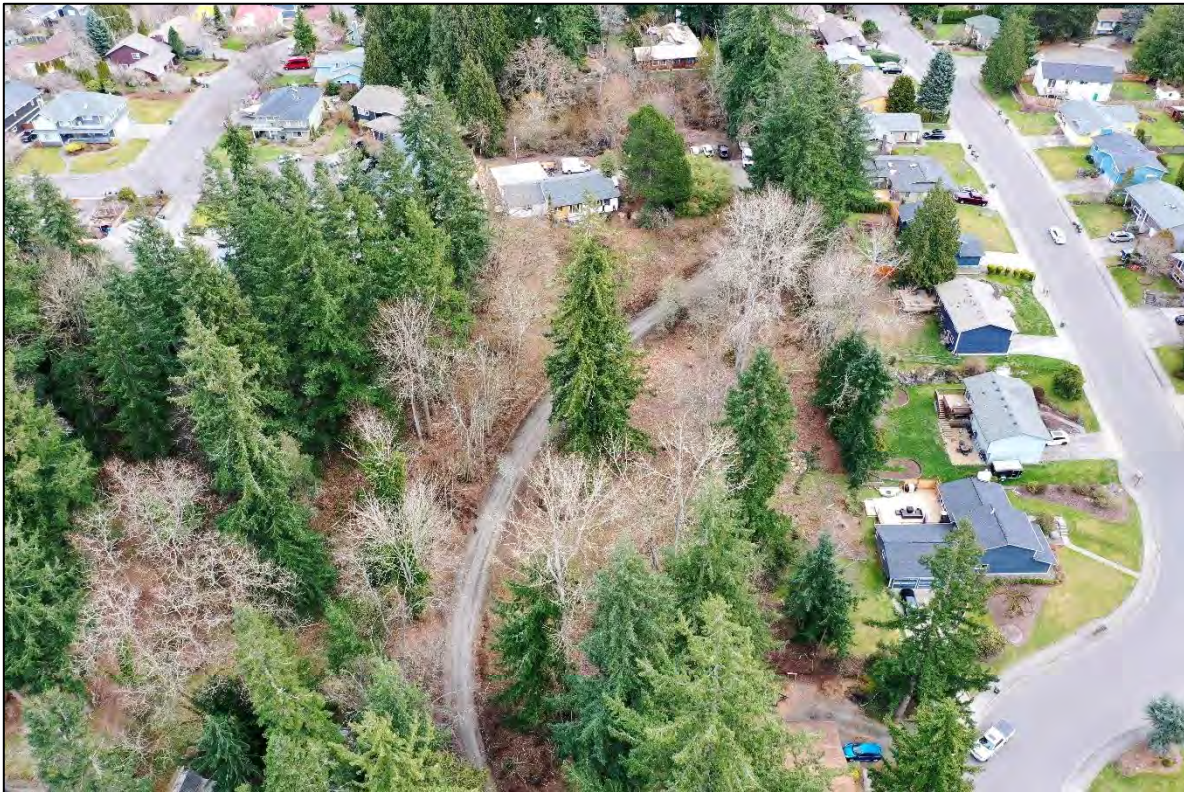
Photo 1: Overhead view of project site. Photo captured by GeoTest drone. Perspective to the east.

The subject site is located along the eastern margin of Yew Street, approximately 900 feet south of the junction on Yew Street and Lakeway Drive in Bellingham, WA. The subject site is surrounded by single-family residences and neighborhoods. The parcel currently contains a single-family residence within its upslope, eastern portion and is accessed by a gravel driveway which enters the property from Yew Street. The project site is generally located within the lower elevation, northern most portion of the Galbraith Mountain highlands and extends from roughly 310 to 370 feet above sea level.

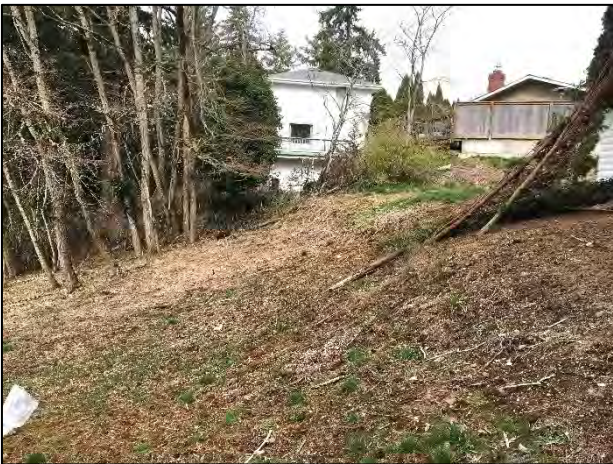
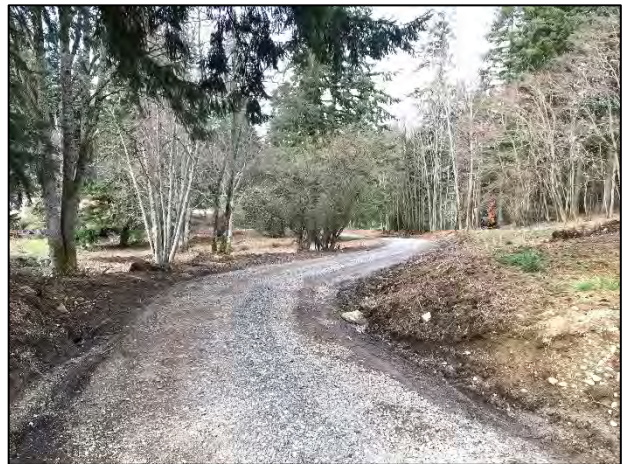
Photos 2 (left) and 3 (right): Photo 2 depicts surface conditions within the upslope, northern portion of the subject property. Note dense vegetation locally steep slopes (just off-site) as well as the generally moderate site topography. Photo 3 illustrates surface conditions within central and western portion of project site.

Slopes appear to briefly exceed 40 percent inclinations in a few localized areas across the site. These areas include the land immediately east of the existing pond location, brief locations adjacent to the access road and most notably, along the northern margin of the project site, to the west / northwest of the existing residence. The majority of these locations only display 40 percent or greater slope inclinations over a few feet of total vertical relief. However, along the northern margin of the project site, the overall relief of steep slopes does increase to a maximum of roughly 12.5 feet of total relief immediately adjacent to the project site.

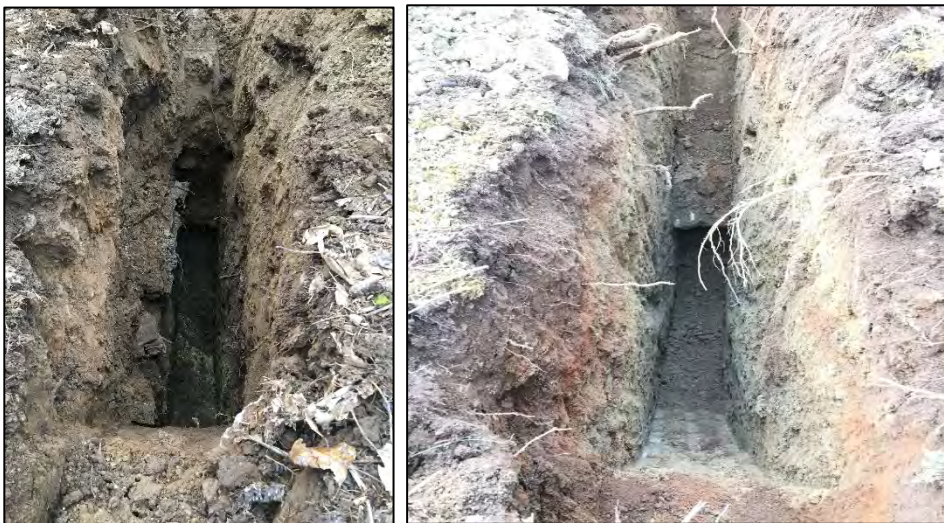
Photo 4 & 5: Subsurface Conditions at TP-1 (left) with roughly 5.5 feet of uncontrolled fill and TP-7(right) depicting native soil conditions as observed across the majority of the project site.

In TP-1 a medium dense to loose, brown, sandy gravelly silt with frequent organic debris as well as concrete and metal debris was encountered at the surface and extended to a depth of 5.5 feet BGS. This is interpreted as reworked native fill, interpreted to have been generated during

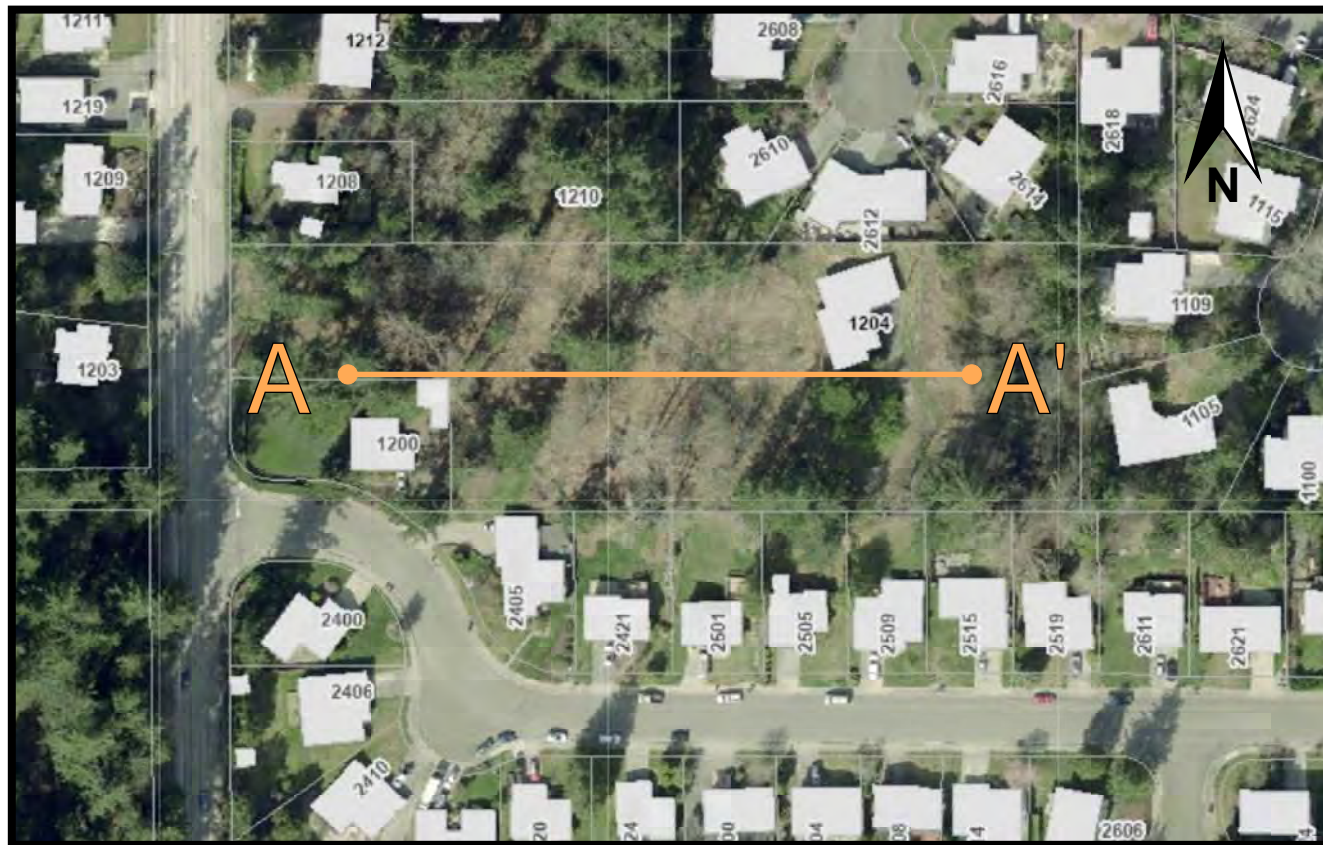
| | | | | FIGURE 4 |

- 1) CROSS SECTION GENERATED USING PUBLIC LIGHT DETECTION AND RANGING DATA (LIDAR) BELLINGHAM, 2013.
- 3) CONTACT BETWEEN UNDIFFERENTIATED GLACIAL DEPOSITS AND CHUCKANUT FORMATION BEDROCK IS SHOWN AS DASHED LINE DUE TO INFERRED CONTACT AT DEPTH. CHUCKANUT FORMATION BEDROCK WAS NOT ENCOUNTERED IN OUR SUBSURFACE EXPLORATIONS.
- 3) SITE PHOTOGRAPHY REFERENCE: BELLINGHAM CITY IQ.
