# PRELIMINARY STORMWATER REPORT

2825 LINDSHIER AVE.

SUBJECT: PROPOSED STORM DRAIN SYSTEM 2825 Lindshier Ave.  
SUB2024-0032, CAP2024-0036, VAR2024-0004, SEP2024-00028

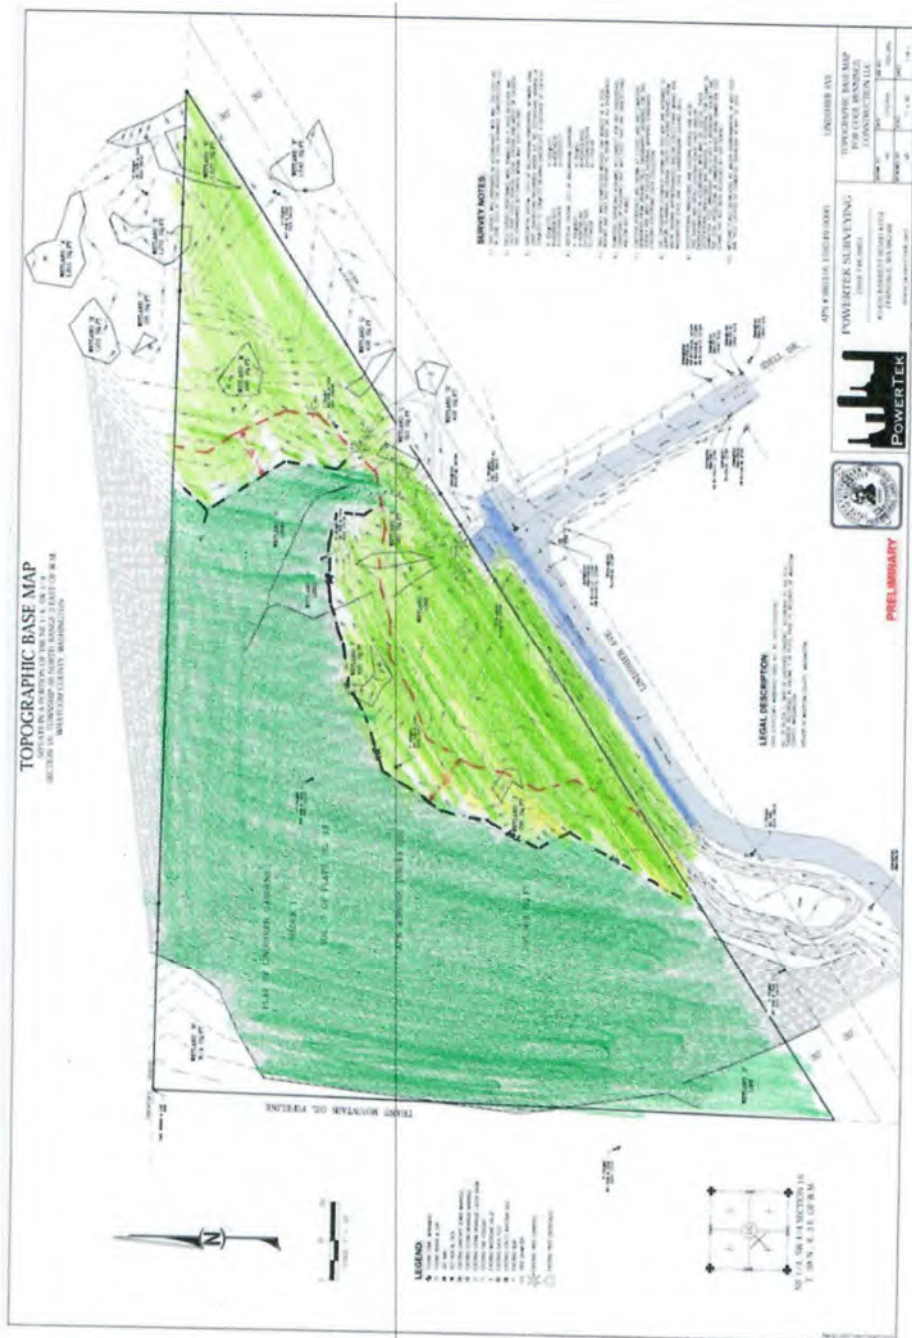
# Pre-Development Drainage Basin Map

Pre-Developed	Roadway	Lot1	Lot 2	Lot3	Lot 4	Total
Building Area	0	0	0	0	0	0
Road Area	1500	0	0	0	0	1500
Landscape Area	0	0	0	0	0	0
Forested - Steep	0	0	0	0	112076	112076
Forested - Mod	12100	16567	8330	7895	60000	104892
<b>Total</b>	<b>13600</b>	<b>16567</b>	<b>8330</b>	<b>7895</b>	<b>172076</b>	<b>218468</b>

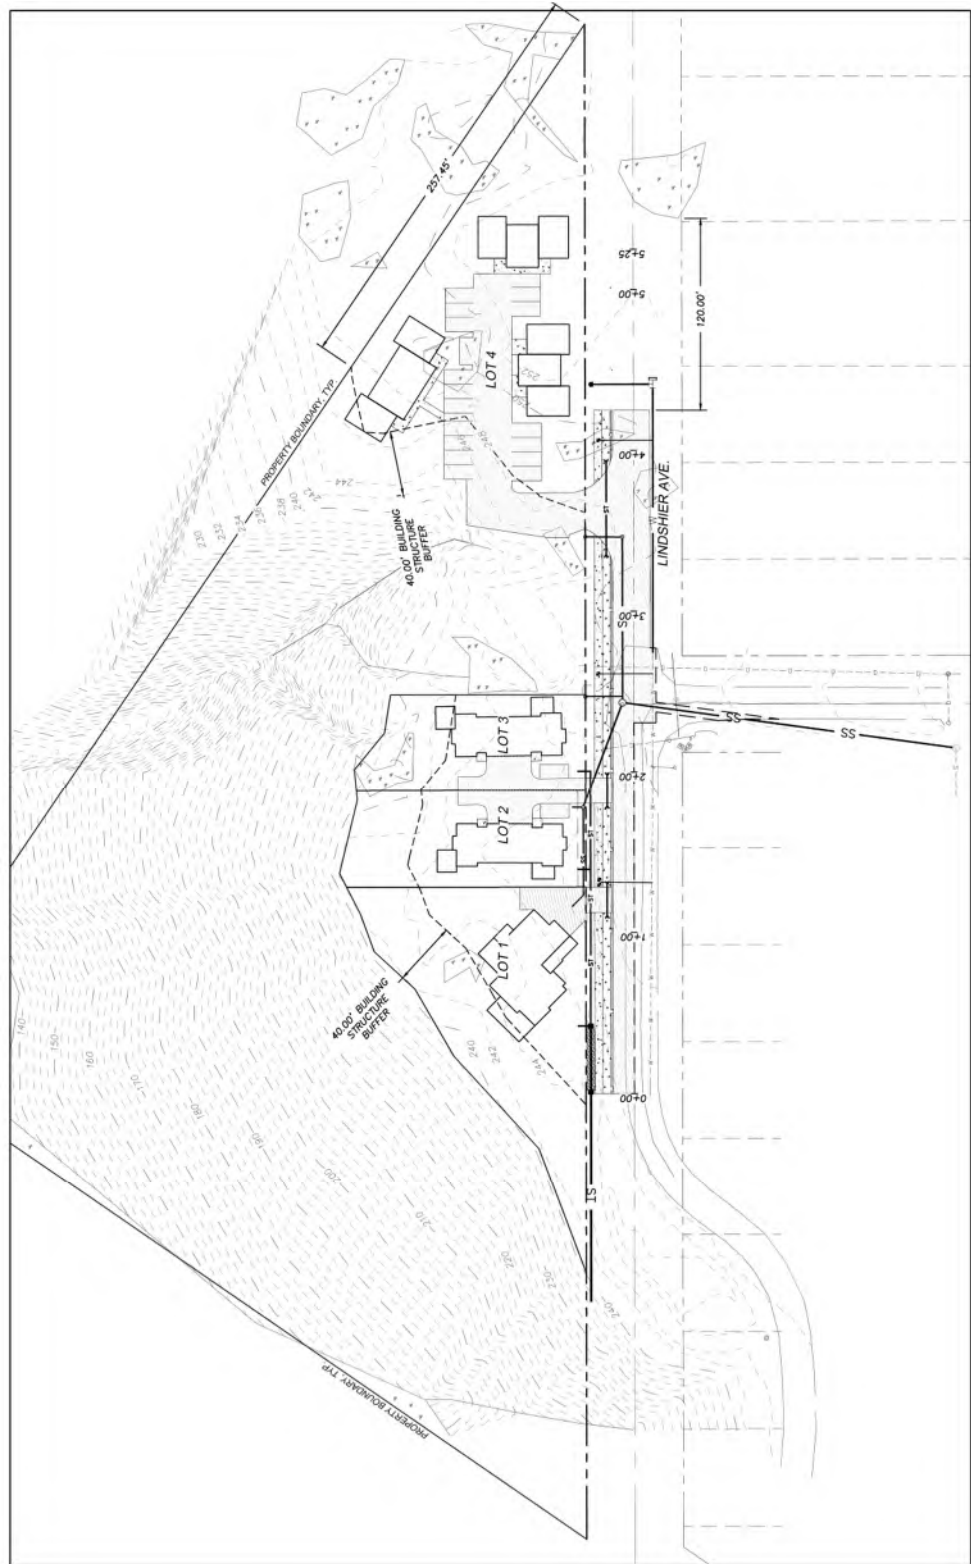
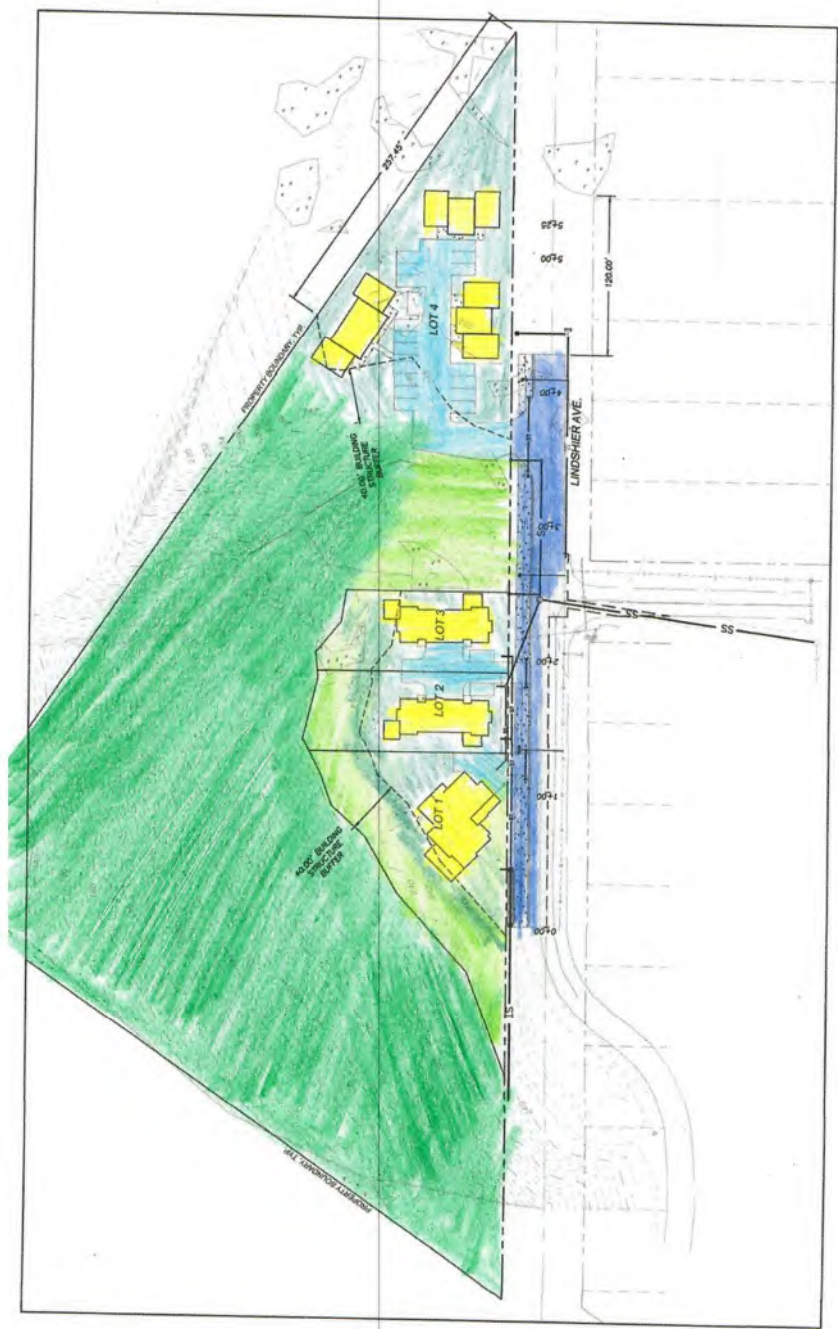
# Post-Development Drainage Basin Map

Post Developed	Roadway	Lot1	Lot 2	Lot3	Lot 4	Total
  Building Area		3600	2400	2400	6000	14400
  Driveway		1500	1600	1600	9600	14300
  Road Area	13600					13600
  Landscape Area		4500	3000	3000	6000	16500
  Forested - Steep		0	0	0	112076	112076
  Forested - Mod	0	6967	1330	895	38400	47592
<b>Total</b>	<b>13600</b>	<b>16567</b>	<b>8330</b>	<b>7895</b>	<b>172076</b>	<b>218468</b>

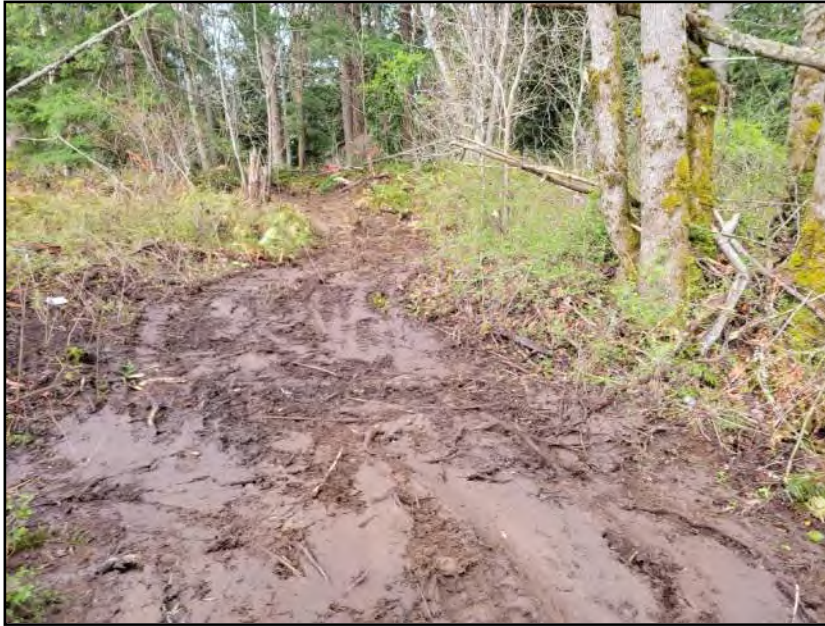
*Image 1. View of the southwestern end of the site facing northwest from the center of the site. Photo taken on 4/05/22.*

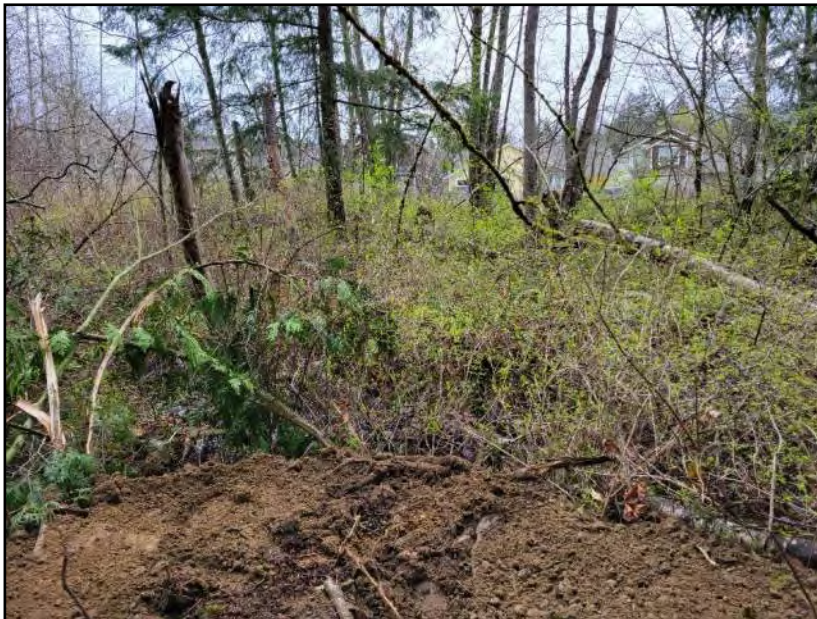
*Image 2. View of the Eastern end of the site facing southeast from the center of the Northeast portion of the site. Photo taken on 4/05/22*

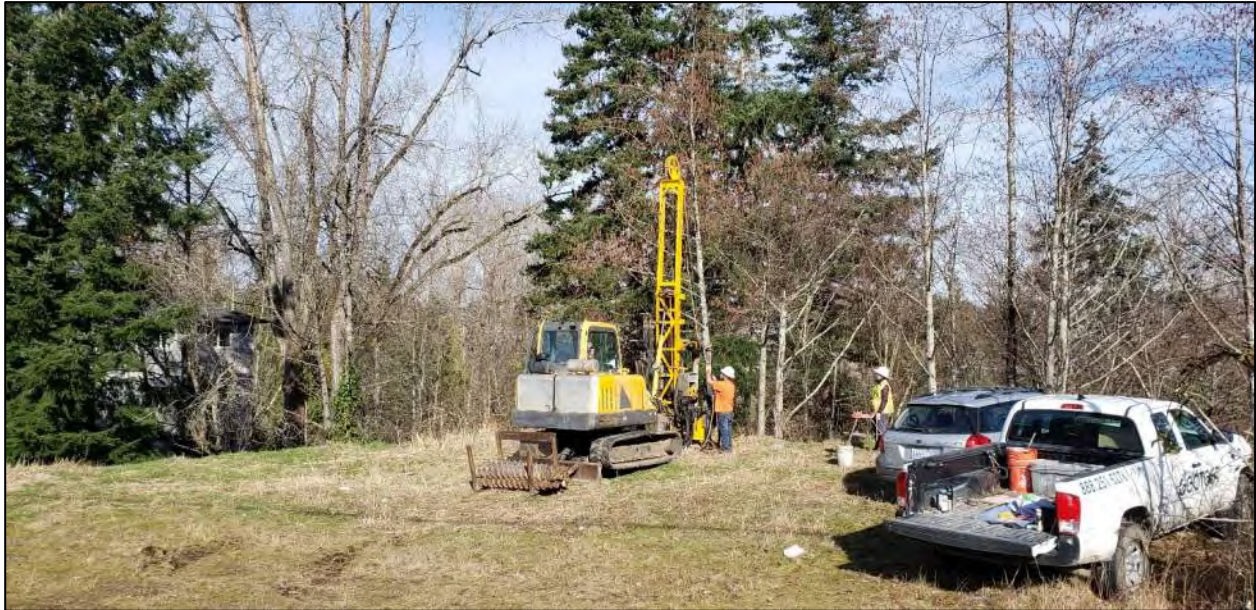
*Image 3. Photo of borehole B-1 in progress, facing northwest.*

Borehole explorations were advanced to depths ranging from 105 to 111 feet below ground surface (BGS) using a 6-inch diameter, hollow-stem auger soil drill on a track-mounted assembly operated by Boretac 1, Inc. Samples were generally taken at 2.5-foot intervals in the upper 10 feet and transitioned to 5-foot intervals below 10 feet and to the termination depth of each boring. A GeoTest Licensed Engineering Geologist directed and observed drilling operations and logged the soils encountered. Upon completion, all of the boring locations were backfilled with soil tailings and bentonite and capped to match pre-existing conditions.

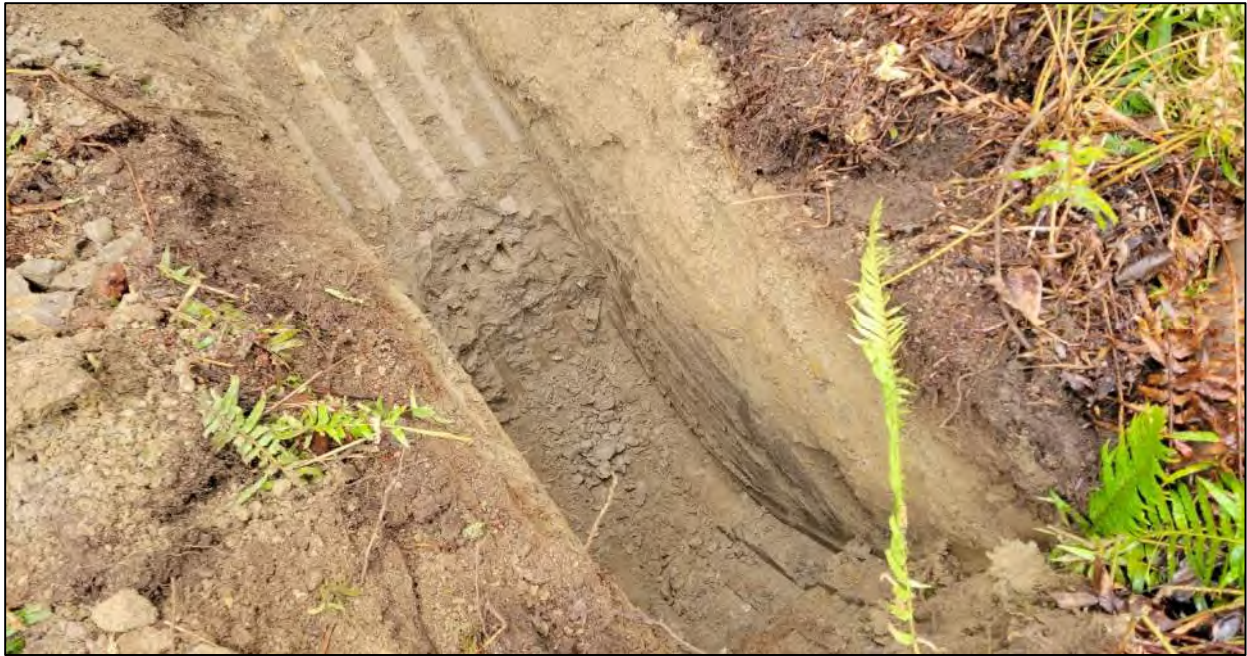
*Image 4. View of excavation at TP-3 exhibiting typical Upper Glaciomarine Drift deposits.*

Underlying topsoil, a very stiff, damp to moist, slightly gravelly, very sandy clay was observed. This material was interpreted as native Upper Glaciomarine Drift and extended to approximately 20 feet BGS in both boring explorations. At approximately 20 feet BGS, the native soils graded to the Middle Glaciomarine Drift consisting of medium stiff to stiff, damp, sandy clay with a slightly elevated moisture content. The Middle Glaciomarine Drift extended to a depth of approximately 40 feet BGS before transitioning to the Lower Glaciomarine Drift. The lower section of the Glaciomarine Drift soil was characterized by an increase in soil density while soil components remained relatively similar to the soils above. The base of the Glaciomarine Drift soils was found at roughly 65 feet BGS where borings encountered a very gravelly, very silty sand deposit that was interpreted as Advance Glacial Outwash. This soil unit was typically gray to brown, dry to slightly moist, and very dense. Outwash soils became wet in boring B-1 at approximately 105 feet BGS where encountering groundwater. These soils extending through the maximum exploration depths of 106.5 to 111 feet BGS.

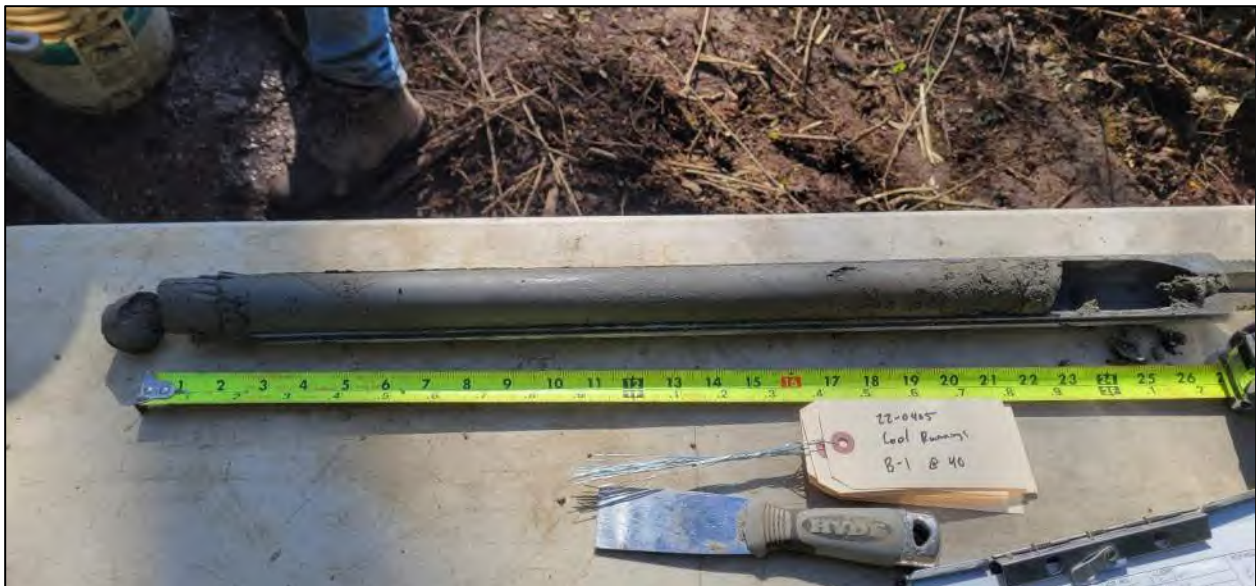
*Image 5. View of sample taken at 40 feet BGS from boring B-1 exhibiting Middle Glaciomarine Drift deposits.*

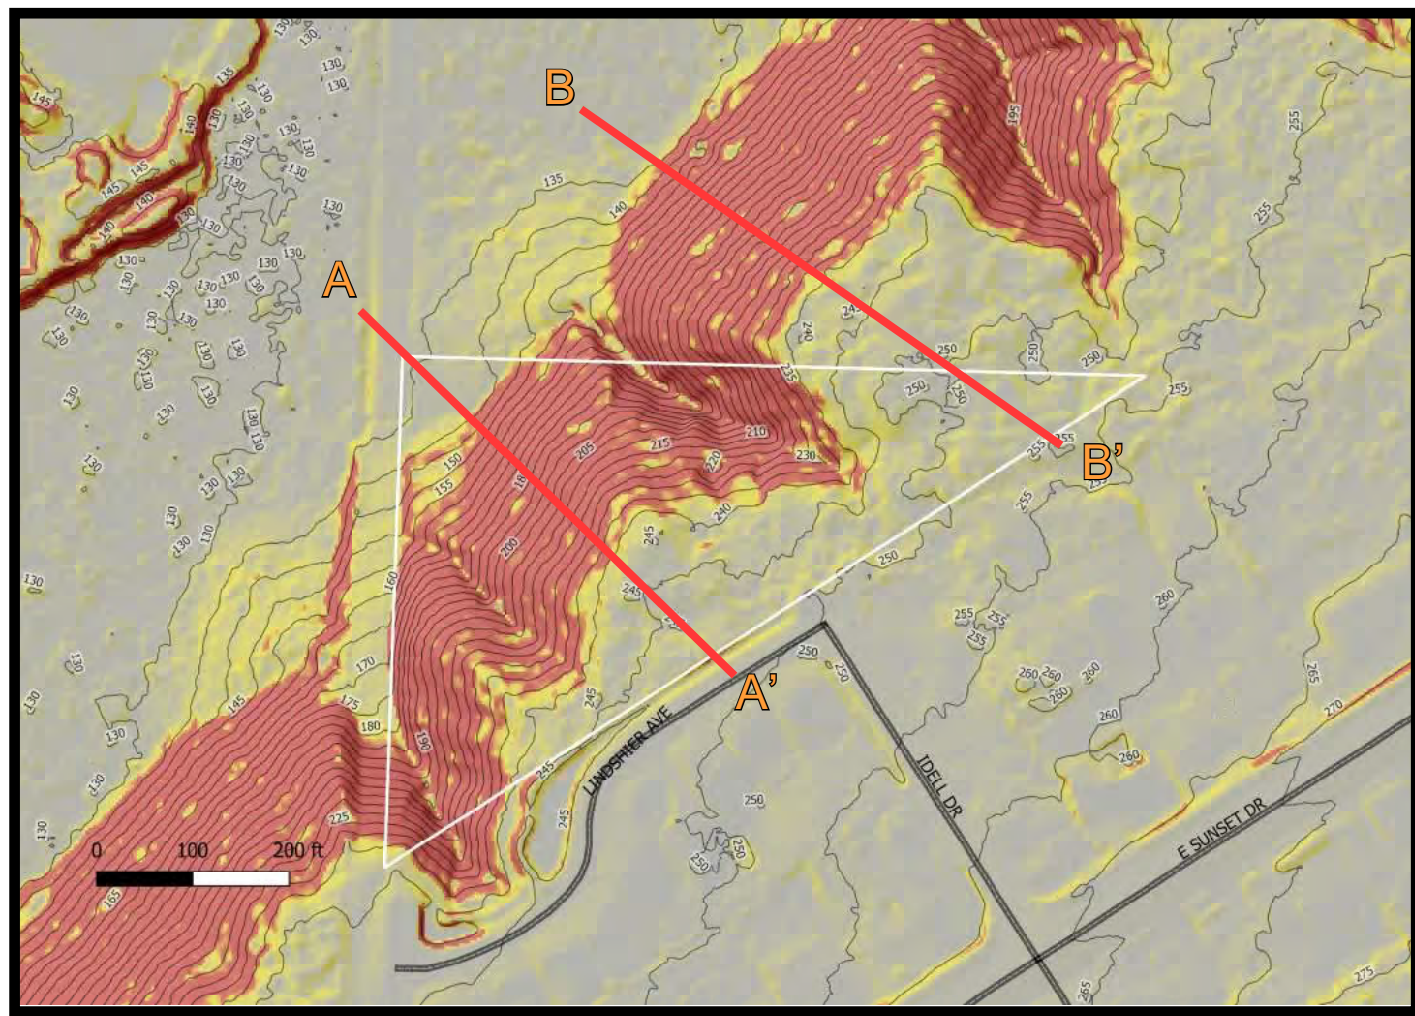
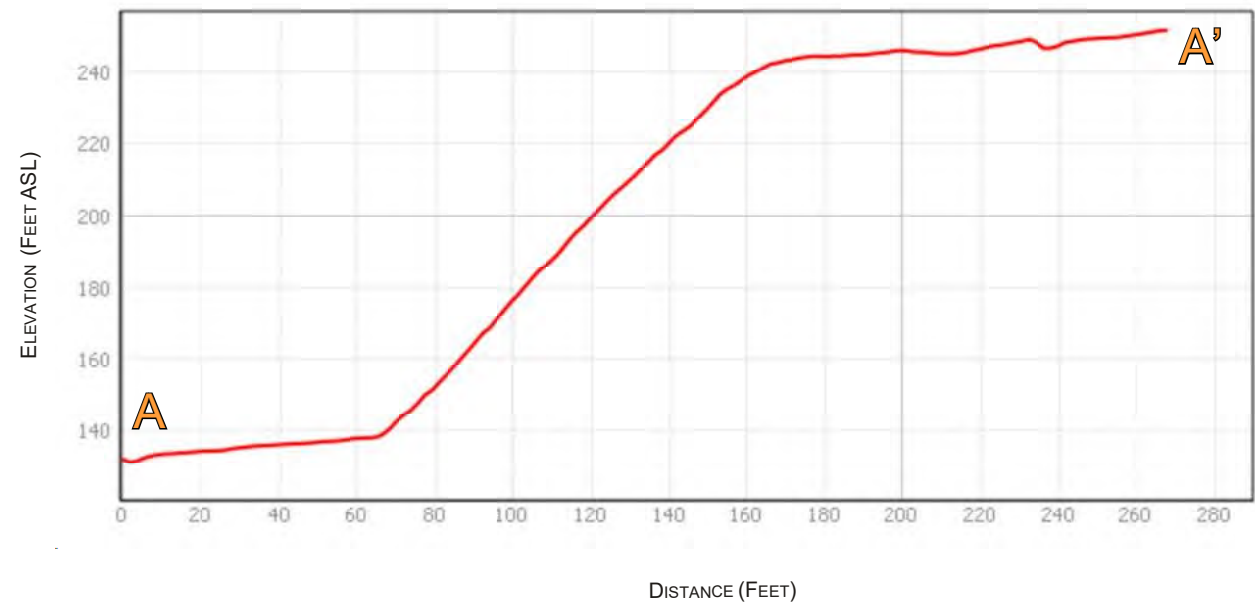
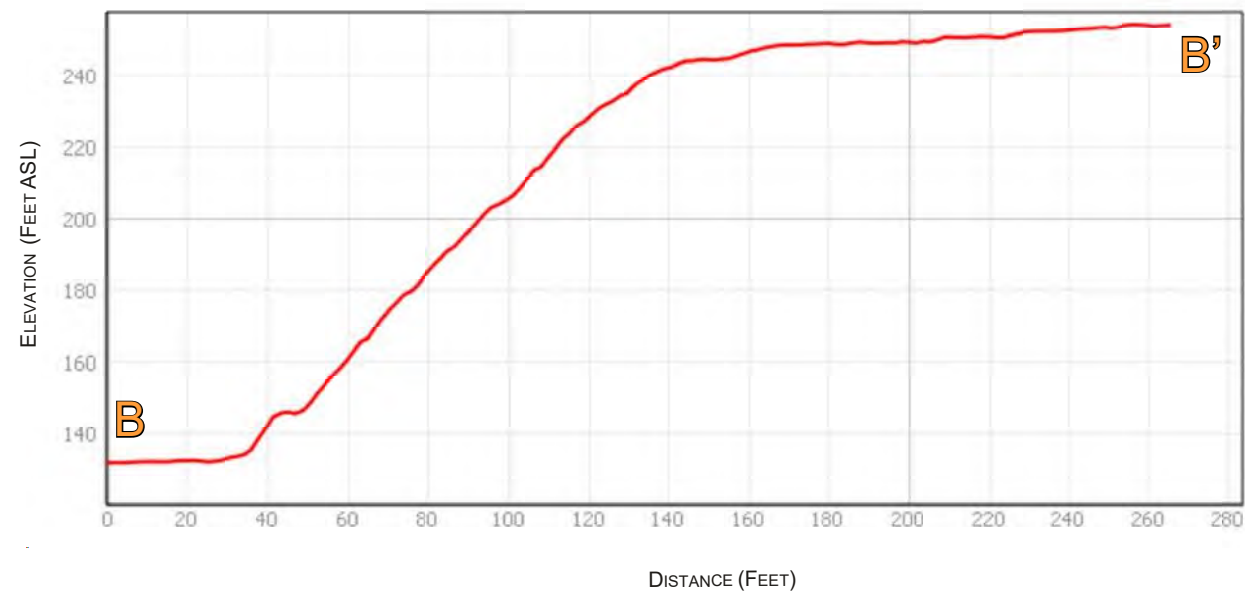
Figure  
**3A**

**BARE EARTH IMAGE - CROSS SECTIONS**  
 COOL RUNNINGS DEVELOPMENT  
 LINDSHIER AVENUE AND IDELL DRIVE  
 BELLINGHAM, WASHINGTON

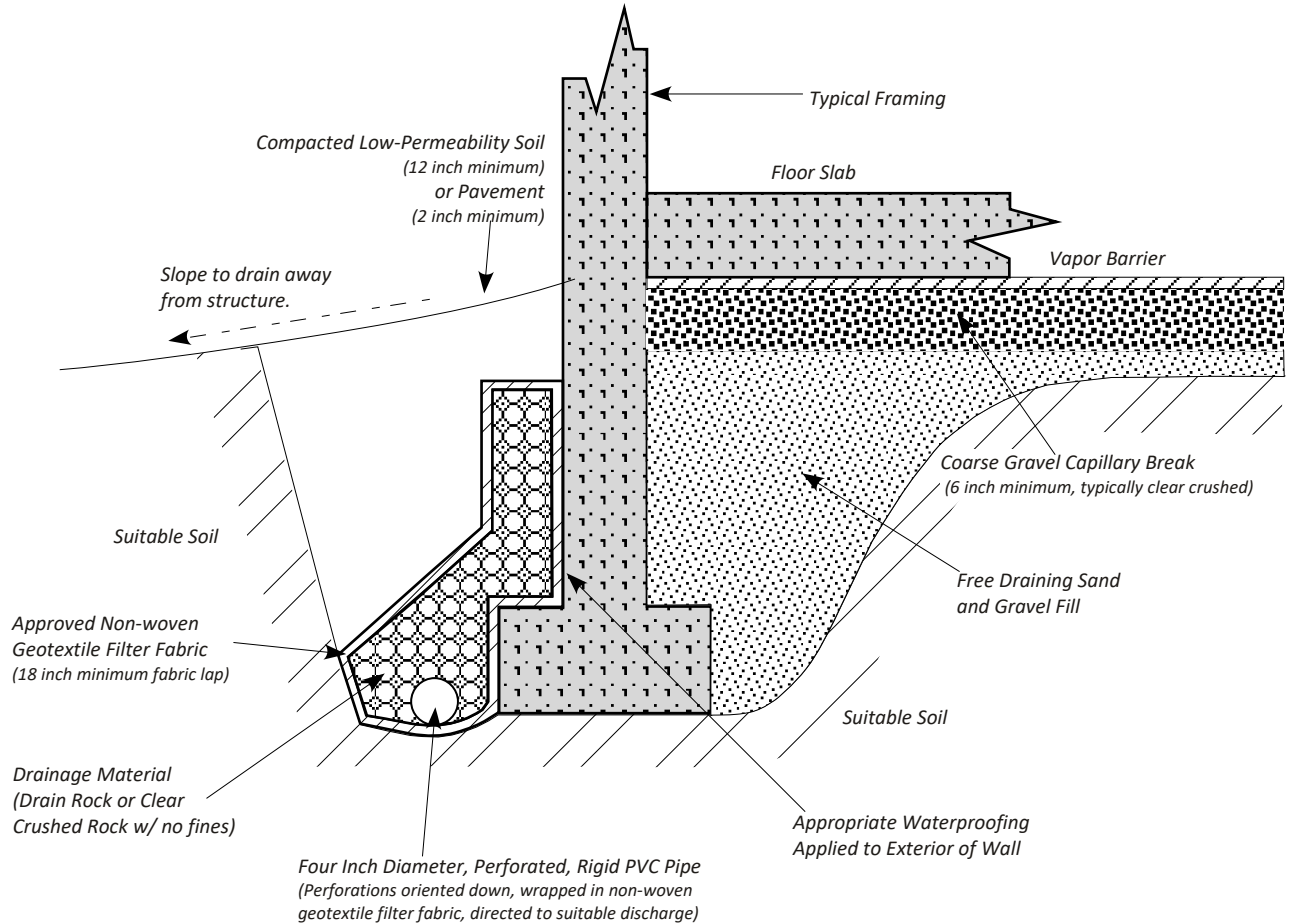
## CONCEPTUAL FOOTINGS WITH INTERIOR SLAB-ON-GRADE

Footings should be properly buried for frost protection in accordance with International Building Code or local building codes (Typically 18 inches below exterior finished grades).

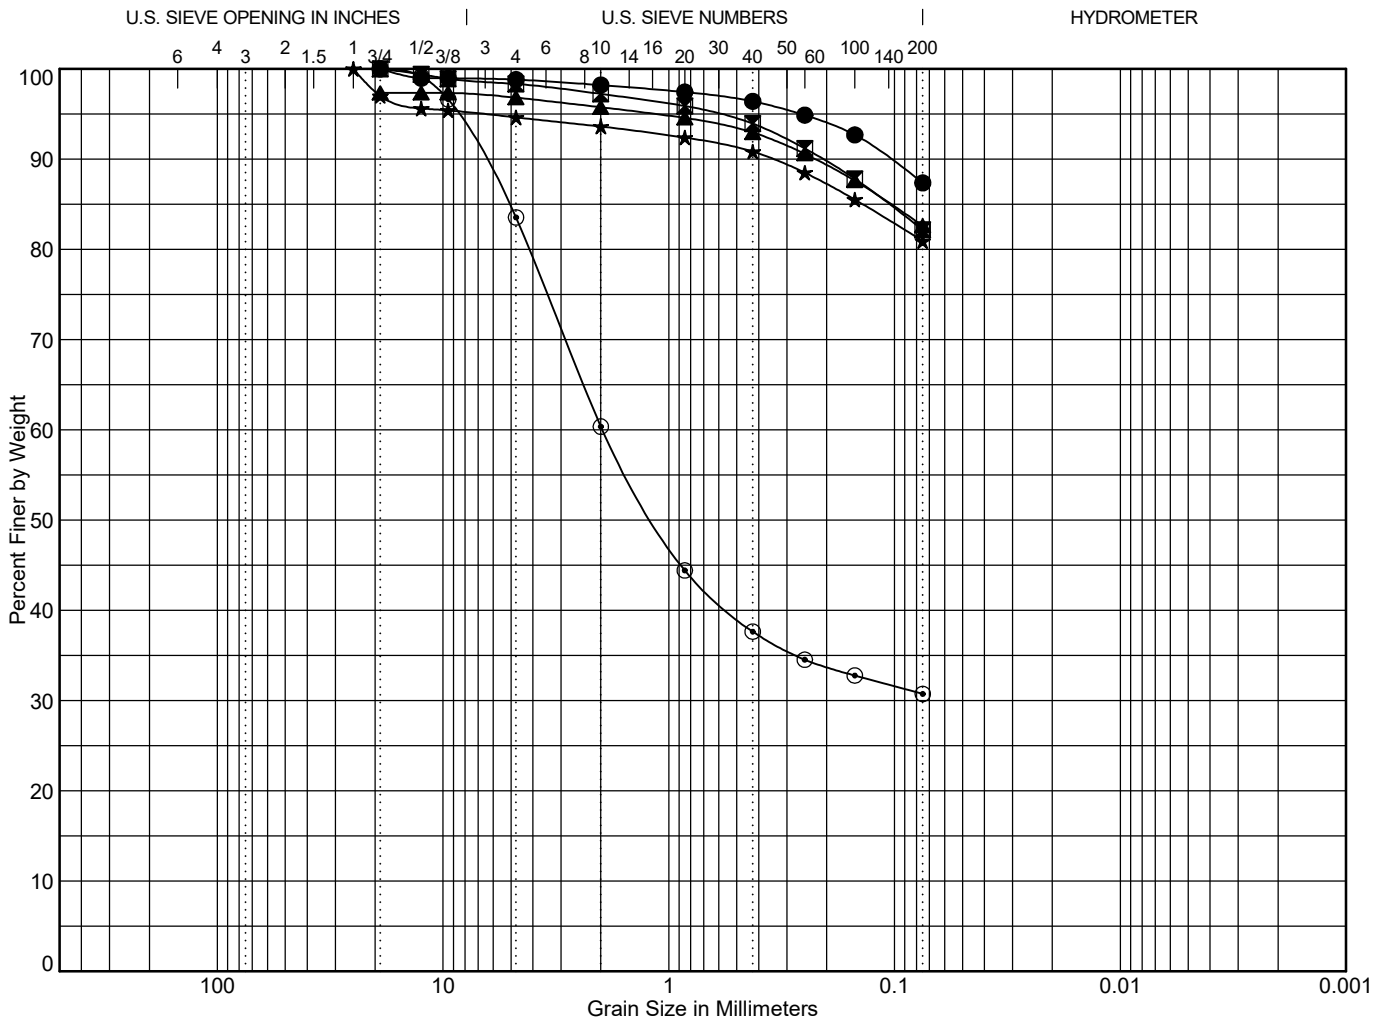
Figure  
**B-1**

Point	Depth	Classification	LL	PL	PI	C <sub>c</sub>	C <sub>u</sub>
●	B-1 10.0	Slightly sandy CLAY, fine to medium grained sand, trace gravel. (CL)					
■	B-1 20.0	Sandy CLAY, fine to medium grained sand, trace gravel. (CL)					
▲	B-1 45.0	Sandy CLAY, fine to medium grained sand, trace gravel. (CL)					
★	B-1 60.0	Sandy, slightly gravelly CLAY, fine to coarse grained sand. (CL)					
○	B-1 70.0	Very silty, gravelly SAND, fine to coarse grained sand. (SM)

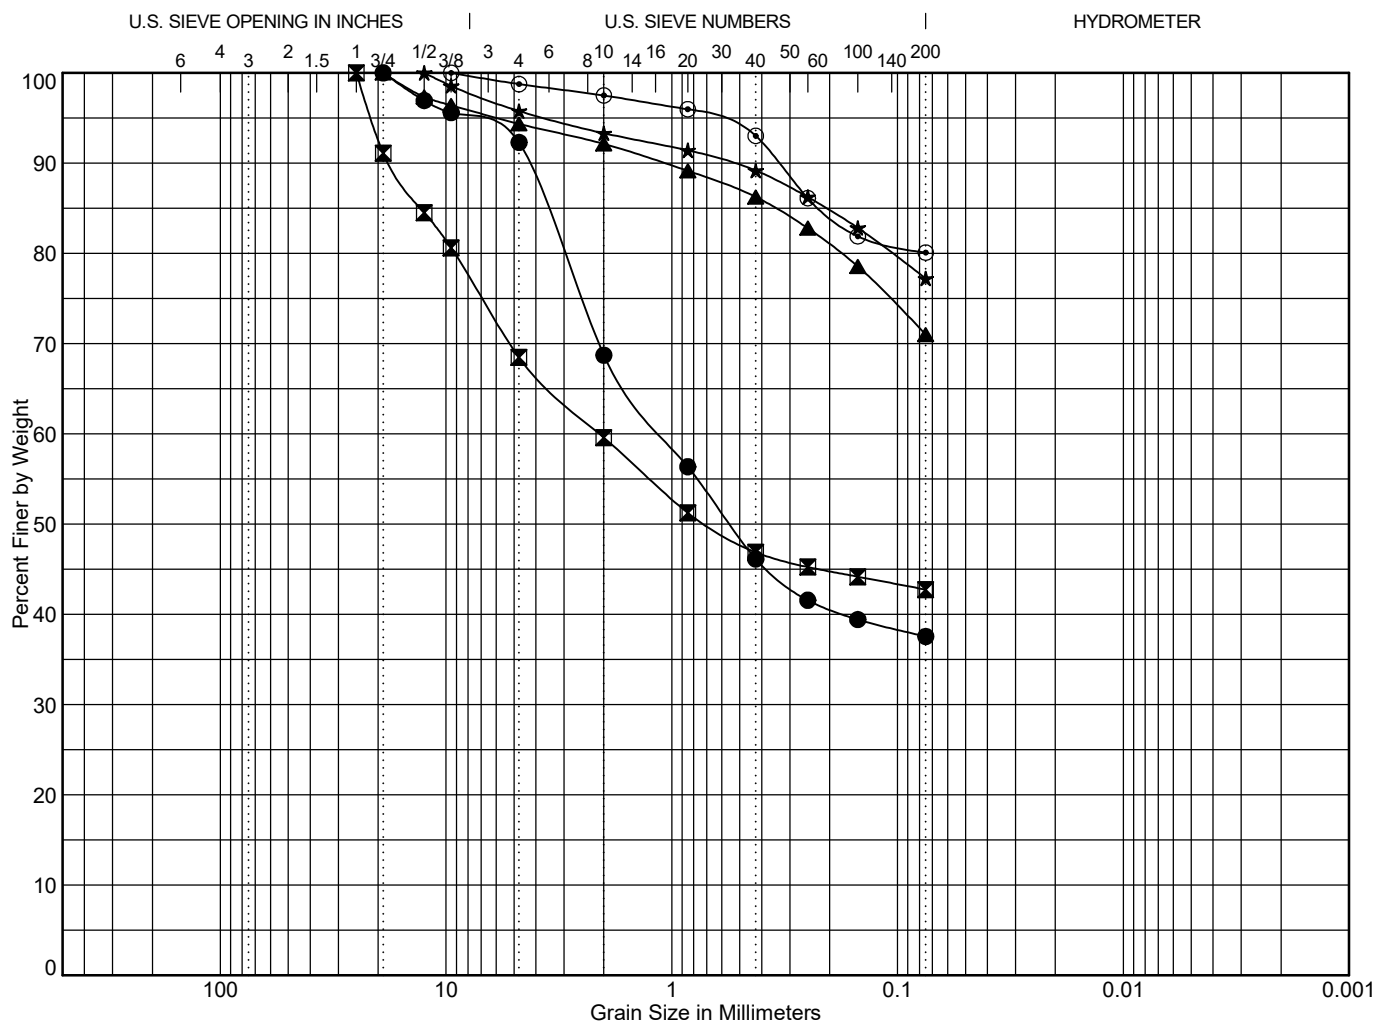
Figure  
B-2

Point	Depth	Classification	LL	PL	PI	C <sub>c</sub>	C <sub>u</sub>
●	B-1 90.0	Very silty, gravelly SAND, fine to coarse grained sand. (SM)					
■	B-1 105.0	Very silty, sandy GRAVEL, fine to coarse grained sand. (GM)					
▲	B-2 5.0	Slightly gravelly, sandy CLAY fine to coarse grained sand. (CL)					
★	B-2 25.0	Slightly gravelly, sandy CLAY, fine to coarse grained sand. (CL)					
○	B-2 35.0	Slightly sandy CLAY, trace gravel. (CL)

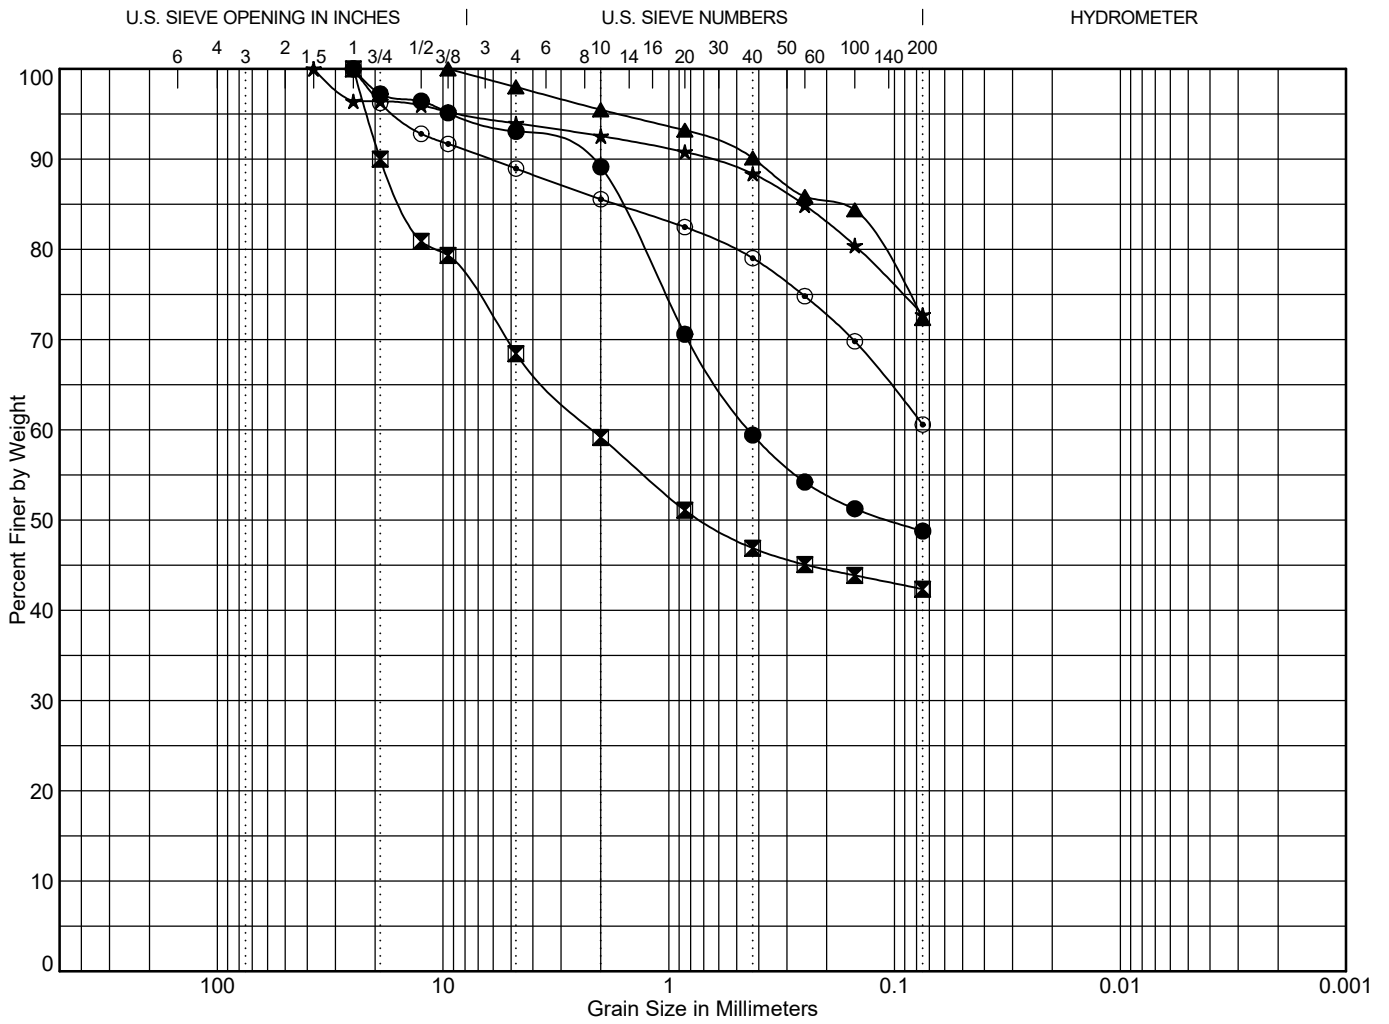
Figure  
**B-3**

Point	Depth	Classification	LL	PL	PI	C <sub>c</sub>	C <sub>u</sub>
●	B-2 80.0	Gravelly, very clayey SAND, fine to coarse grained sand. (SM)					
☒	B-2 95.0	Very gravelly, very sandy CLAY, fine to coarse grained sand. (CL)					
▲	TP-2 6.8	Slightly gravelly, very sandy CLAY, fine to coarse grained sand. (CL)					
★	TP-3 5.4	Gravelly, sandy CLAY, fine to coarse grained sand. (CL)					
⊙	TP-4 2.5	Slightly gravelly, very sandy CLAY, fine to coarse grained sand. (CL)

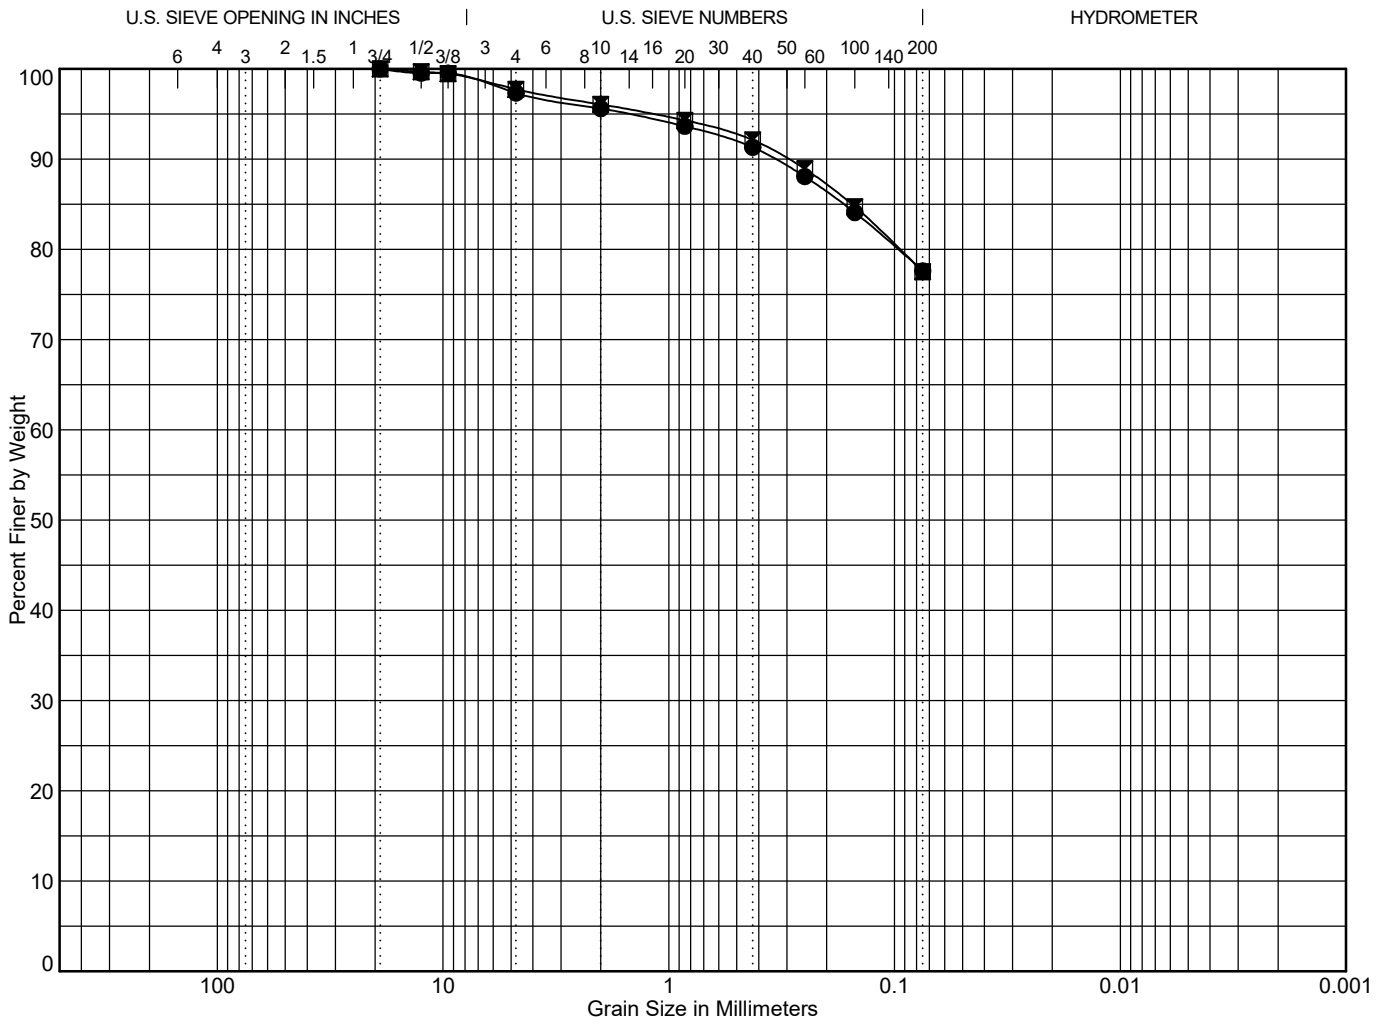
Figure  
**B-4**

Point	Depth	Classification	LL	PL	PI	C <sub>c</sub>	C <sub>u</sub>
●	TP-5 2.8	Slightly gravelly, sandy CLAY, fine to coarse grained sand. (CL)					
☒	TP-6 5.8	Sandy CLAY, fine to coarse grained sand, trace gravel. (CL)

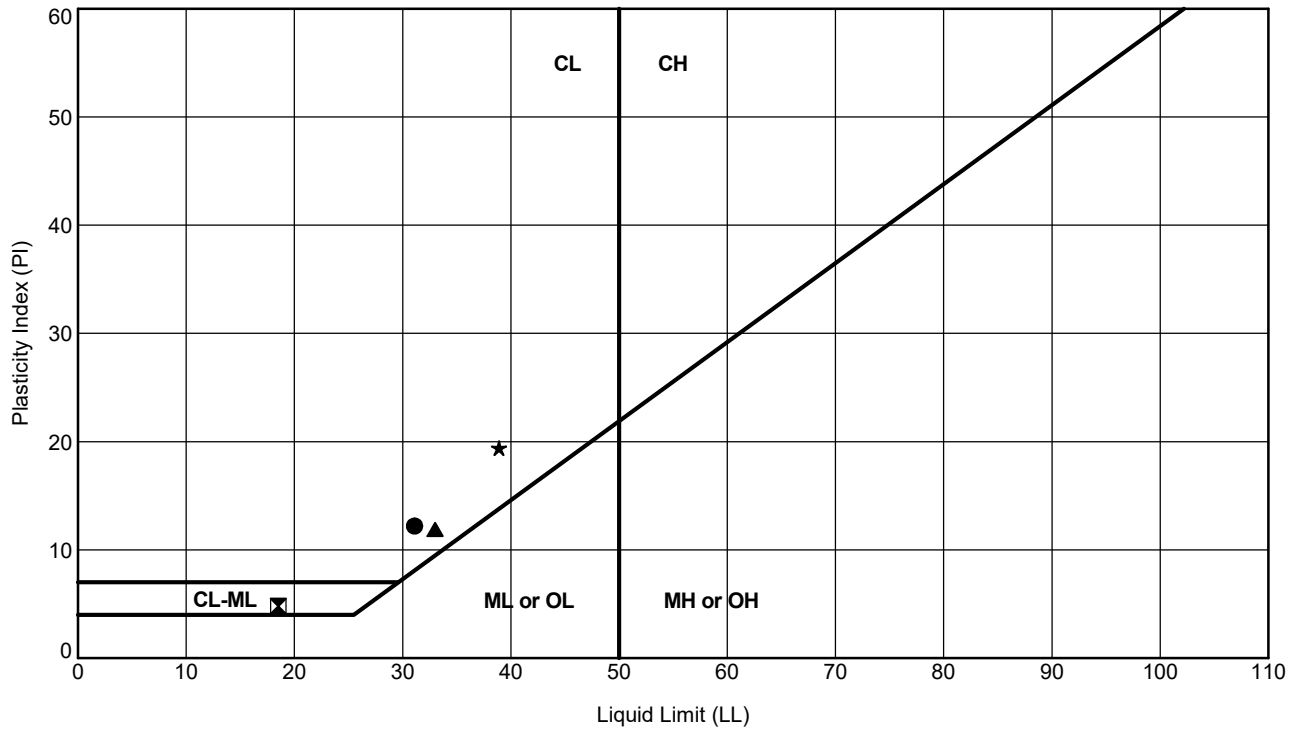
Figure  
**B-1**

### ATTERBERG LIMIT TEST RESULTS

Symbol	Exploration Number	Sample Number	Depth (ft)	Liquid Limit (%)	Plastic Limit (%)	Plasticity Index (%)	Natural Moisture (%)	Soil Description	Unified Soil Classification
●	B-1	31	25.0	31	19	12	20	Sandy CLAY, trace gravel.	CL
☒	B-2	53	15.0	19	14	4	26	Slightly gravelly, sand CLAY/SILT.	CL-ML
▲	TP-1	2	3.0	33	21	12	21	Slightly gravelly, very sandy CLAY.	CL
★	TP-7	24	7.3	39	20	19	18	Sandy CLAY, trace gravel.	CL

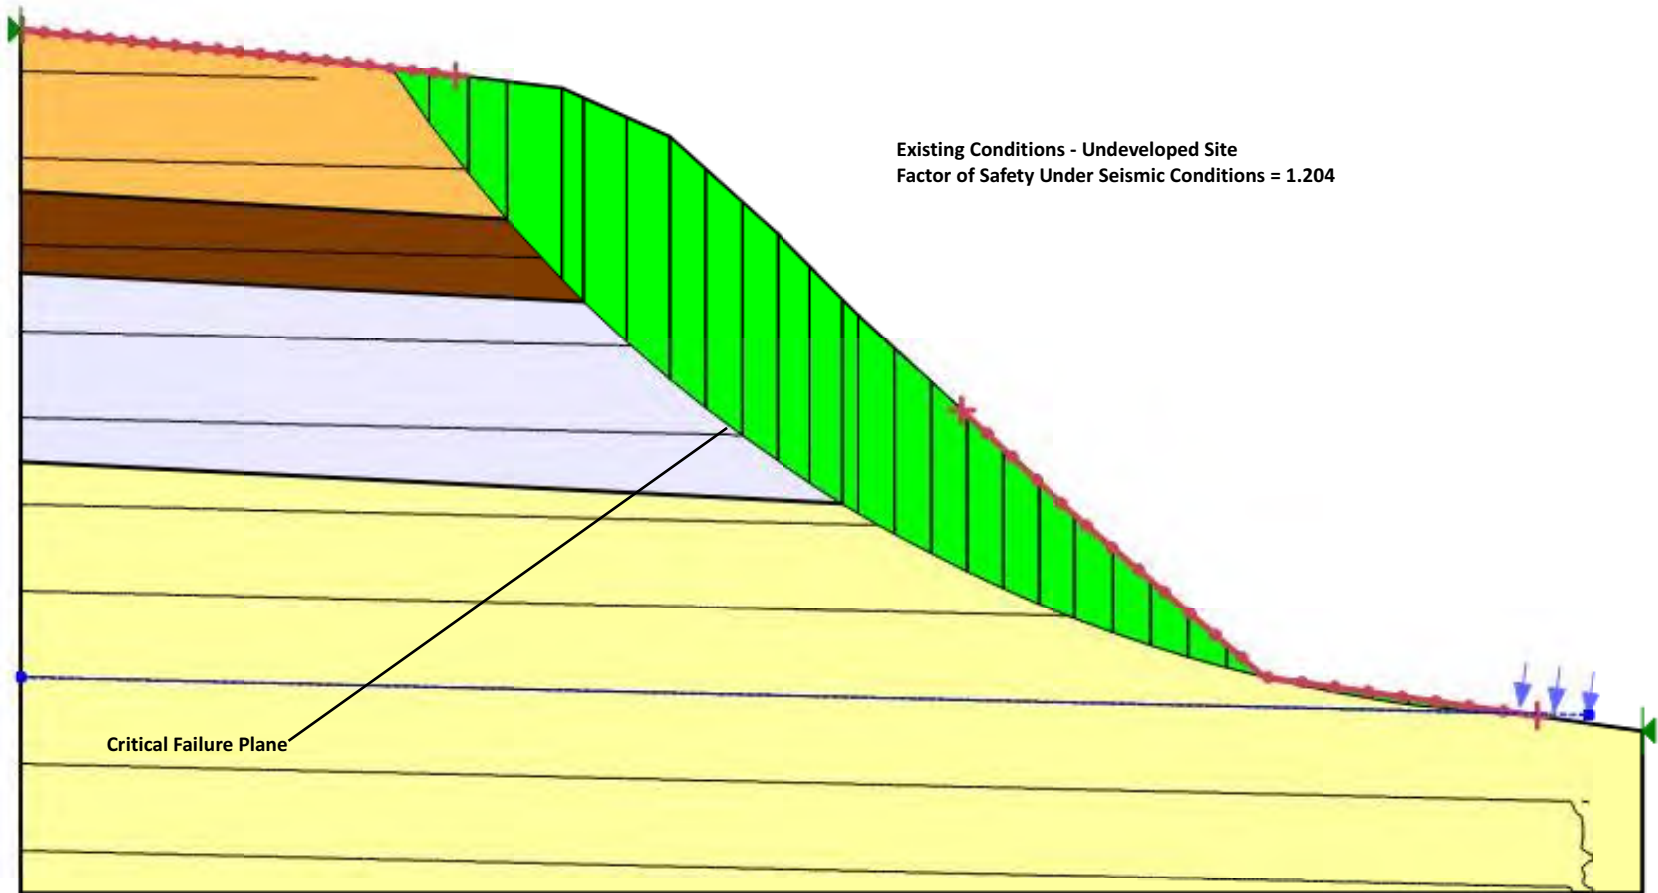
Existing Conditions - Undeveloped Site  
Factor of Safety Under Seismic Conditions = 1.204

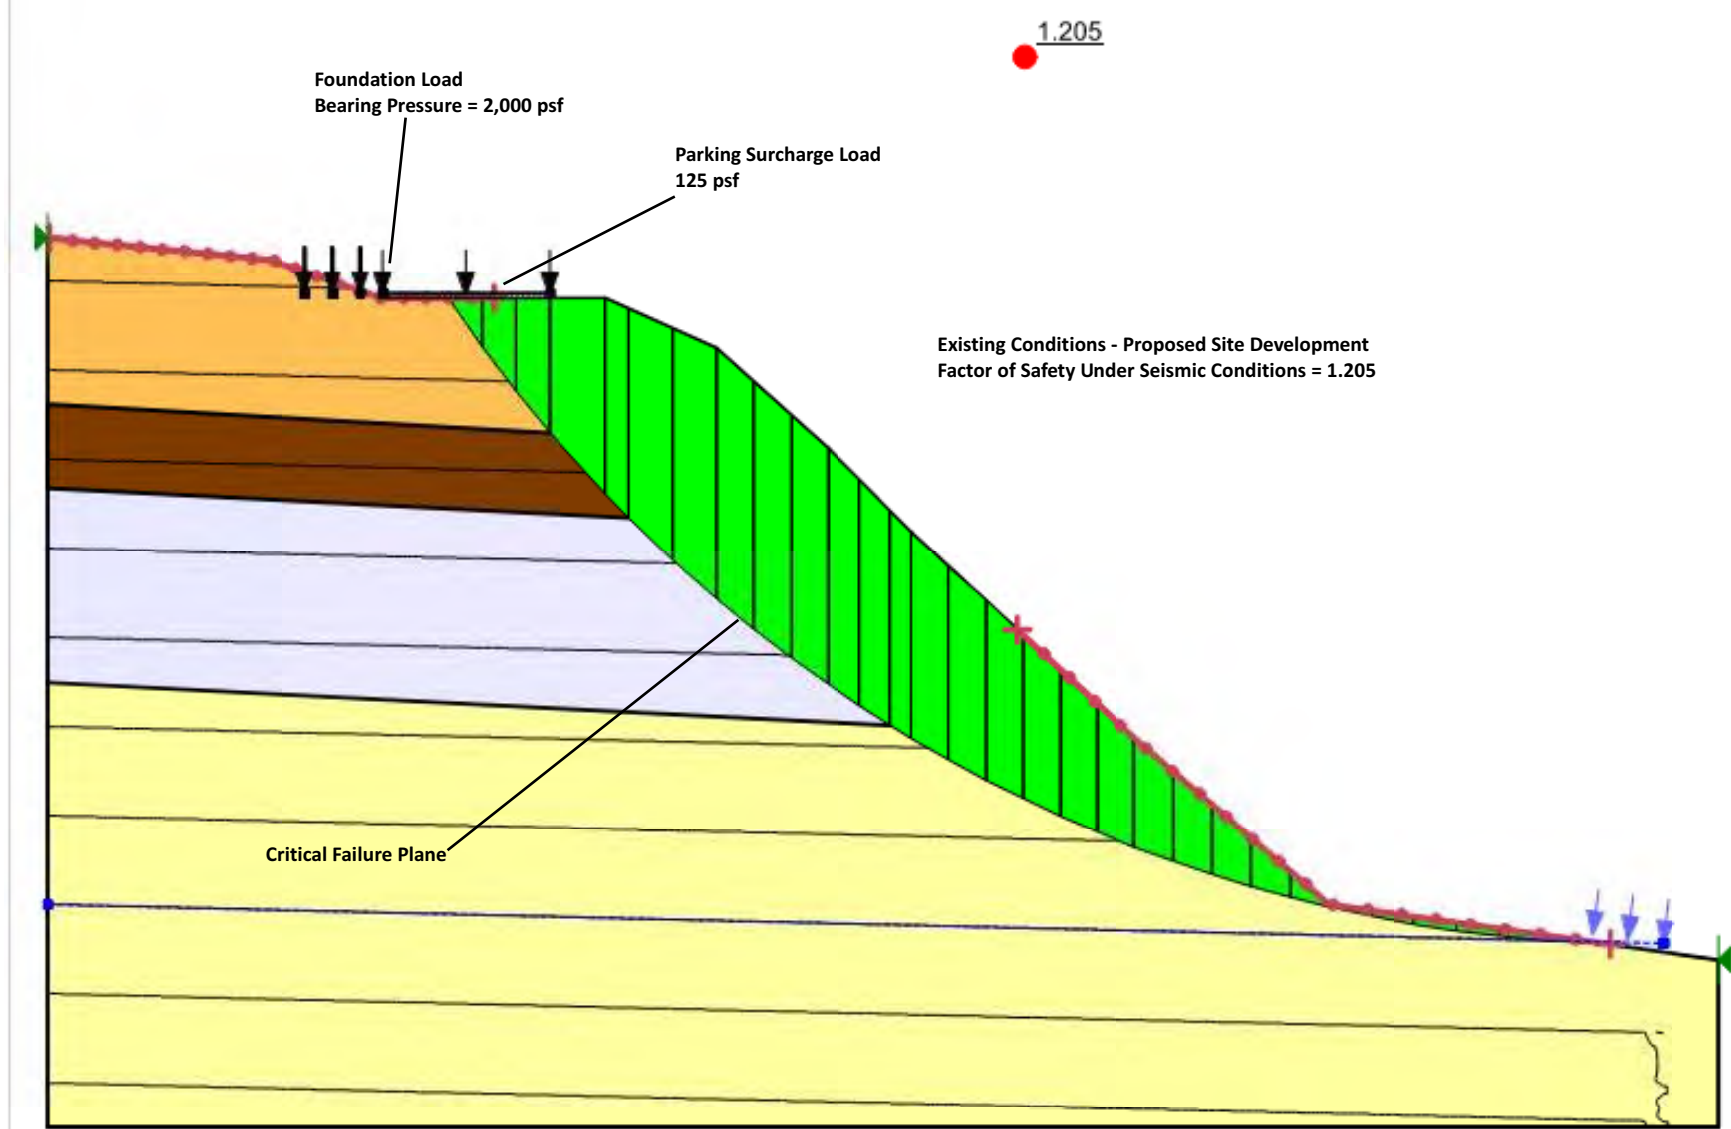
# Slope Stability Analysis - Proposed Development - Seismic Conditions

**SLOPE STABILITY ANALYSIS (SEISMIC)**  
Cool Runnings Development  
Lindshier Avenue and Idell Drive  
Bellingham, Washington
