March 27, 2024
Report No.: 24-013

RE: Coal Mine Hazard Report for 2530 Jaeger Street, Bellingham, Washington
Parcel No.: 380224230126

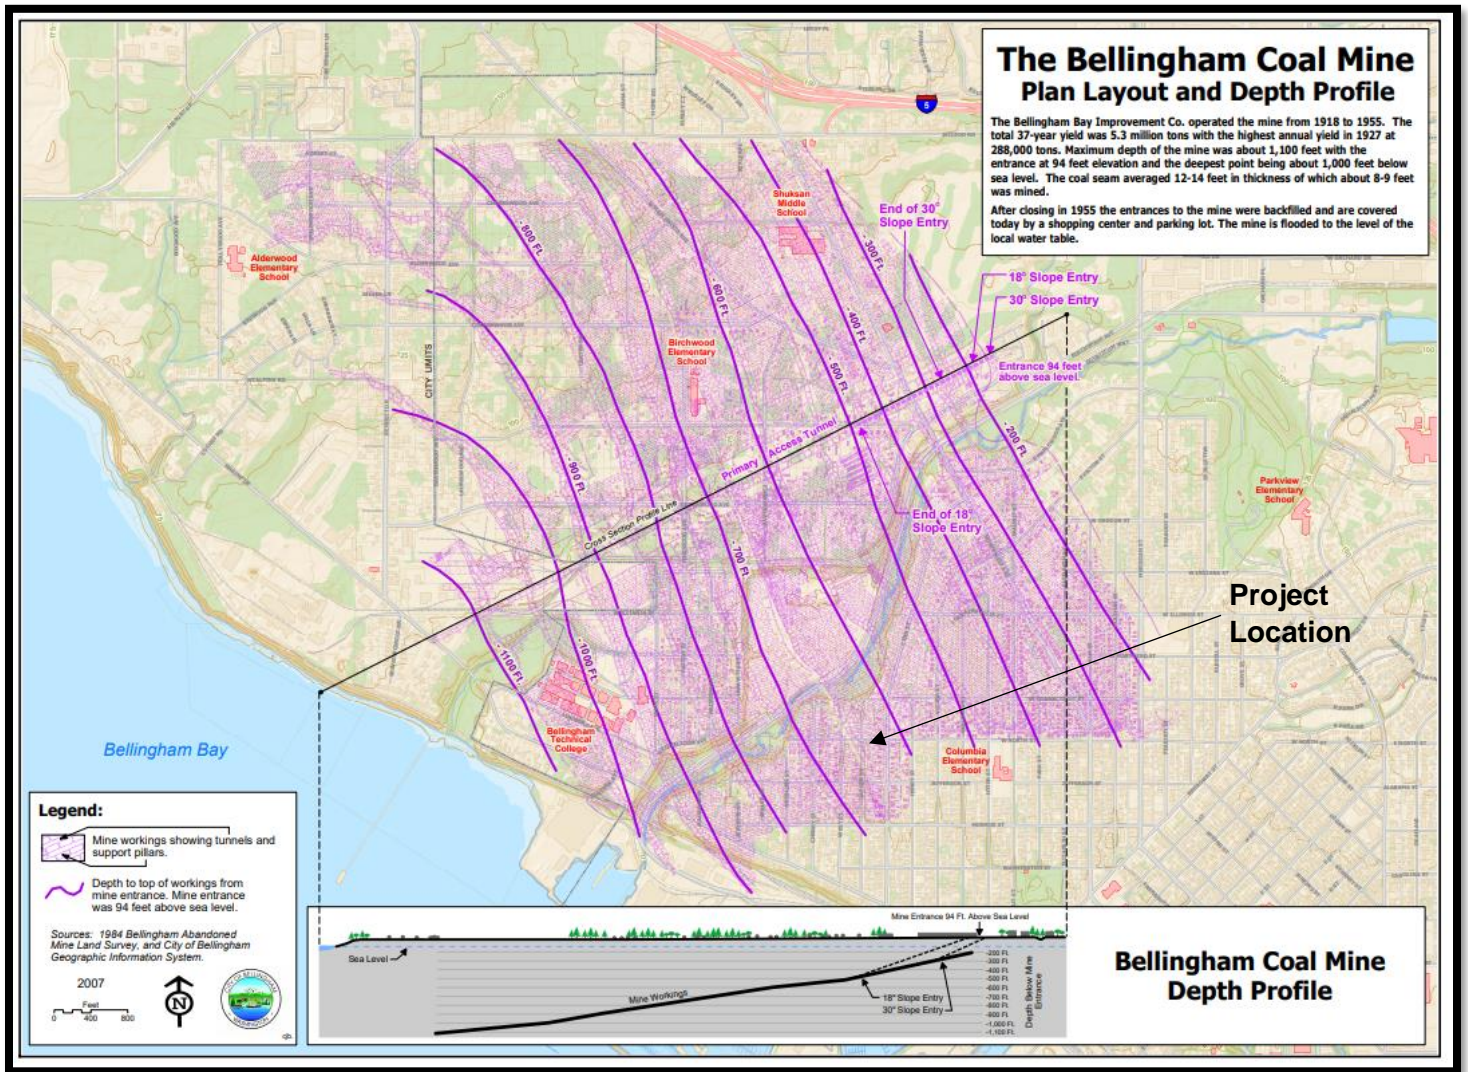
NW Geologic reviewed the 1984 *Bellingham Abandoned Mine Land Survey* report by Tetra Tech, the 2007 *Bellingham Coal Mine: Plan Layout and Depth Profile* map, and the City of Bellingham GIS geodatabase information representing the mine extents and hazards as outlined in the Tetra Tech report. According to these documents, the primary hazard at the subject site is the potential for subsidence due to the failure of mine pillars which would cause roof collapse. It is our understanding that there are no known adits or airshafts underlying the subject property.

Figure 2: The Bellingham Coal Mine map showing the general project location within the City of Bellingham. Image acquired from City of Bellingham, 2024.
