March 26, 2024

Project: **Proposed Residential Redevelopment (#2024058)**
2302 Alabama Street, Bellingham, WA 98229 (WC Parcel #: 380320 540078)

Subject: **Geotechnical Evaluation & Stormwater Feasibility Assessment**

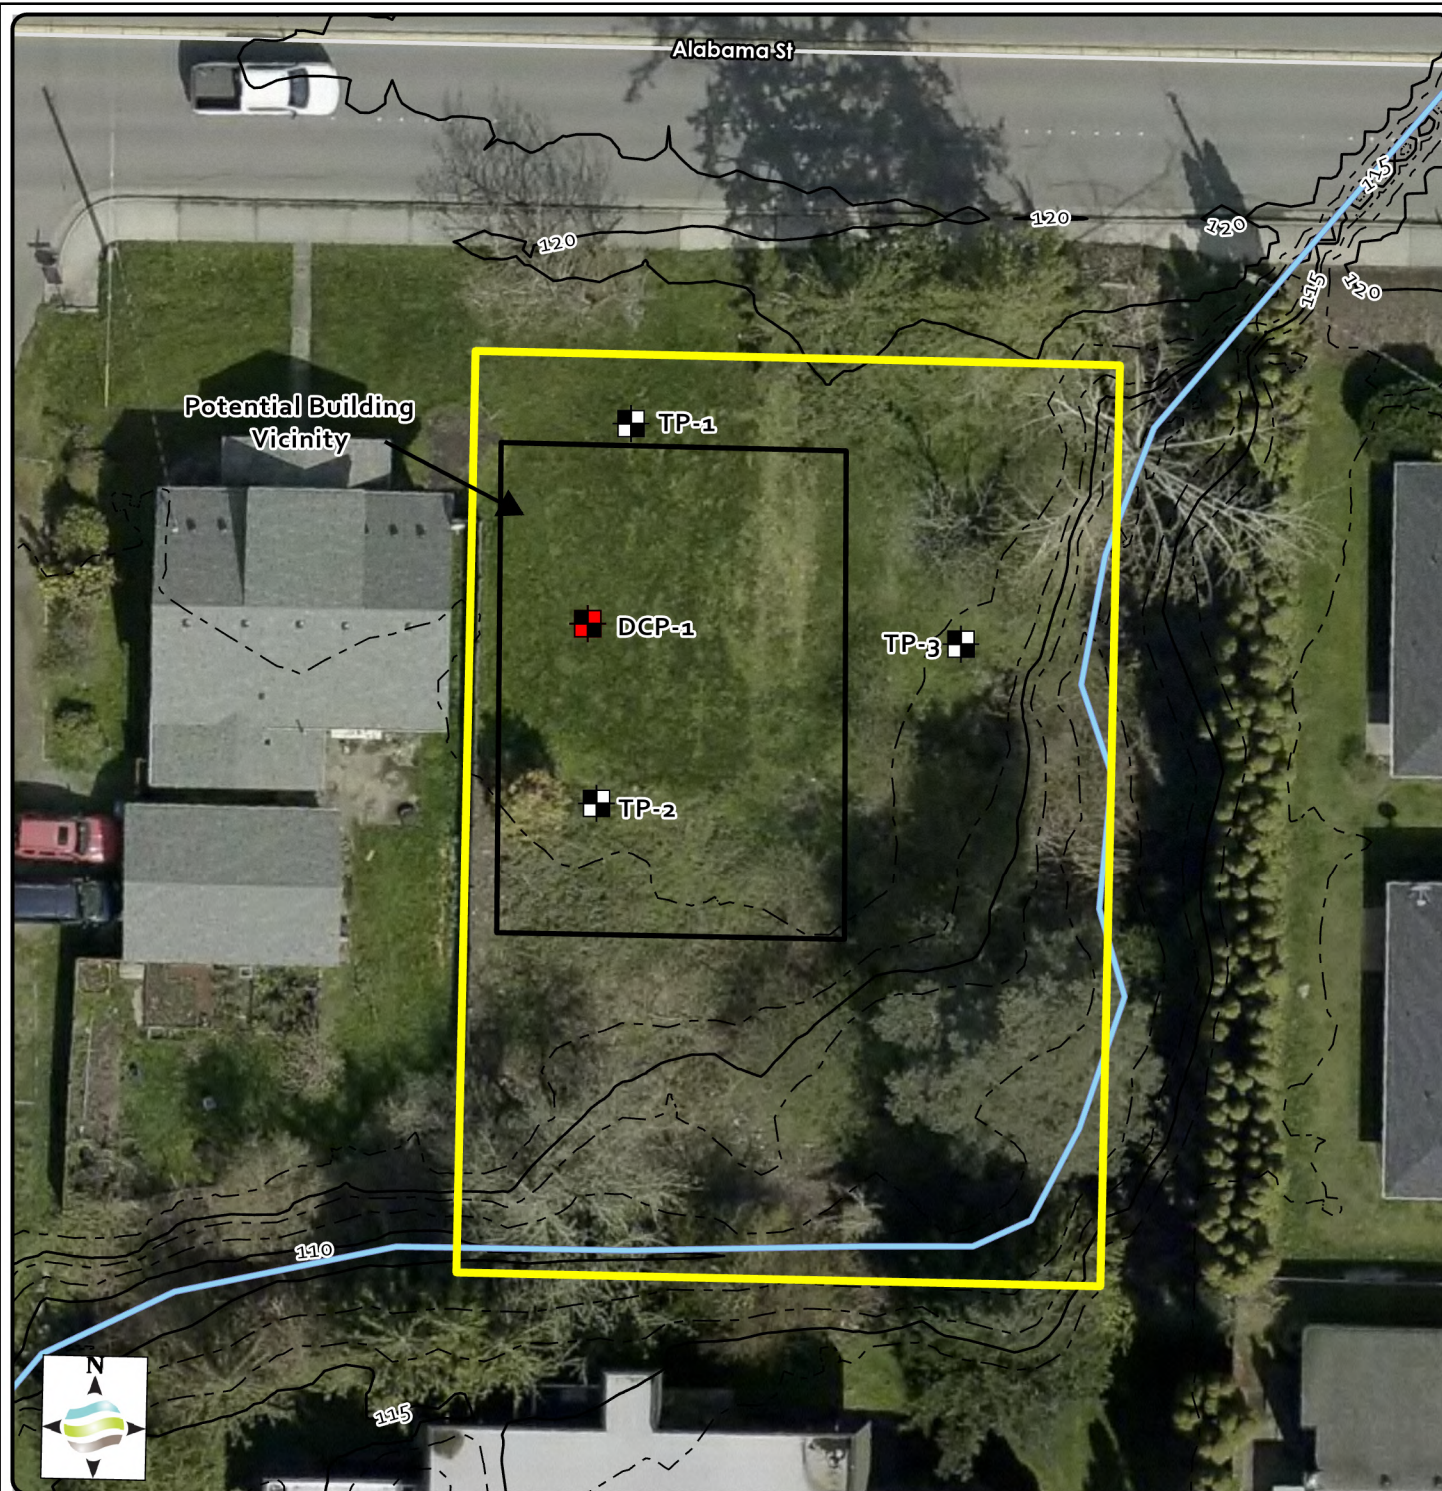
Figure 2
 Stormwater Feasibility Assessment
 2302 Alabama Street, Bellingham, WA
 Aerial Site Map
 Date: 3/26/2024

For the sake of clarity and physical reference, ***we recommend a minimum structural setback of 20 feet from the creek bank slope crest to new foundations.*** This assumes building foundations are constructed as recommended below, and incorporates the interpreted bank erosion potential over the design life of the project. The 20-foot setback line from mapped top of bank is illustrated on Figure 3 along with the approximate proposed building vicinity which we understand will meet or exceed this setback.
