# Geohazard and Infiltration Feasibility Report

Ashley Street Residence  
119 Ashley Street  
Bellingham, WA 98225

August 29, 2024 (Revised September 6, 2024)  
Project No. 24-2327

**Regarding: Geohazard and Infiltration Feasibility Report – Revision 1**  
**Ashley Street Residence**  
119 Ashley Street  
Bellingham, WA 98225  
(Parcel No. 3803320250950000)

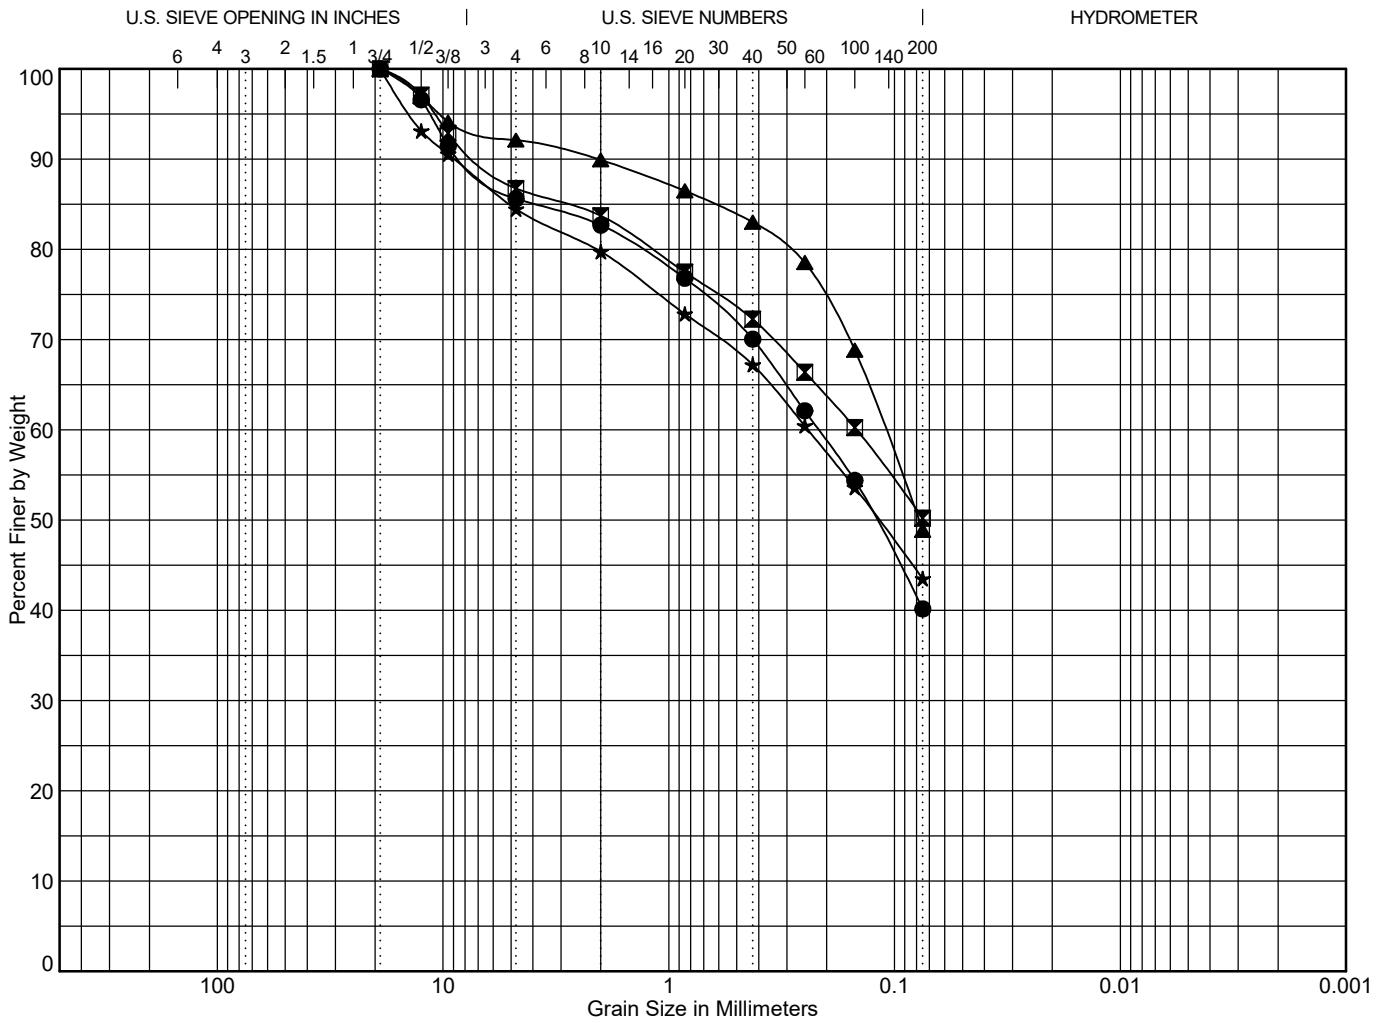
Point	Depth	Classification	LL	PL	PI	C <sub>c</sub>	C <sub>u</sub>
●	TP-1 0.6	Gravelly, very silty SAND (SM)					
☒	TP-1 3.4	Gravelly, very sandy SILT (ML)					
▲	TP-2 2.8	Slightly gravelly, very silty SAND (SM)					
★	TP-2 7.5	Gravelly, very silty SAND (SM)
