**Re: Geotechnical Engineering Reports – Updated Site Plan
Queen Mountain Plat**
4175 Iron Gate Road
Bellingham, WA 98226
Parcel No. 380308336210

Geotechnical Engineering Report

As requested, GeoTest Services, Inc. (GeoTest) is pleased to submit the following report summarizing the results of our geotechnical evaluation for the proposed Queen Mountain Plat located at the above referenced address and parcel in Bellingham, Washington (see Vicinity Map, Figure 1). This report has been prepared in general accordance with the terms and conditions established in our services agreement (20-374G) dated July 17th, 2020.

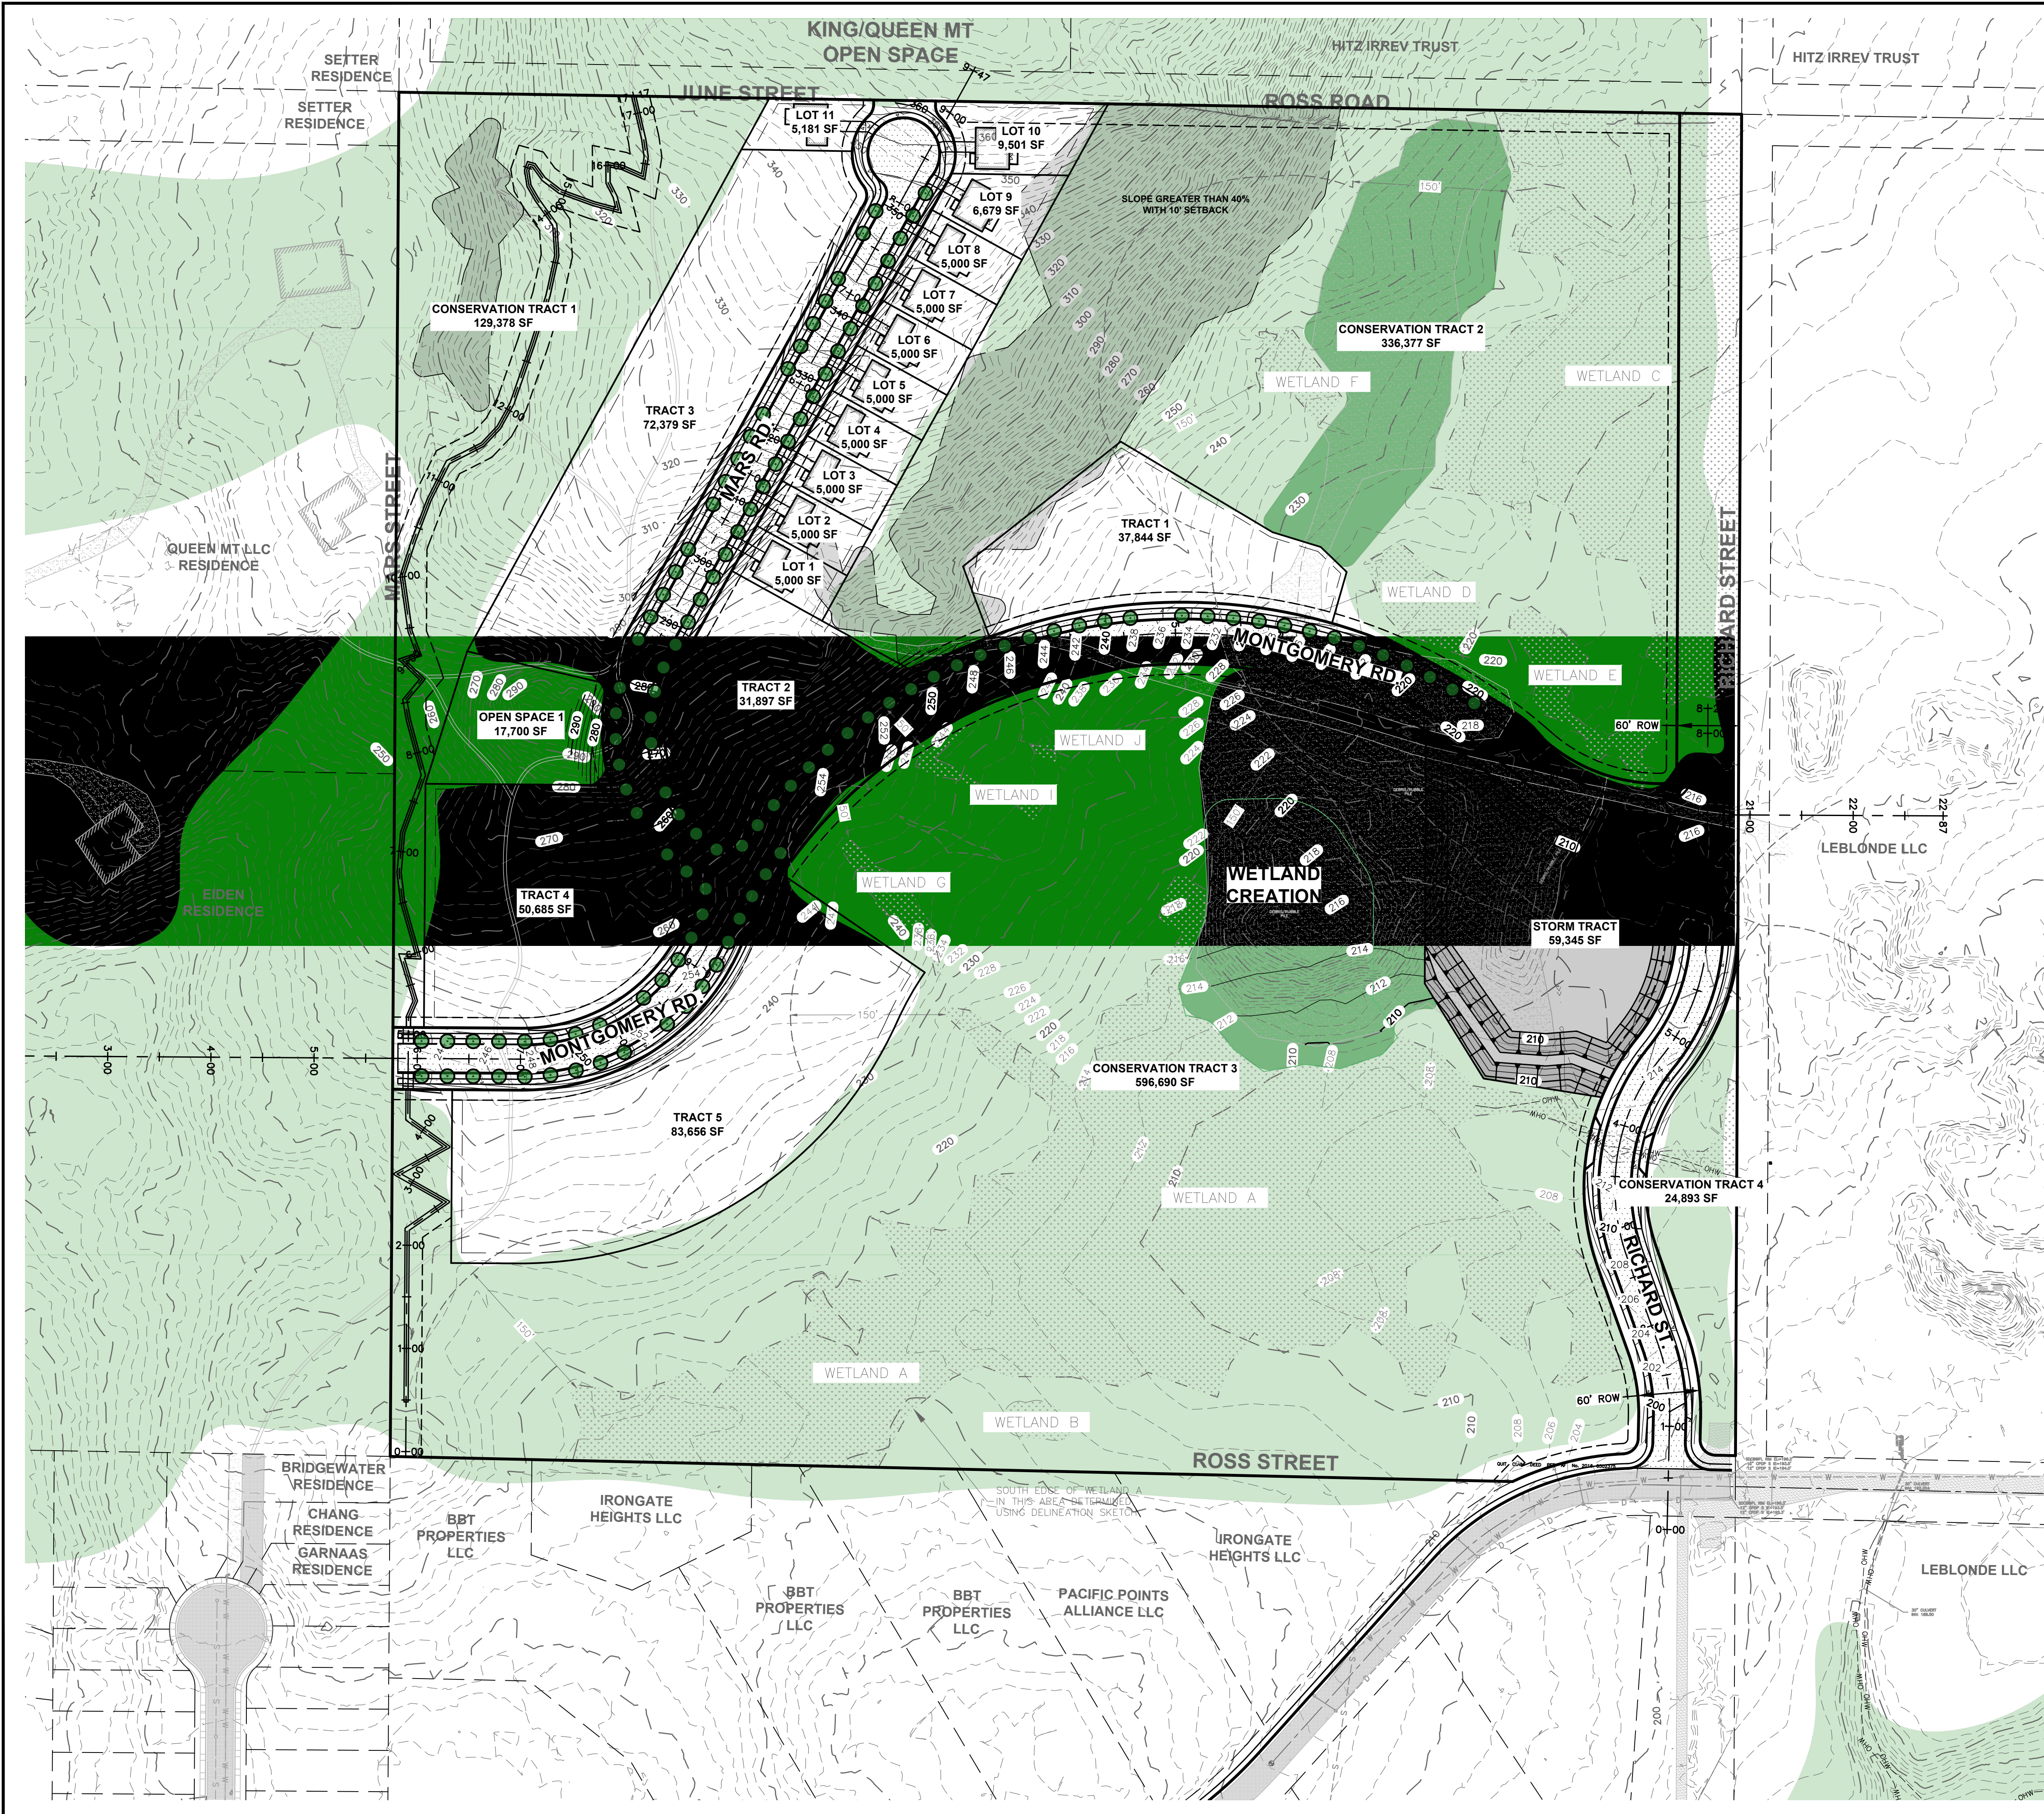
SHEET CONTENTS: **OVERALL SITE PLAN**

On February 23, 2023, Freeland and Associates provided GeoTest with an updated site plan, dated February 14, 2023, for the Queen Mountain Plat project. It is our understanding the City of Bellingham is requiring that current or future revisions to plat layout be included within Geological Reports. The new site plan details 11 residential lots located within the northwest corner of the subject parcel with 5 other tracts future development ranging from approximately 31,897 to 83,656 square feet and new roadways. Additionally, wetland creation area, stormwater management tract, four conservation tracts, and an open space are detailed on the updated site plan.

- *Overall Site Plan: Plat of Queen Mountain, dated February 14, 2023. (1 Page)*
- *Geotechnical Engineering Report: Queen Mountain Plat, dated September 3, 2020. (53 Pages)*
- *Stormwater Dispersion Addendum Letter: Queen Mountain Plat, dated April 8, 2022. (4 Pages)*

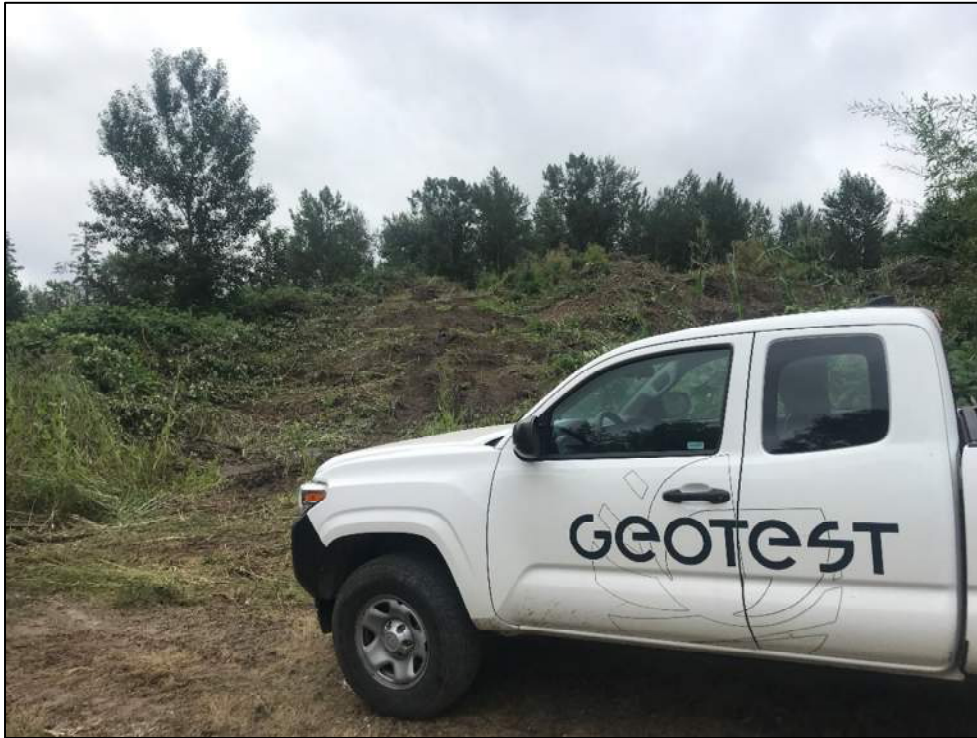
Image 2. Surface conditions in the vicinity of test pit TP-3, facing south. Existing stockpiles (focus of environmental sampling) pictured.

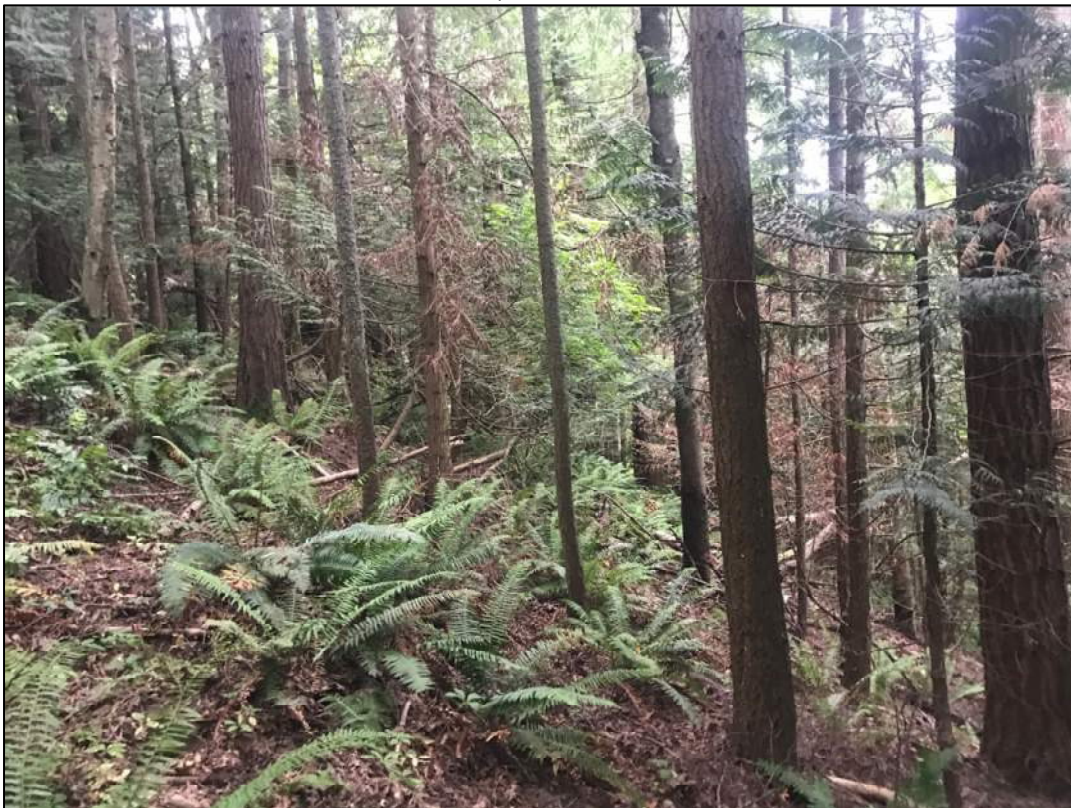
Image 3. Typical slope conditions on east face of queen mountain, facing north. Note vertical, coniferous trees. No indications of hydrophytic or first growth vegetation indicative of recent slope movement.

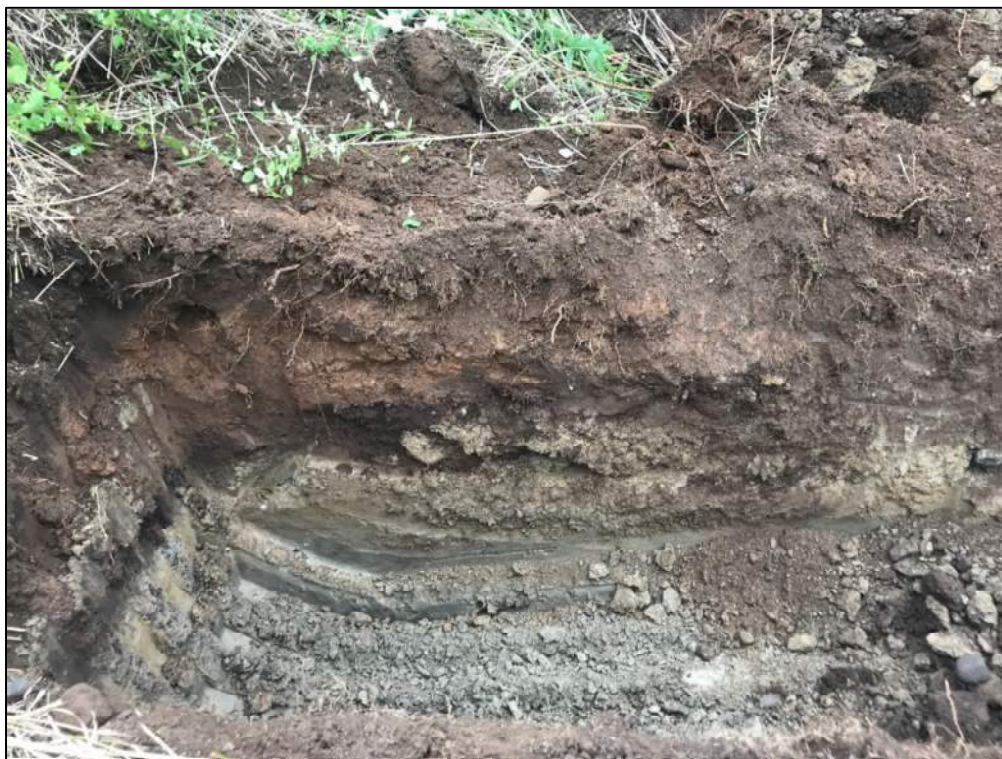
Image 5. Subsurface conditions in test pit TP-3 showing surficial brown fill with debris, dark brown relict topsoil, and tan, very stiff clay.

Test pits TP-1, TP-2, TP-3, TP-4, and TP-8 all exhibited similar and consistent subsurface profiles. The general profile of each pit consisted of surficial fill (as encountered in TP-2 and TP-3) or topsoil/forest duff extending to approximate depths of 1 to 2 feet BGS. The next stratum encountered was a very stiff, tan, moist, very sandy, low plasticity clay with trace gravel. This layer exhibited pocket penetrometer results of 1.75 to 2 tons per square foot (tsf). At depths of 3 to 4 feet BGS, the clay transitioned to hard and gray, exhibited pocket penetrometer measurements more than 4.5 tsf. Isolated, water bearing sand layers were encountered in TP-1 and TP-8 at depths of 8 and 9 feet. These layers were 0.5 to 1 foot thick and were positioned between clay strata. At depths of 8 to 10 feet (and not encountered in TP-3 or TP-4), the clay transitioned to blue-gray, wet, with a lower relative density. Pocket penetrometer results within this material averaged 2 tsf.

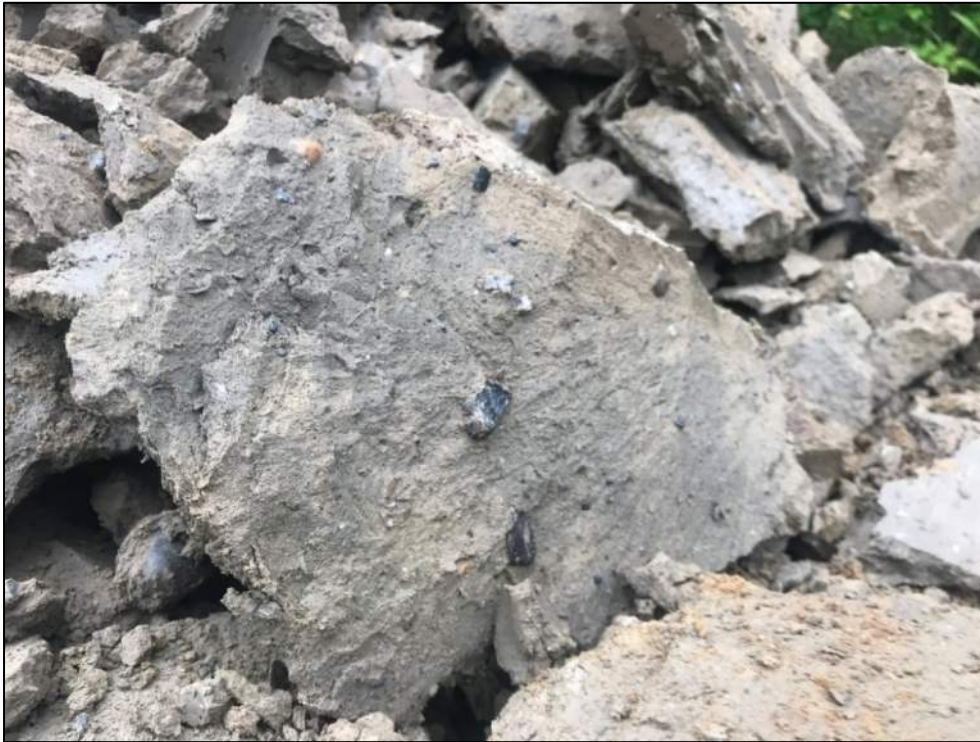
Image 6. Test pit TP-4 spoils from approximately 8 feet BGS. Note scattered gravel (dropstones) in clay matrix often indicative of glaciomarine drift soils.

These soils are interpreted to be glaciomarine drift deposits and will be elaborated upon in the following section (*General Geologic Conditions*) of this report.

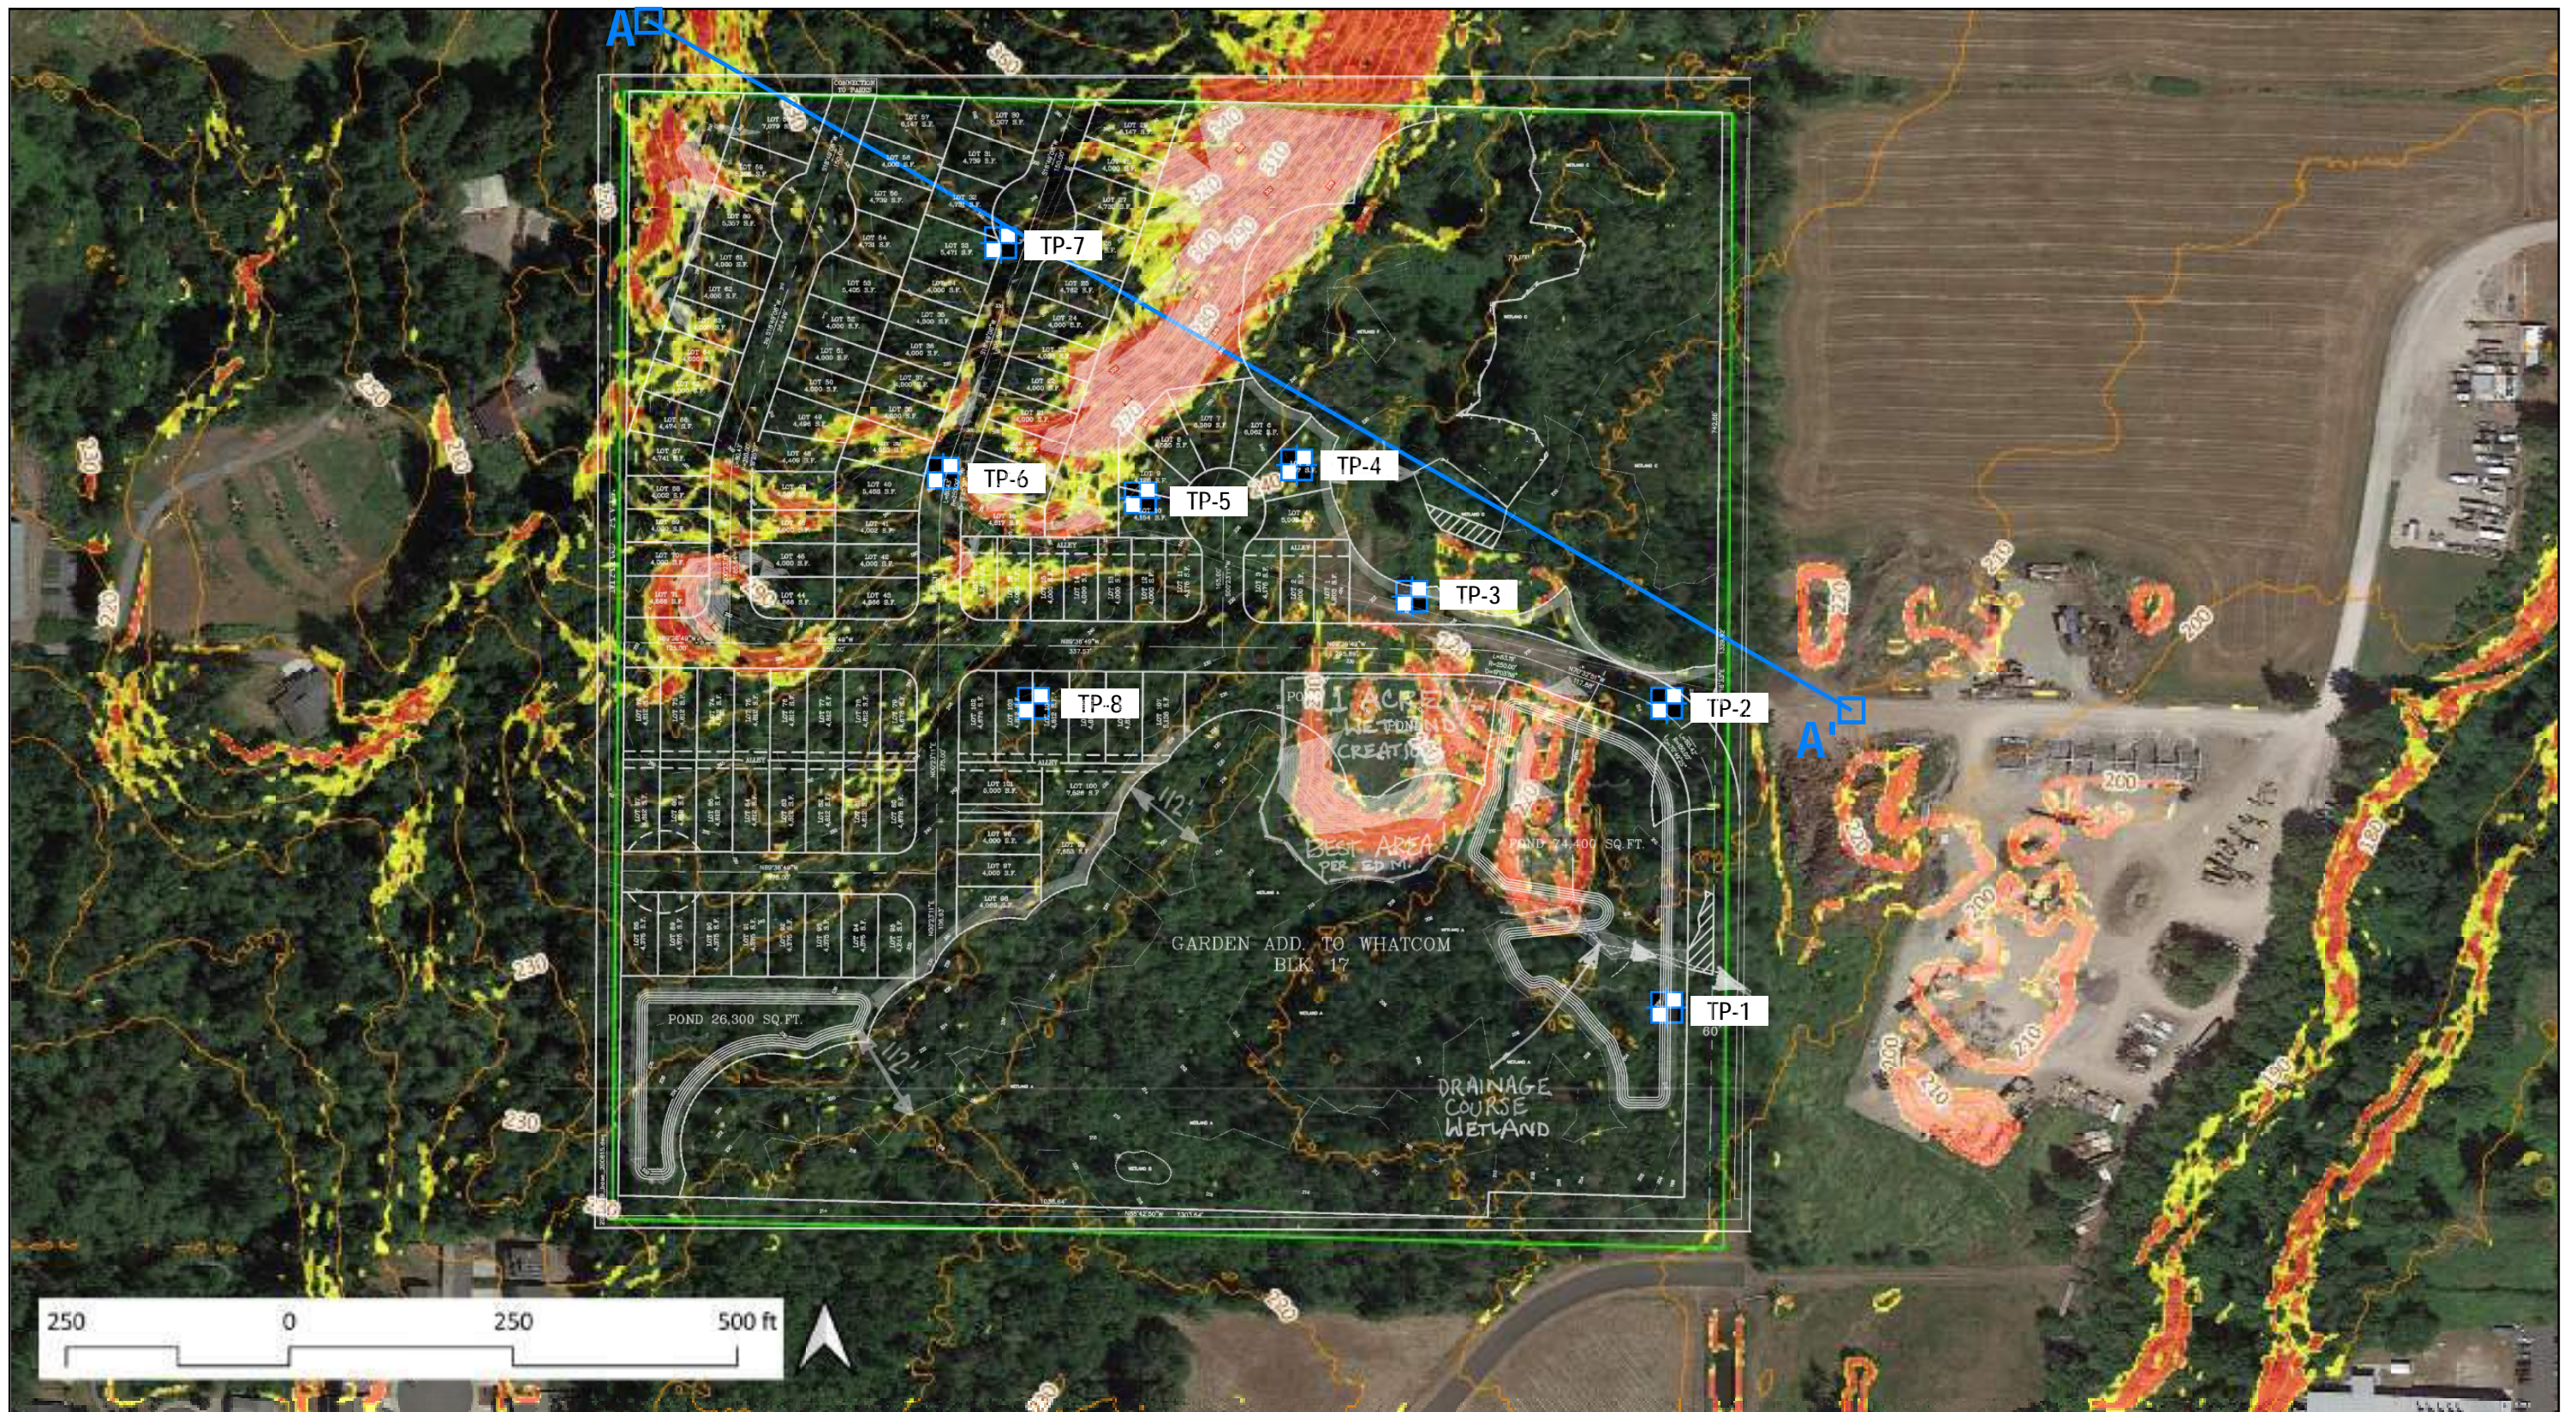
-   TP-# = Approximate Test Pit Location
-   = Slopes > 15% Gradient
-   = Slopes > 40% Gradient

DATE: 8.10.2020	BY: NGD	SCALE: As SHOWN	PROJECT 20-0591
SITE AND EXPLORATION PLAN			FIGURE 2
QUEEN MOUNTAIN PLAT 4175 IRON GATE ROAD BELLINGHAM WA, 98226

Subsurface conditions were explored by advancing 8 test pits ranging from 3.5 to 13 feet below ground surface (BGS) with a subcontracted excavator on July 24, 2020. Relative soil density was explored via T-probe and pocket penetrometer. Rock competency was evaluated with a rock hammer and pocketknife. The approximate locations of the test pits have been plotted on the *Site and Exploration Plan – Figure 2* and *Bare Earth Site Plan – Figure 3*. A *Soil Classification System and Key* can be found in *Figure 5*, and detailed exploration logs can be found in *Figures 6 through 9 – test pit logs*.

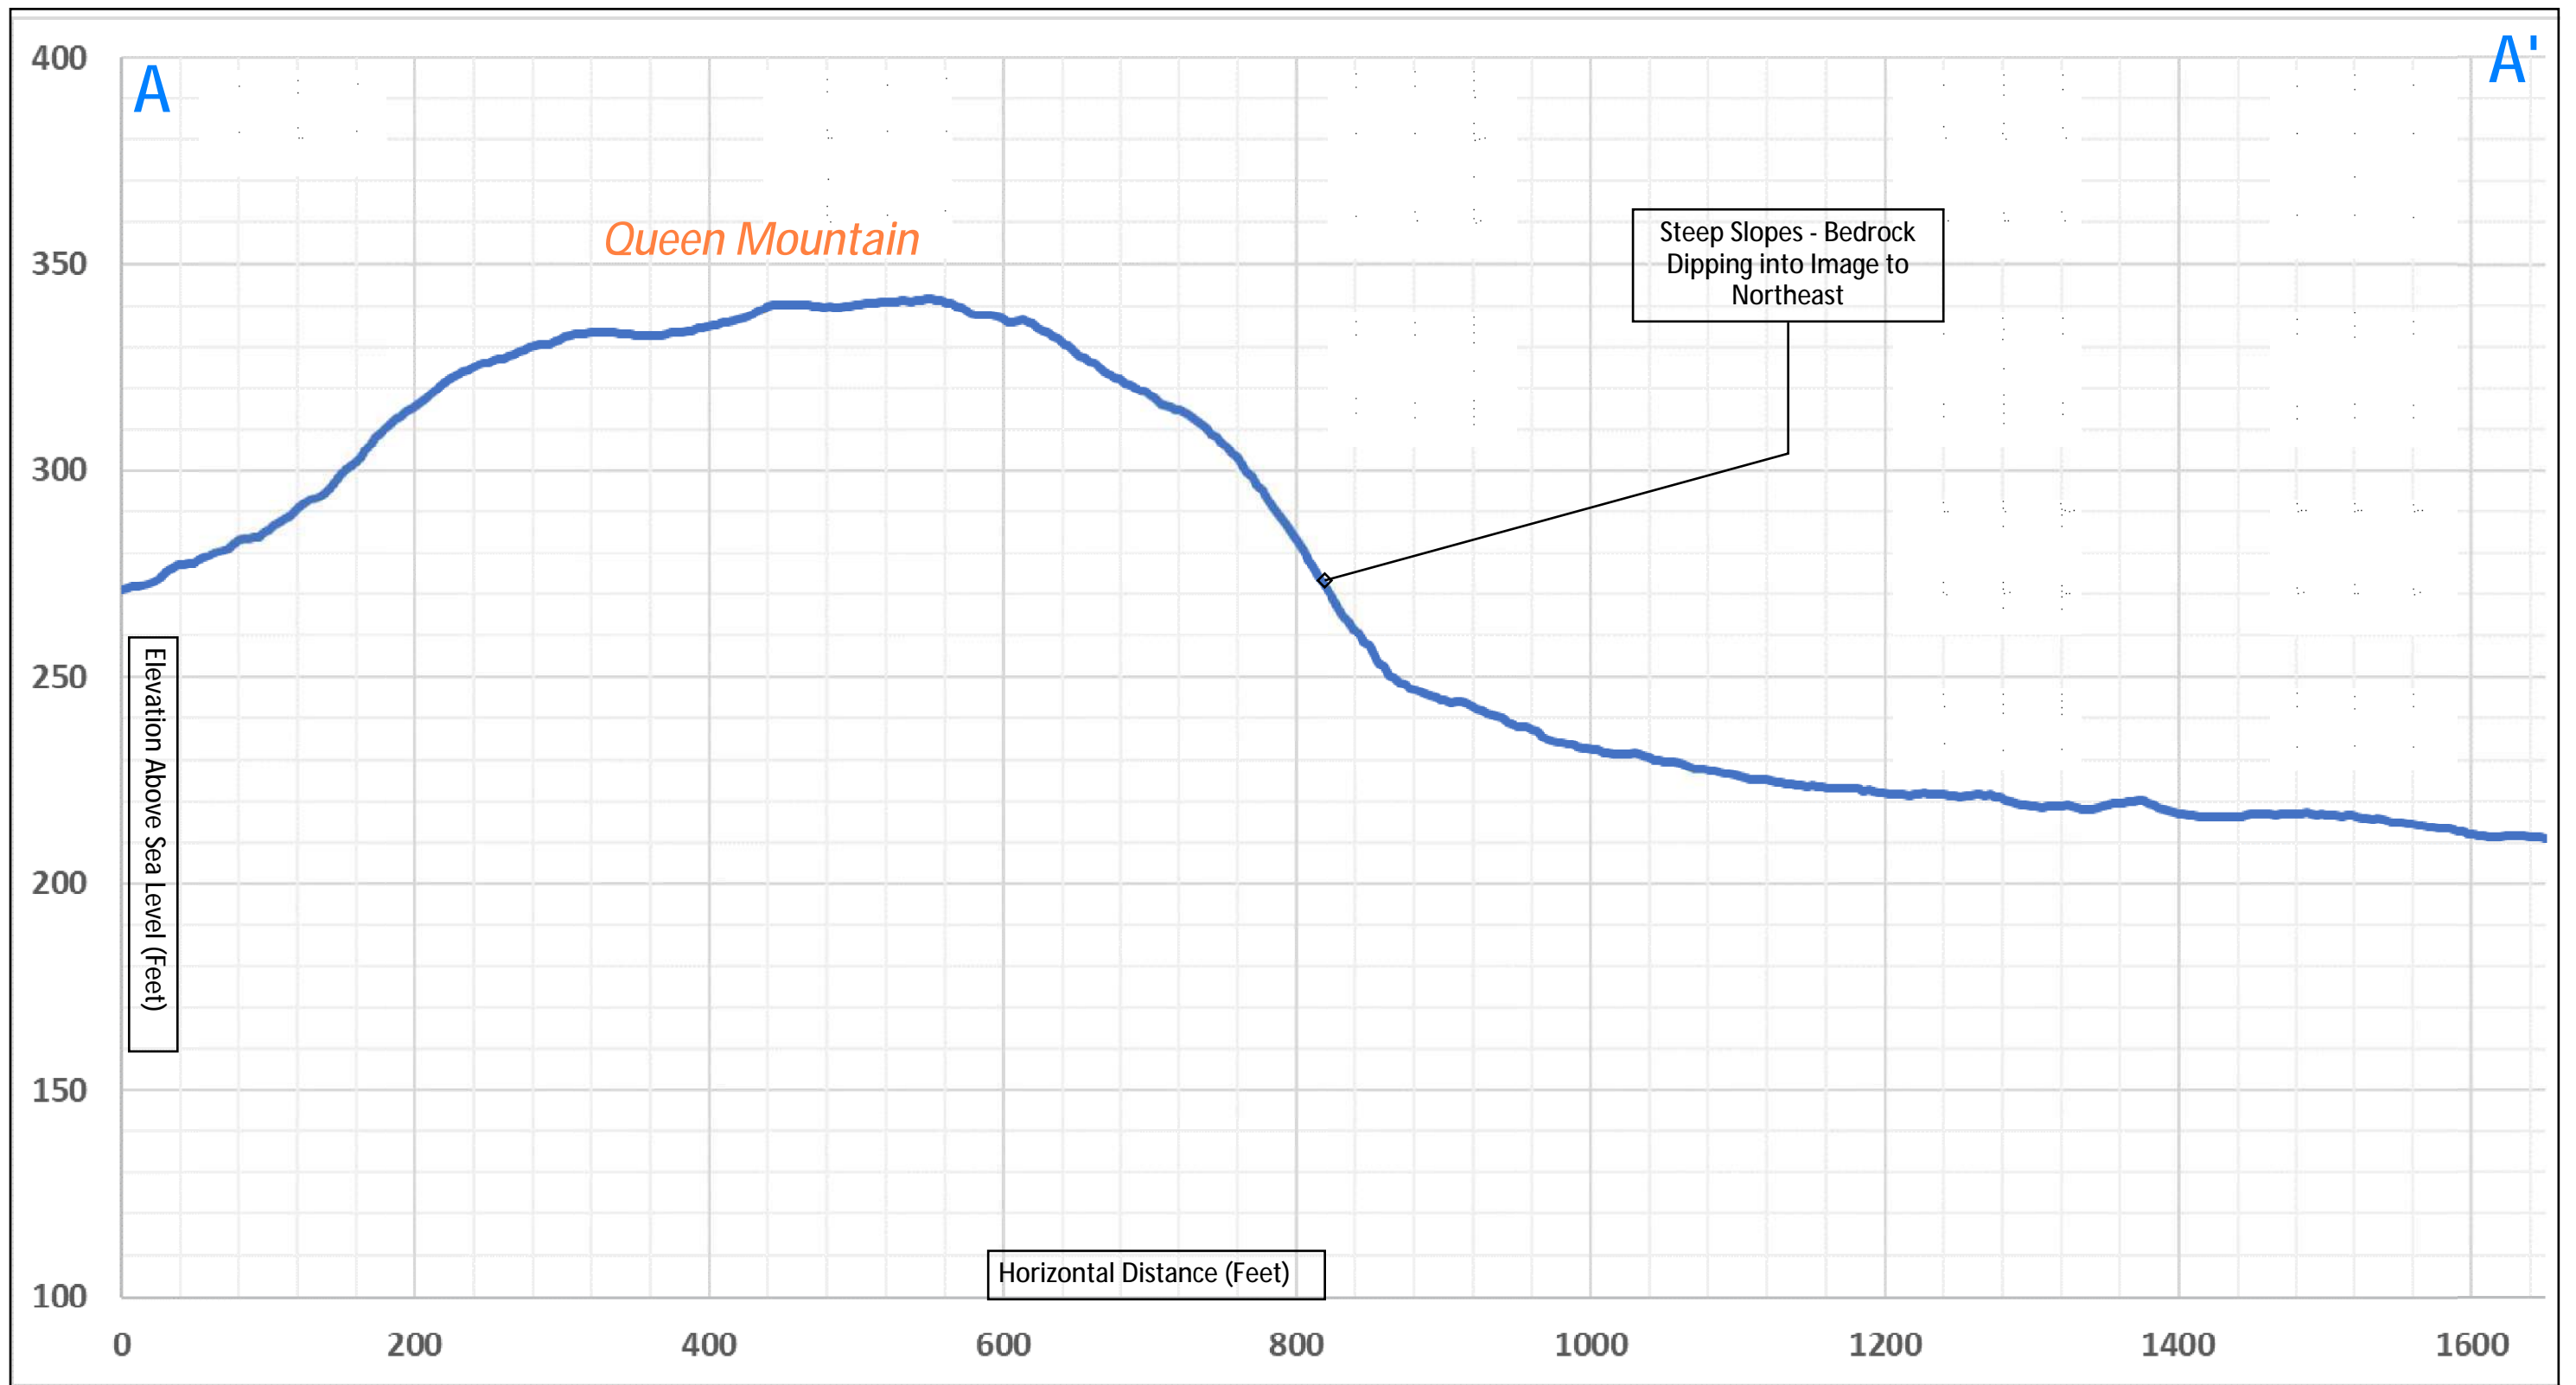
DATE: 8.10.2020	BY: NGD	SCALE: As Shown	PROJECT 20-0591
TOPOGRAPHIC PROFILE QUEEN MOUNTAIN PLAT 4175 IRON GATE ROAD BELLINGHAM WA, 98226			FIGURE 4

An annotated LiDAR site plan and generated cross section of the proposed development can be found in *Figure 3* and *Figure 4* at the end of this report.
