FREELAND
& ASSOCIATES
CIVIL ENGINEERS

Subject: Preliminary Stormwater Proposal
Franklin Academy Addition - 3000 Northwest Avenue
Parcel #380224-412399

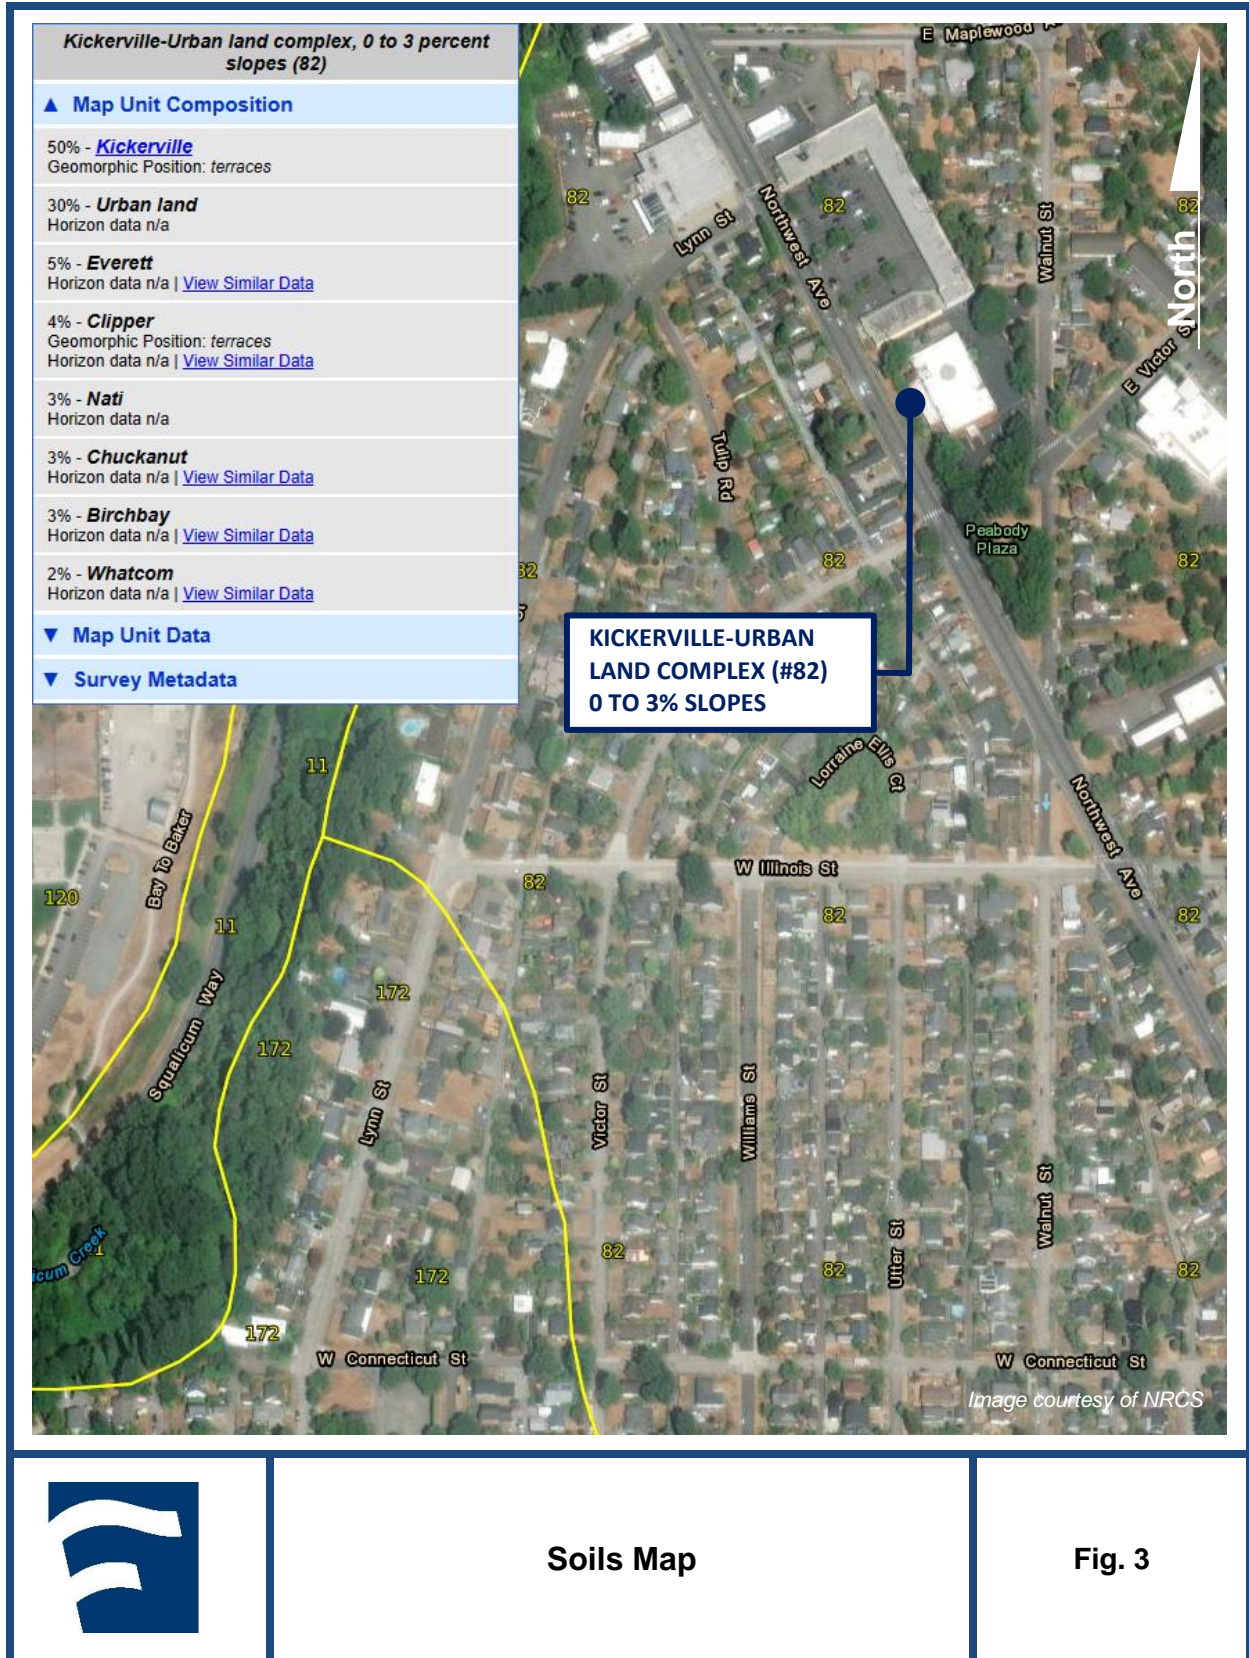
Fig. 3

Soils Map

Soils on the site are mapped as Kickerville sandy loam (#82) of hydrologic group 'B'. Hydrologic group 'B' soils have a moderate infiltration rate when thoroughly wetted and contain a fine to coarse texture. Refer to *Fig. 3 – Soils Map* for the regional soil information.
